## Tracking the behaviour of hydraulic structures. Case study - Valea de Pești Dam, Hunedoara County

Lucian Dragomir<sup>1</sup>      Mihai Valentin Herbei<sup>2</sup>      Iacob Nemes<sup>3</sup>

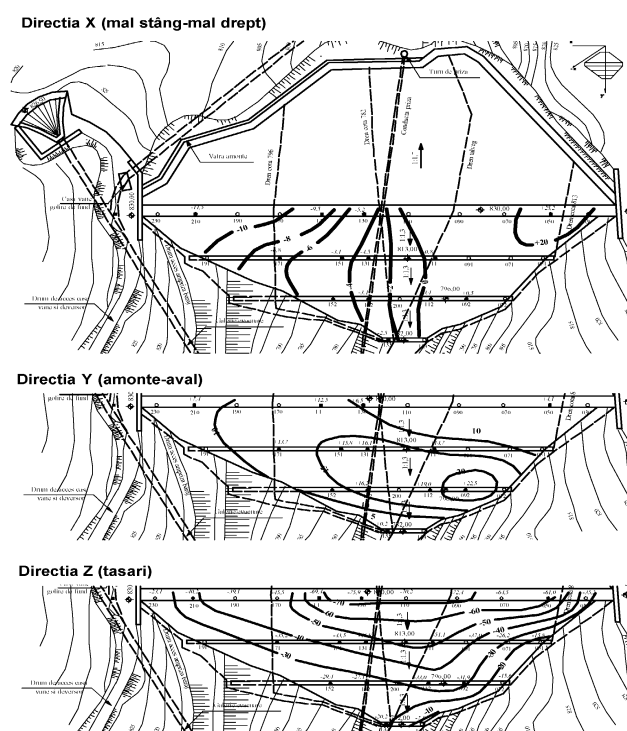
Maximum horizontal displacement from launching, after 20 years of operation was 21.2 mm, being much less than the allowable limit, located in the section from the left bank to the canopy.

The nature of these horizontal movements is a residual plastic deformation due to the release of the dam under load, elastic deformations resulted from changes of the level are very low, close to the precision measurement survey and so, basically, hard to determine.

Horizontal movements showed a slight deformation trend downstream.

In general most of the profiles analyzed present plan deformations of max 22.3 mm in the direction Ox, overall global and relative displacements are small and within the normal behavior of the dam.

Fig. 1. Horizontal displacement graph

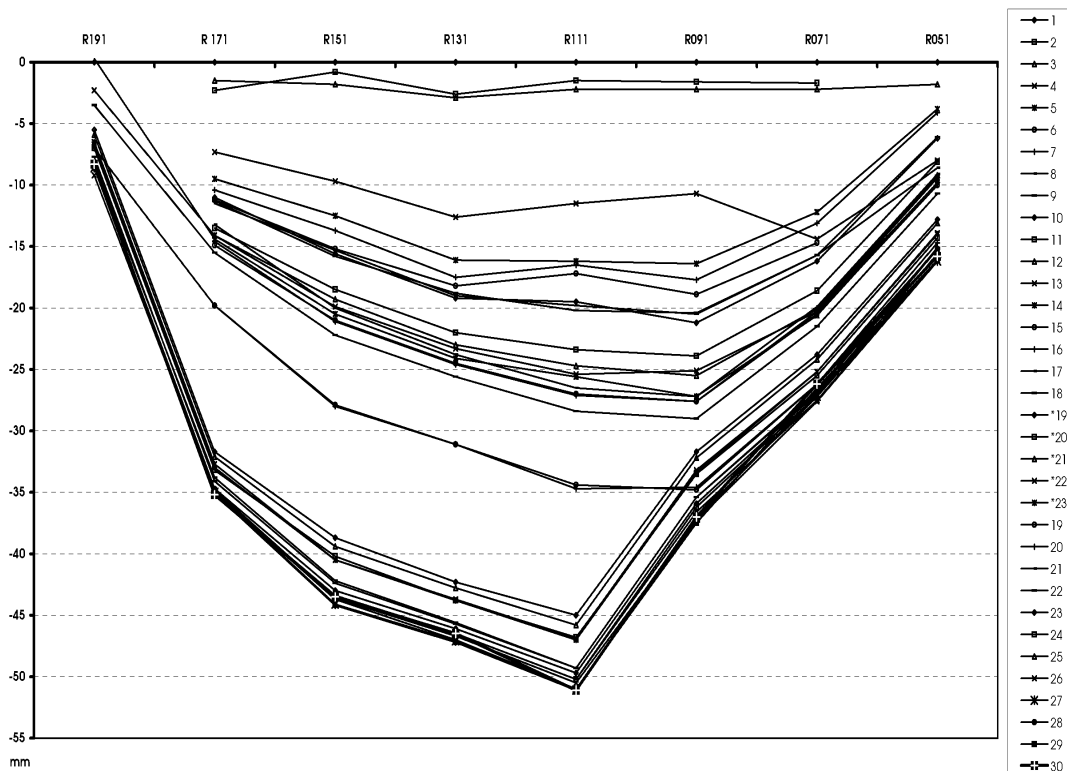
Maximum settlement is recorded in the canopy, but also at the 3 berms of the downstream level: 813mdM, 796 mdM, 782 mdM and their plan distribution is normal considering the asymmetry of the valley, having the steeper left bank and right bank leaner.

For the landmarks on the 3 berms downstream we have similar phenomena, continuous appearance of curves showing normal behavior.

Fig. 2. Vertical displacement graph - berm

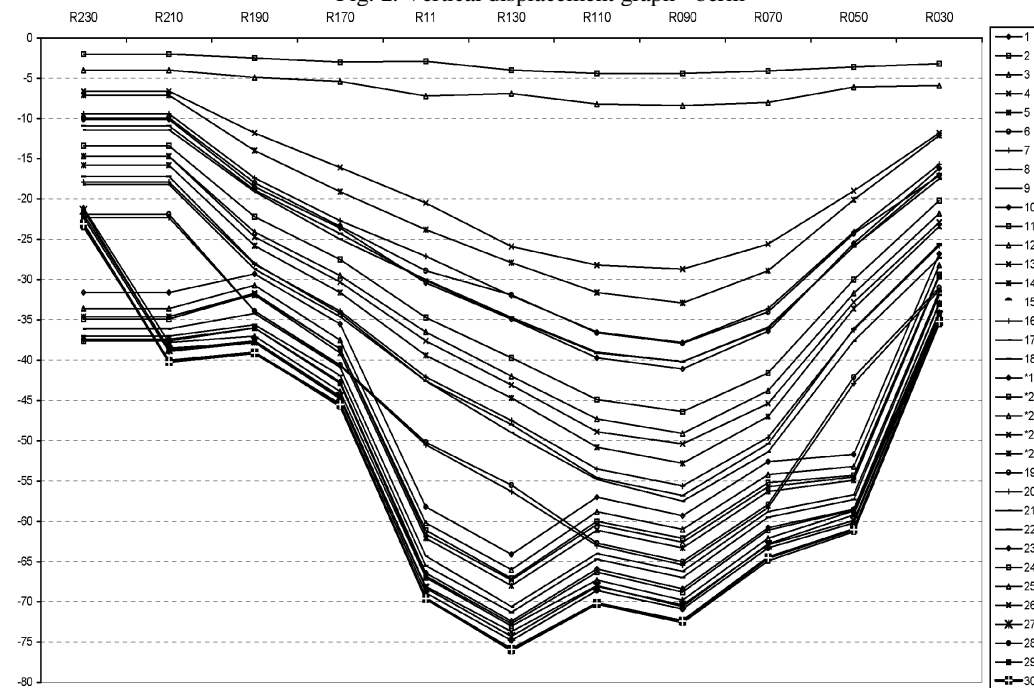
Maximum settlement level during 1973-1999 is 74.3 mm for landmark 130 on the canopy, falling generally within the normal range of this type of dam, leading to the conclusion that the fillings from rock fill were well compacted during execution.

In the period 1973-2005, were carried out a series of 36 geodetic measurements, generally on an annual basis. Distribution along the canopy of vertical displacements of different series of measurements results lead to the conclusion that the settlement is proportional to the section height, as normally should be.

Vertical displacements are maximum at the canopy - 78.9 mm in the direction of the old river bed where fillings have higher height (R130).

Fig. 3. Vertical displacement graph - canopy
