# BEHAVIOR OF SĂCELE DAM FROM BRAȘOV COUNTY IN PERIOD 03.2018 - 05.2020

**Abstract:** The paper has as objective the analysis of the behaviour of the Săcele Dam from Brașov County in the period 03.2018 - 05.2020, [11,12,14,15,16,17]. During the analysed period, two events were registered in operation, namely: the flood from March 13 to 16, 2018, which led to an increase in the level in the reservoir to 745.82 maSL; and the flood during June 24 - July 5, 2018, when the maximum level was registered as 745.91 maSL (July 1, 2018). The overall behaviour of the work, throughout the operation was in accordance with the nature and size of the requests and were within the limits of evolution below the accepted values. The visual observations did not reveal any elements that would lead to a reduction in the safety of the objects or restrictions on operation. The operation restrictions are due to the non-achievement of the DN1A national road overhang. The hydro-mechanical equipment in the retention front of the arrangement had a normal behaviour during the analysed period, without major events or accidents. The planned tests were performed. By processing the photographic images collected dur

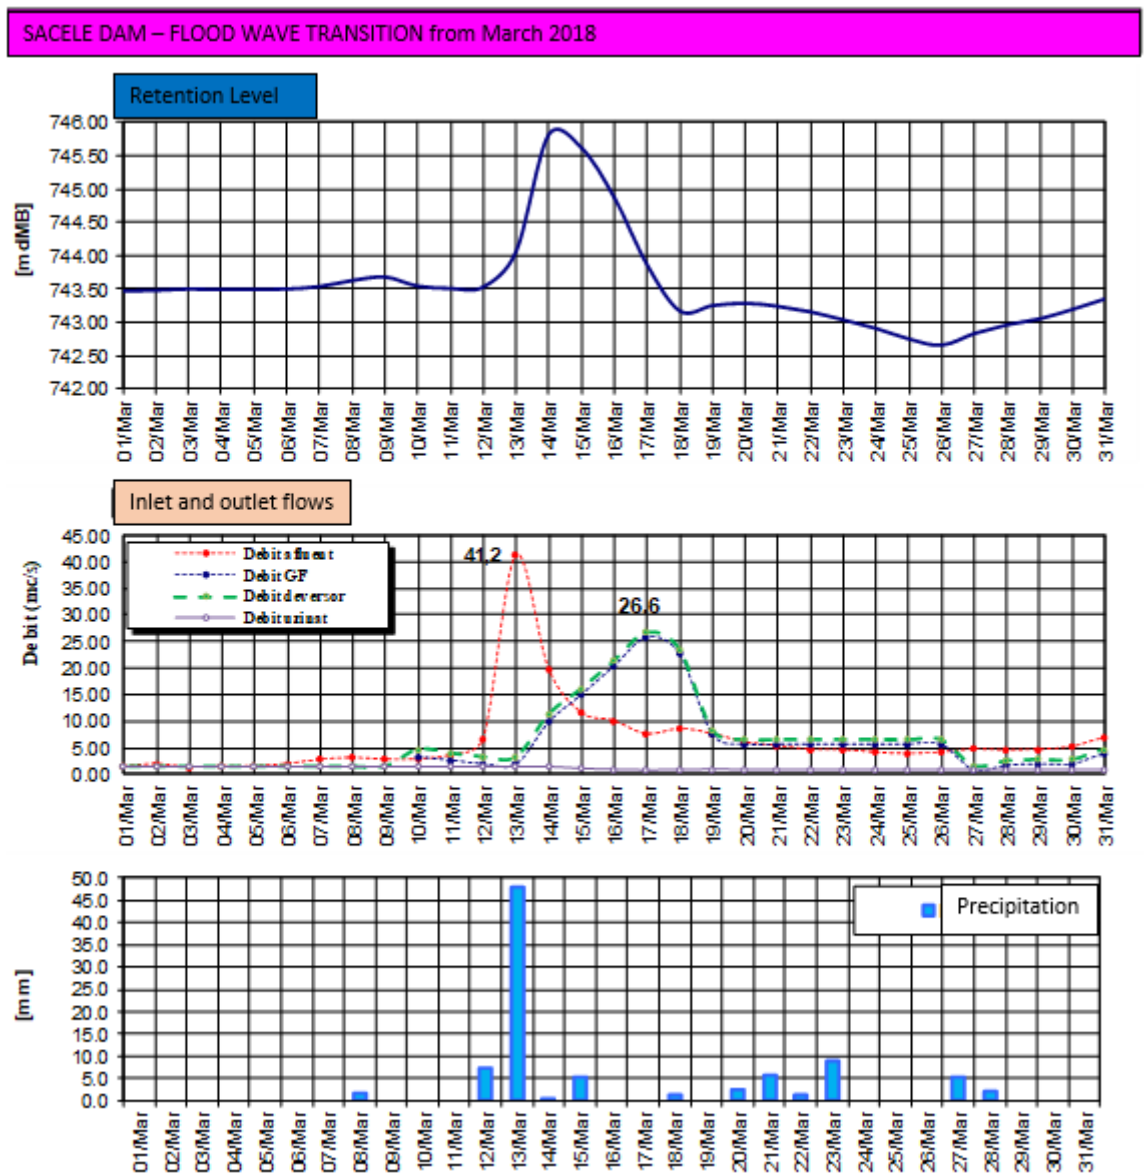
Figure 4. Flow hydrographs in March 2018

The March 2018 flood event was caused by heavy rains. The maximum tributary flow was 41.21 m<sup>3</sup>/s. The hourly evolution of the tributary flow and the outflows discharged through the bottom outlet and pumping station are illustrated in Table 1.

The Maximum Retention Level reached for the first time the 746.00 maSL. The discharge over the spillway (745.00 maSL) started through all four openings. The flooding volume was 18.6 mil. Cm. In Figure 4 are illustrated the March flood event hydrographs.

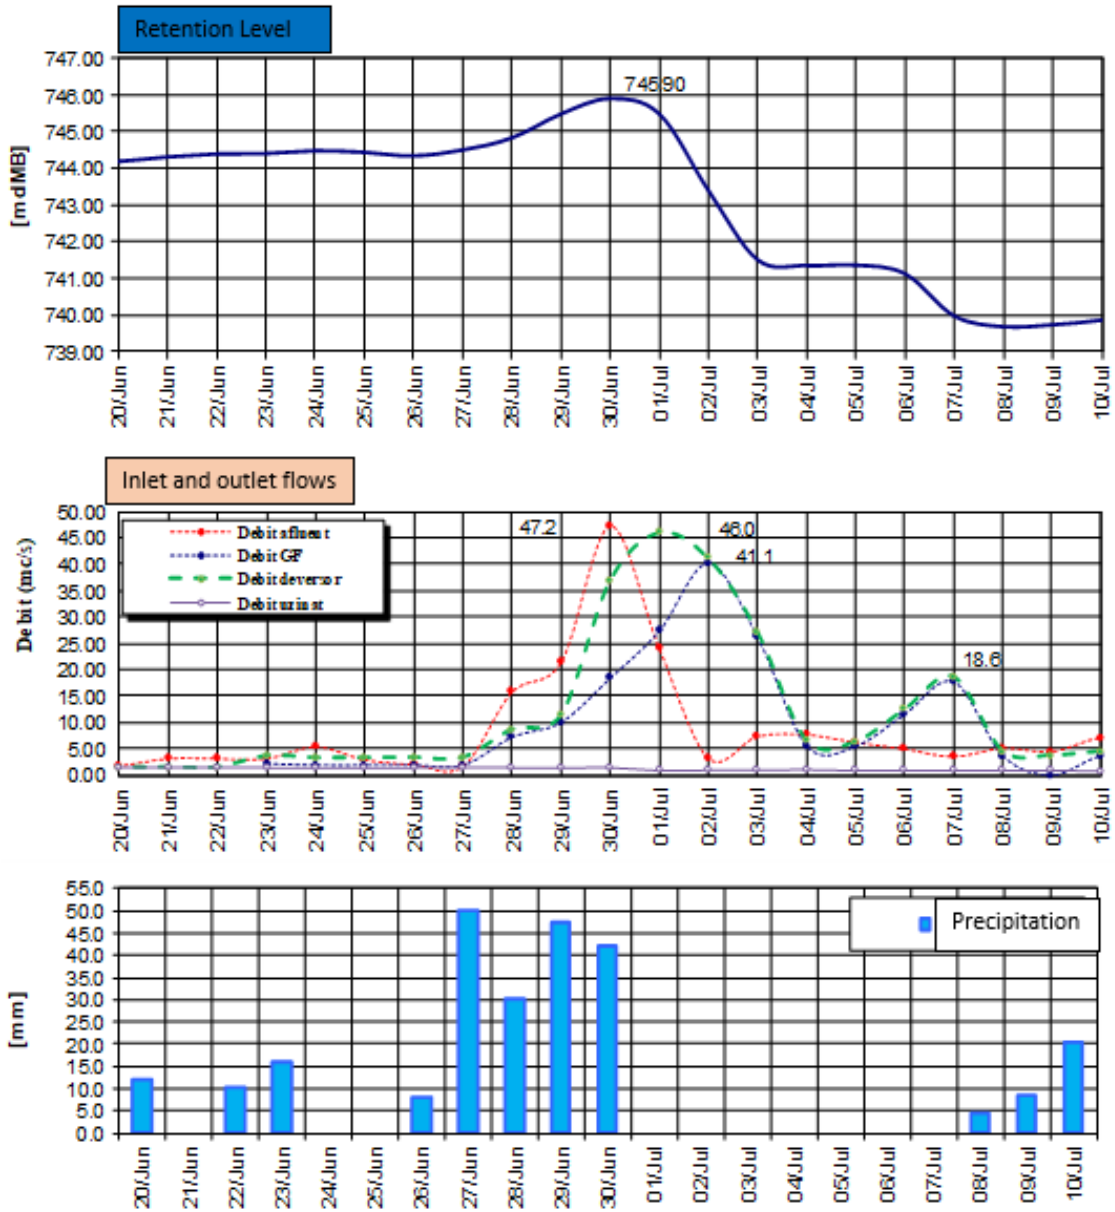
Figure 5. Săcele Dam- Flow hydrographs in June-July 2018

The June-July 2018 flood event was caused by heavily rain through the river basin. The maximum tributary flow was 47.2m<sup>3</sup>/s. The hourly evolution of the tributary flow and the outflows discharged through the bottom outlet and pumping station are illustrated in Table 2.

The Maximum Retention Level reached for the first time the 746.58 maSL for flood attenuation on Târlung watercourse, upstream of the dam. The discharge over the spillway (745.00 maSL) started through all four openings, overtopping the spillway maximum level with 98 cm. The flooding volume was 18.6 mil. Cm. In Figure 4 are illustrated the March flood event hydrographs.
