APPLICATION OF THE CONDOR STATISTICAL MODEL IN THE CASE OF THE CLOCOȚIȘ ARCHED DAM FROM GORJ COUNTY

Albert Titus CONSTANTIN¹ Marie-Alice GHÎTESCU¹ Cristina ALEXANDRU¹

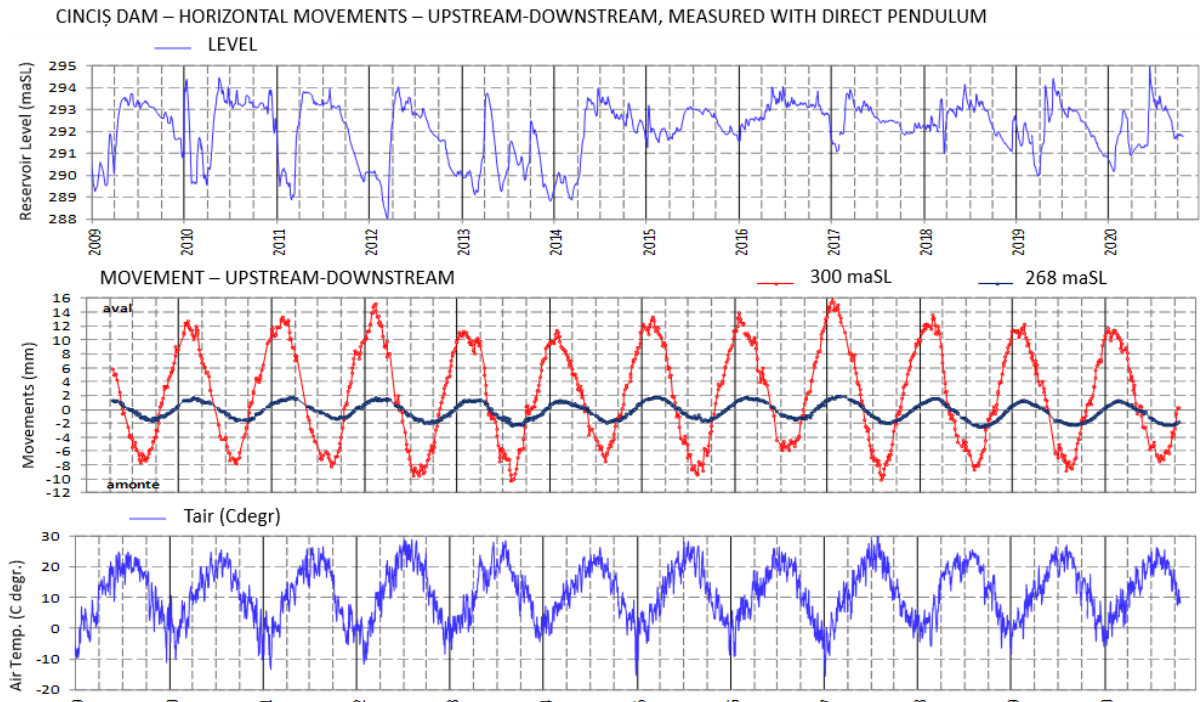
Figure 4. Horizontal displacements on upstream – downstream direction

- 1) Upstream – downstream movements are influenced by the seasonal thermal factor. This shear stress is significant, measurements showing seasonal variation.

- 2) The displacements measured during the analysed period falls within the range values from the previous functioning period.
- 3) The extreme values, slightly different, from 2017 are due to the fact that on January 10th, 2017, were recorded the lowest temperatures on site (-15.8°C) from the entire period of analysis (2009 – 2020), and on August 3rd, 2017, the highest temperatures on site (30.5°C) from the entire analysed period.

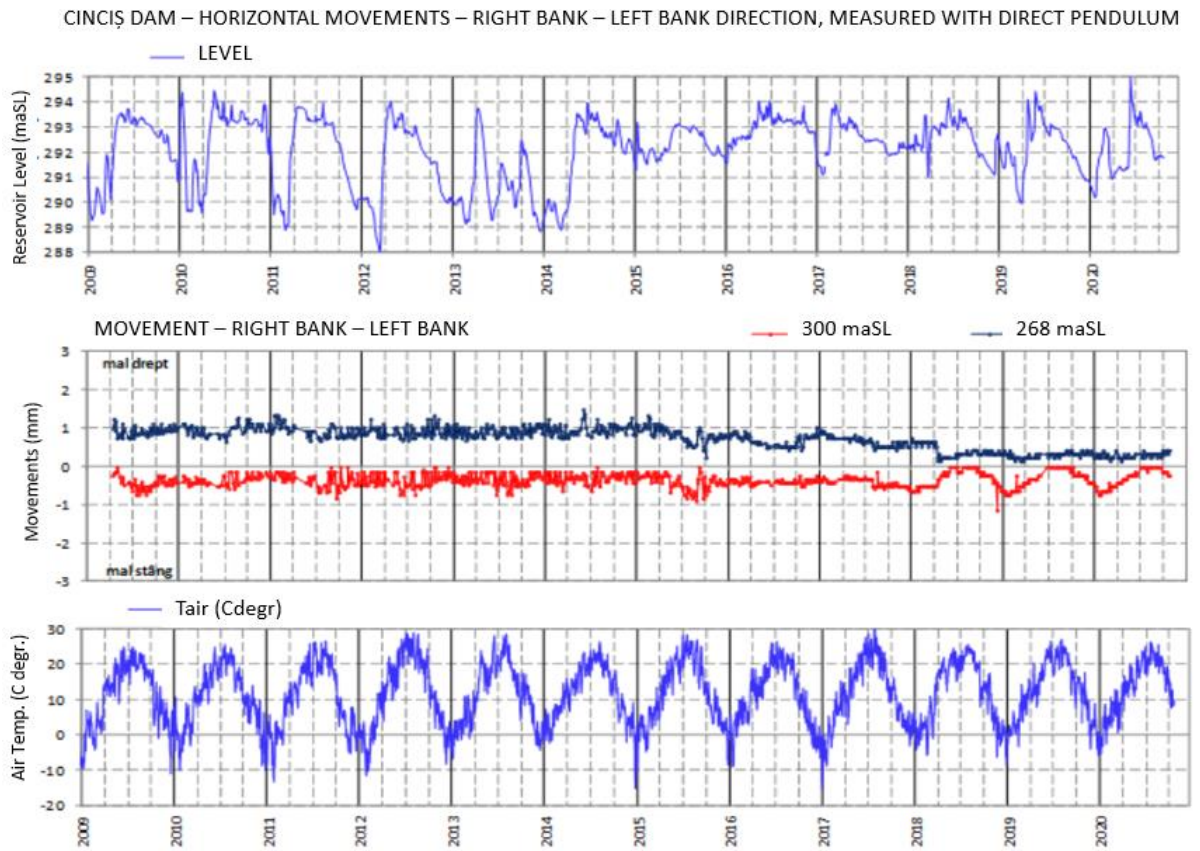
Figure 5. Horizontal displacements on right bank – left bank direction

- 4) In the right bank – left bank direction, the measured displacements are small, under millimetres, the influence of external factors being in the accuracy range of the measurement system.

- 5) Starting with 2018, at the measurement point, elevation of 300maSL, the displacements on the right bank – left bank direction were influenced by the seasonal thermal factor, which demonstrates a qualitative improvement in the measurement's performance.

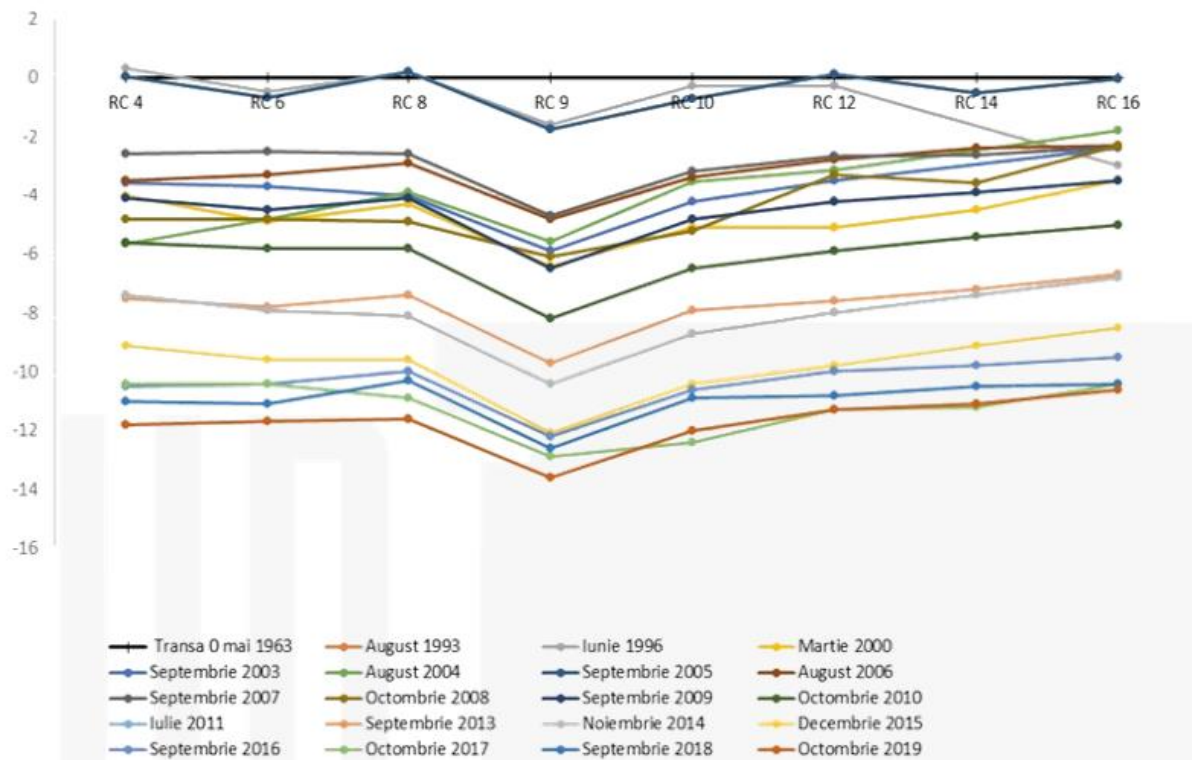
Figure 8. Settlements at crest level

- In 2006, the total settlements measured were between 2.35 mm and 4.68 mm, compared to the year 1963.

- In the tranche of measurements from 2016, the settlements total results of 9.8÷10.6 mm in the right milestones RC4, RC6, RC8, RC10, RC12 and RC14 and of 9.5 mm at the RC16 benchmark, the maximum value of 12.2 mm being measured near the RC9 mark.

Compared to the previous stage, from 2015, the subsidence at the crest of the Cinciş dam had a growth between 0.1÷1.4 mm.

- In the tranche of measurements from the year 2019, the settlements maximum at the crest have values between 10.6÷13.6 mm throughout the follow-up period (1989÷2019). The maximum value of settlements at crest is 13.6 mm and was measured at landmark RC9 located in the central area of the dam.

In the period 2006÷2019, the evolution of subsidence occurred with the rate of 0.2÷0.4 mm/year. In the area of the slopes, the subsidence has lower values, between 10.6÷11.8 mm with the annual rate in the period 2006÷2019 between 0.2÷0.4 mm/year.

Compared to the measurements carried out in the 2018 stage, the settlements measured in 2019 evolved with 0÷1.4 mm. The maximum was recorded at the landmark RC4 from the left shoulder of the dam. Were also recorded elevations (swells) in points RC10 of 0.4 mm and in RC14, of 0.1 mm, due probably the influence of temperature.

It is found that the vertical deformations increase in the cold period of the year and there are returns in the summer period. Against this behaviour can consider that the deformations produced are generated by the efforts given by the temperature which are usually characterized by cyclical returns to previously achieved values. On the other hand, the size of these deformations is very reduced and can be entered in the measurement error gap. In conclusion, it can be stated that the dam had, from point of view of vertical displacements, a normal behaviour over time, consistent with the demands to which it was subjected.
