# HIGH HEAD HYDROPOWER STATION TECHNICAL REHABILITATION AND REFURBISHMENT

**Abstract.** The specific subject of the presented paper is to describe the technical and constructive rehabilitation and refurbishment of the Grebla HydroPower Station (HPS) and its annex elements. The Grebla HPS operates the discharge captured from Văliug Dam reservoir, as employed in the complex scheme of Upper Bârzava River Hydropower Arrangement, upstream of Reșița Town, south-west of Romania. The headrace gallery is loaded mainly by a bottom catchment at the base of the Gozna Dam, but also by adding the already turbinated discharge from Breazova HPS tailrace. The main headrace canal has a length of 14.2 km, accomplished mostly by excavation and lined by stone masonry with mortar. Still, about one third of the headrace length is represented by tunnels dug into the rock, some being concreted, others built in brick, and others being in natural state. In addition to these, there are also eight masonry aqueducts, with a total length of 65 m. The main canal ends at the Ranchina surging tank from where the three rivet metal penstock pipes (of 900mm in diameter) are loaded.

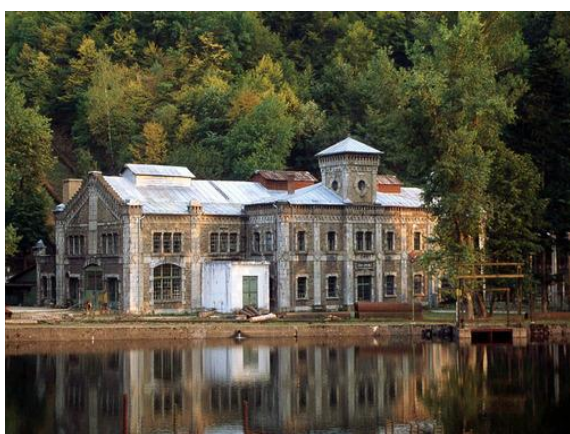
Figure 2. Grebla HPS main building, prior the rehabilitation

According to the technical expertise report [7], the general condition of the construction is good. There are no degradations of materials as due to the ascent of capillary water or due to the rainwater collecting. The effects of the frost clefiness cycles are not visible and there are no cracks in the structural load-bearing walls.

Both the infrastructure and the superstructure of the building are not affected by uneven settlements or sliding of the foundation supporting ground.

The floors arranged over the basement are on proper working condition and do not show degradations. The roof supporting structure does not show any damage due to the rainwater infiltration.

The whole structural ensemble of the building does not show degradations generated by previous seismic phenomena.

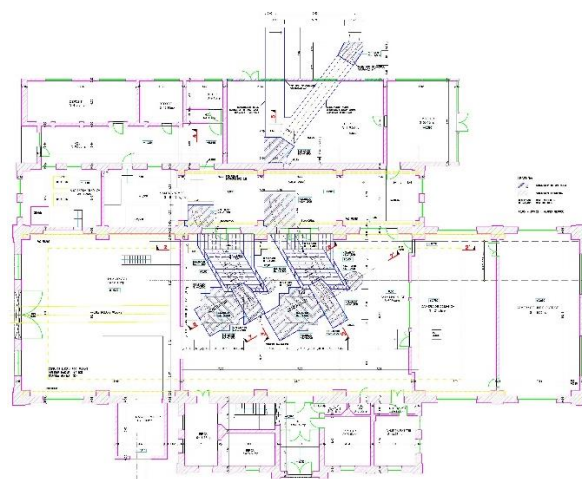
Figure 3. Plan of interventions at Grebla HPS building

- the partial demolition of the foundations from the existing equipment (turbines, generators) in the machine room (floors and concrete massifs) and their reconstruction according to the requirements for the placement of new equipment;
- demolition of the cable channel foundation and increase of the related functional space;
- demolition and geometry restoration of the access space corresponding to the vacuum tube;
- demolition and restoration of the wall in the access area of the new forced pipeline with DN 900.

The restoration of the structural resistance elements, necessary to support the new equipment, is made with reinforced concrete of C30/37 class [4] and corresponding to the exposure class XC1+XA1+XM1. At the same time, the restoration of the access gap corresponding to the vacuum tube will be done also with C30/37 reinforced concrete, corresponding to the exposure class XC2+ XA1+XM1.

As about the concrete floors and beams supporting the equipment, they are to be reinforced with double nets (made up of straight bars) and with resistance bars, made of concrete steel PC52, respectively with OB37 the distribution bars (the steel bars coating with concrete is to be of at least 25 mm).

The cooperation of the new structural elements with the existing structures is achieved by anchoring the new reinforcement rods in the existing supporting material on a depth of at least 40 diameters, respectively by fixing it with injection mortar.

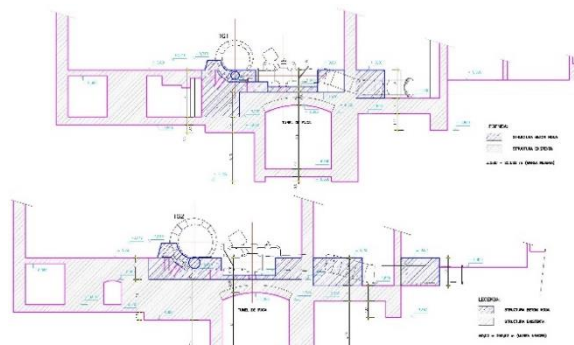
Figure 4. Cross-view by Grebla HPS pointing out some of the intervention structural works

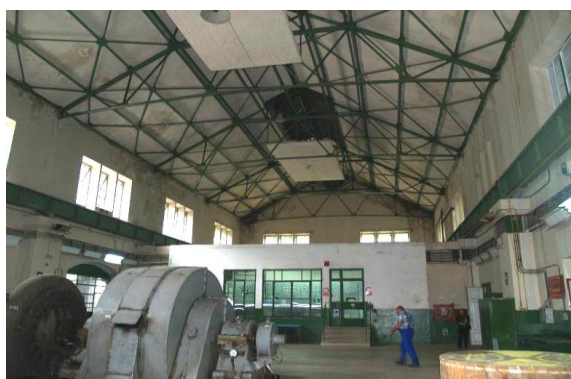
For sure the most important aspect of the power station rehabilitation is the replacement of the old turbines with new, more efficient ones. They are located in the machinery room, as shown in Figure 5.

Figure 5. Machinery room at Grebla HPS, previously the rehabilitation process

Along with the hydropower machines replacement, it is also foreseen the replacement or modernization of all hydraulic, electrical, operating and automation equipment related to the power station.

The turbine water intake valves as well as the downstream coffer-gates on the turbinated water runway will be refurbished or replaced.

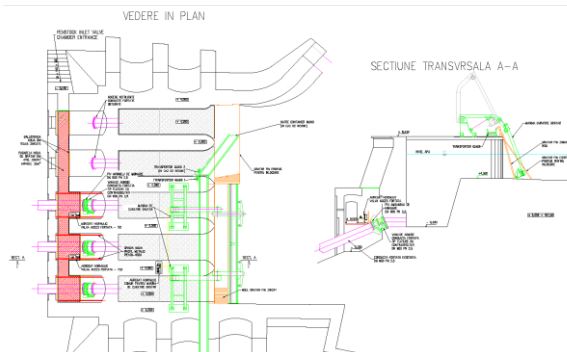
Figure 7. Interventions plan at Ranchina surge tank

- the washing gate is going to be replaced with a new (galvanized) one;
- two new automatic cleaning machines, equipped with hydraulically operated arms, for cleaning the grate will be installed for the grate on the access to the penstock pipes (the cleaning machine will be automatically operated from the power station control room);
- the installing area will be adapted to the needs of fitting new grates, also tailored to the requirements of the automatic cleaning machine;
- two new machines for cleaning the grate will be installed, as equipped with hydraulically operated arms.

The access valves to the penstock pipes (3pcs) will be replaced by new hydraulically operated butterfly valves of the same size. They are to be mounted with new mounting compensators and are going to be operated remotely from the power station control room. For the three valves operation control, two maneuvering groups will be installed (the valve for the pipe leading to TG1 turbine will be operated by the first group, and the two other valves will be operated by the second hydraulic drive group).

Each forced pipe will be equipped with overpressure sensors behind each butterfly valve that will signal the alarm situation in the control room.

All three forced ducts will be endowed with vent valves and ventilation ducts.

All the metal elements will be protected against corrosion.

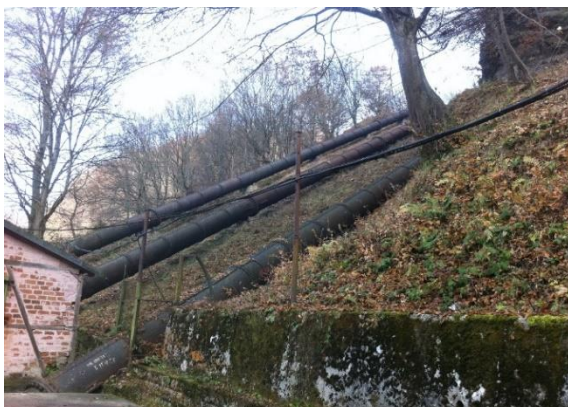
In the existing situation, from the surge tank common outlet start three penstock metal pipes ND 900 that lead the water to the power station (figure 8), where the three pipes are connected to a collector from which the water is distributed to the two turbines. Each forced pipe has one valve before the collector and each turbine has a spherical valve in front of it.

Figure 8. The three penstock metal pipes

So, the present shared outlet will be completely disassembled and the connection of the forced pipes to the turbines will be modified. The TG1 small turbine will be supplied directly from a ND900 forced pipe, the two other penstock pipes will be connected with a “Y” collector and will feed the large TG2 turbine.
