MONITORING THE EXPLOITATION BEHAVIOR OF THE "VALEA DE PEȘTI" DAM

Romeo Hriscan¹ Sorin Corici¹ Gabriel Codruț Leucuța² Teodor Eugen Man²

Abstract: This paper describes the observations in monitoring the exploitation behavior of "Valea de Pești" Dam, a gravitational dam, situated on the rock-fill of "Valea de Pești" river, about 500 m upstream of the confluence with Western Jiu river. The dam was traced with a plan curve radius of 2000 m. The construction of the dam was started in 1967 and was completed in 1973 when the dam was put into operation. The "Valea de Pești" Dam serves all the settlements along Western Jiu. Development of serviced land use imposed supplementation in 1985 by commissioning the capture of the Western Jiu Buta ($Q = 1 \text{ m}^3 / \text{s}$ and adduction $D = 1000 \text{ L} = 6.7 \text{ km}$) to the outlet conduits in "Valea de Pești" Lake.

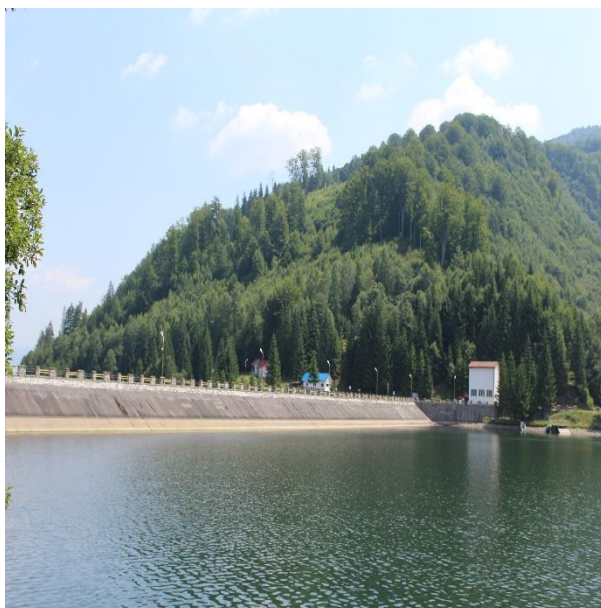
Photo 1. Upstream view - "Valea de Pești" Dam

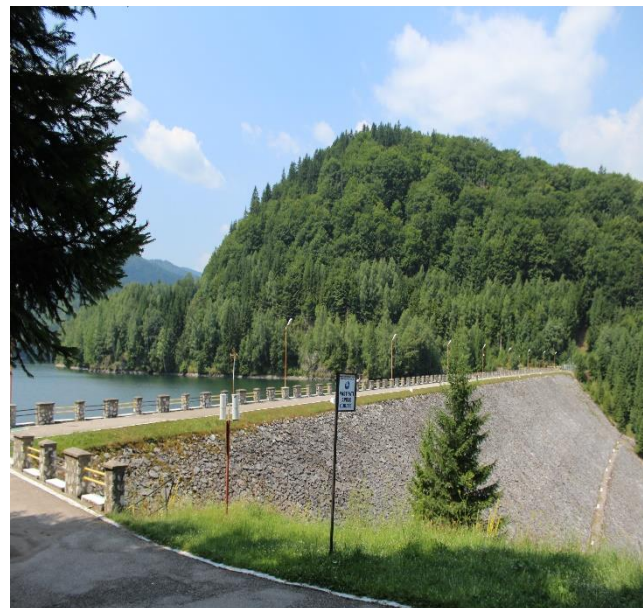
Photo 2. Downstream view - "Valea de Pești" Dam

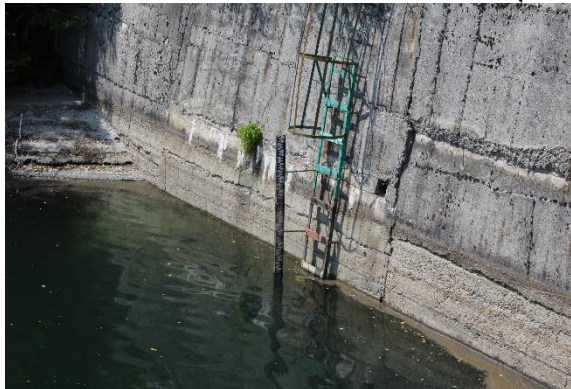
Photo. 3. Mira "Valea de Pești" Dam
