Transactions on HYDROTECHNICS

Volume 60(74), Issue 1, 2015

ASSESSMENT QUESTIONNAIRES FOR TAILING PONDS SAFETY – APPLICATION TO A CASE STUDY

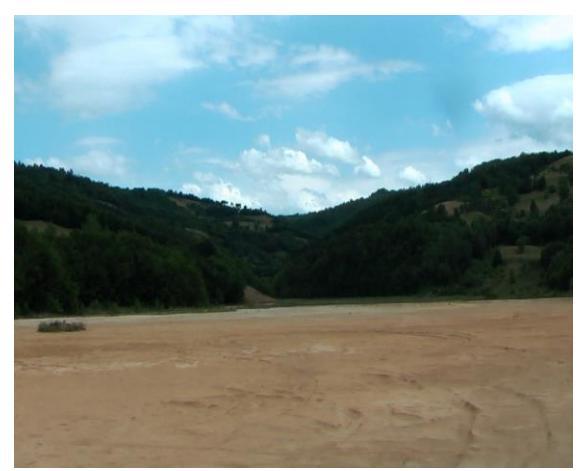
Figure 2. General view of Săliștei Valley pond

Tailings deposit is in restoration since 2006, is stable but shows local seepage phenomena on the downstream of the retention and on the sealing contact between the dam and the right side, where he was made a collection drain. The slopes adjacent to the pond has no active phenomena of instability, but areas with springs that have been collected and channeled downstream through drainage systems. Plants used in the process during operation of tailing pond were partially dismantled. Downstream of tailing pond no chemical treatment plant wastewater, but on the watercourse downstream, a monitoring section. The pond has in case of large waters, a large coastal spillway and an concreted exhaust manifold where are routed downstream, both upstream tributary waters and large waters collected in the pond. [9]

Lake clarification is very low and is pulled towards the tail pond near inverse probe still in operation. During operation Săliștei Valley pond, some dangerous phenomena for the safety of tailings deposit occured. There were suffusion, strong seepage of increasingly heigths, dangerous lifting of water level in piezometers. In 2004 began construction of a prism for the setting of downstream slope disposed at its base in order to improve the stability of the pond. Ballasting work has not been completed to this day, but it is contained in the technical design of the closure of the facility to be launched in the future. [9]

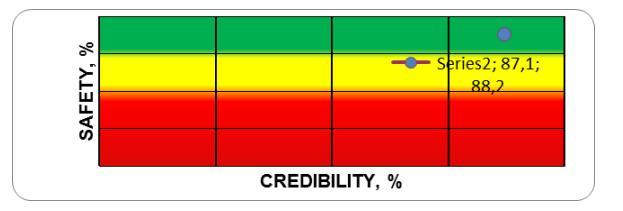
Figure 3. Two-Dimensional diagram of safety indices

The overall level of safety represented as a blue dot is positioned in the green and in the high credibility area.

In conclusion, inspected pond is classified as "safe" and do not require the use of the recommended actions from the catalog of measures.

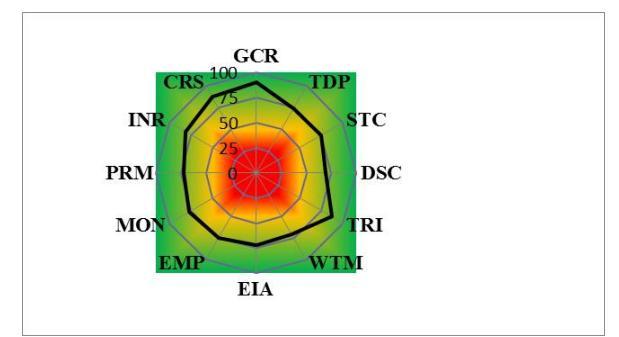
Safety index values for each category are used to create a polar diagram (spider diagram), shown in Figure 4. Figure includes representation in colors from red to green (in the article are shades of gray) and percentage (from 0 to 100) for values of the 12 safety indices centered on values (0.0).

In conclusion inspected tailing pond is classified as "safe" and do not require the use of the recommended actions from the catalog of measures.
