Artificial lakes: Problems and solutions

Man Teodor Eugen¹, Ienci Ioan Catalin¹

Abstract

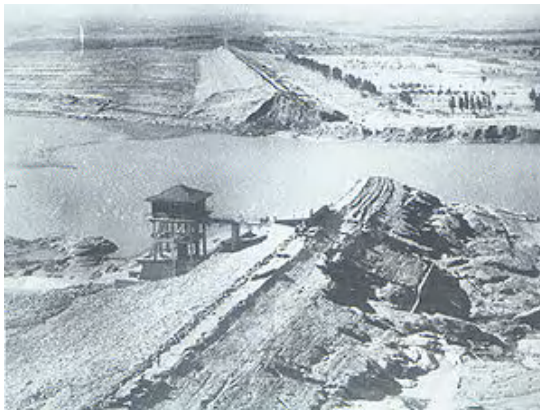
Fig.3 Banqiao Dam after the break.

Banqiao Dam (Fig. 3) was built in the early 1950s on the Ru River as part of a project to control flooding and generate electricity and as a response to severe flooding in the Huai River basin in 1949 and 1950. The dam was 118 meters tall and had a storage capacity of 492 million m^3 , 375 million m^3 reserved for storing water from floods. After completion the

building had cracks in the dam due to mistakes of execution and design. They were repaired with tips from Soviet engineers and the new design, called the barrage of iron, was considered indistructible.

The dam was designed to survive a flood of 0.1% (once every 1,000 years) insurance. However, in August 1975 has been a flood of 0.05% (once every 2,000 years) insurance, the water of rainfall in 24 hours exceeded rainfall for a whole year (new records were set, to 189.5 mm / h and 1060 mm / day) so that weather forecasts failed to predict it.

On August 7 at 21:30, 34450 unit of the People's Liberation Army, who were at the Banqiao dam, sent the first warning of a dam failure by telegraph. On August 8, 0:30, the smaller Shimantan dam upstream, which was designed to withstand a flood with 0.2% (once every 500 years) insurance, had to take a quantity of water twice as that and broke, just 10 minutes after the 34450 unit sent a request that would open the dam Banqiao by air attack. A half hour later, the water discharged over the dam and Banqiao broke at 1:00. This led to failure of 62 dams in total.
