Buletinul Ştiințific al Universității "POLITEHNICA" din Timişoara Seria HIDROTEHNICA TRANSACTIONS on HYDROTECHNICS

Post- ecologyzation disasters- Case of Rusca Montana and **Ruschita** localities

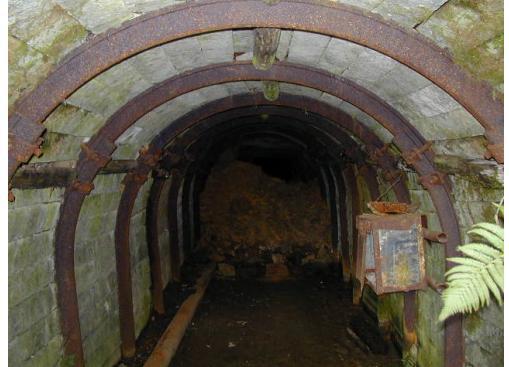
Fig. 1- The 3 ISEM collapse- gallery

If in the period between 1963 year and 1969 year, the mines was temporaly closed because of some wrong works (was outbursted to much in few galleries, in ceiling area) all three levels are collaopse in falls. To continue the ore transportation from dump to floating station, the mountain is perforated, under galleries, by a tunnel at 917 altitude where was and the preparation foundry. Instead of the three systems of galleries is form a cone which was near by the Colony.

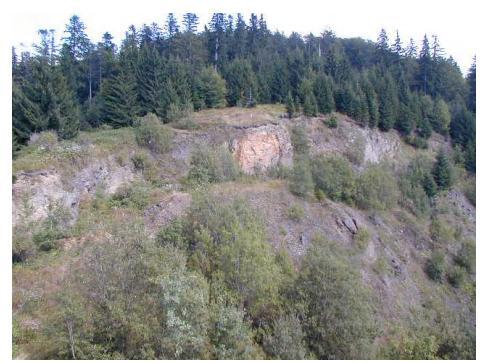
Fig. 2- "Boul" Peak- collapse

This disaster increase the contamination of area (of water the 6th time and of vegetation the 3th time).

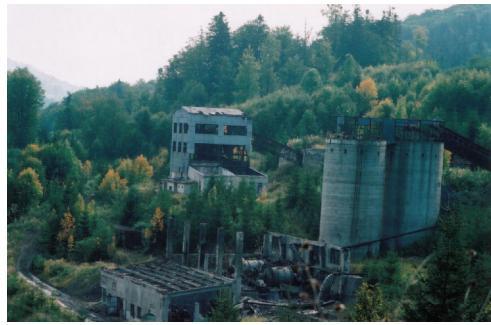
Fig. 3- The 917 complete flotation

Pumps flow over, the contaminated water directly in near river. At these phenomena accumulate and the contamination with flotation pulp. The radiometric evaluation, gamma global, show this value 900- 1800 Cps (1720 Bq/kg). The transport of proccessing ore was executed with trucks descover on the mountain road which caused the contamination of water from downstream to Voislova railway station (where was the area of depositing and boarding in train). After 2000 year the ecologization works of all galleries and annex-stations begin. In fact cut the iron (larries, locomotives, transformers, engines, pumps, well station, pipes, rails, metal fittings from mines), the buildings are demolished (barracks, annexbuilding) and at the entry of gallery is built an brick wall. The slopes are not solidify, the retaining walls were not built and the mining works are not revegeted. By those ecologization work, the disaster is increase, the radioactive and heavy metals pollution may be uncontrollable.[3] In 2000 year, after some rain with devastating phenomens, take place a dislocation of an sterile slope which destroy some houses and pile up 6-8 m of tailings. The slag ironstone slopes, mixed with branerite, are pushed to upstream and the contaminated water arrives in potable water tanks from Ruschita locality. In the area with mountain roads where the support wells are collapse, some of the mountains slope with their vegetation are dislocated.

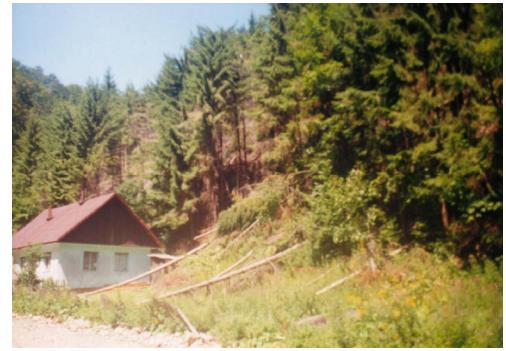
Fig. 4- Dislocated slope

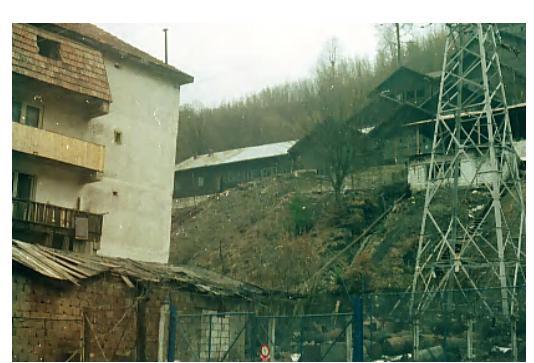
Fig. 5- "Ruschita" locality- lead flotation

In the midle of the Ruschita locality, the slag slopes of lead flotation arived to enter on windows at lower levels of apartment building.

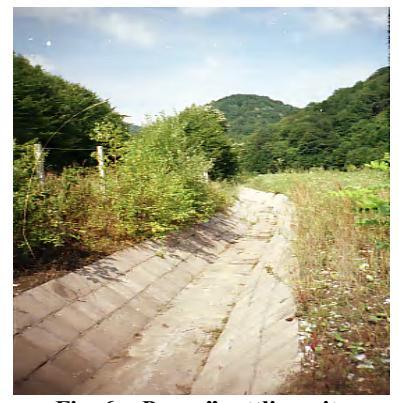
Fig. 6- "Porcu" settling pit

That material will not only eights valley, but will block the road and will contaminate a considerable length on "Padeş" valley, till after the confluence with the "Bistra" river. After some analysis, in the settling pit, were identified rare metals (gold, silver), heavy metals (lead, copper, zinc) even radioactive metals (uranium, thorium, yttrium); dislocation potential is high because was extract large amounts of marble blocks from dam protection; marble blocks which was used in constructions and local industrialized to obtain construct products (marble powder and kibble for mosaic). The displacement phenomenon can be amplified by the destruction of vegetation situated on dam. Both, the horizontal surface and the outer slope is crossed by ditches caused by rainwater flow; considering that the base is not stabilized in any way, are high chances that the dam to dislodge.

From efectuated researches, results that would be necesary a new works ecologyzation, correctly executed which to be focused on all slopes stabilization with mining works and situ treatment of water which draining from galleries.
