Researches Regarding Soil Erosion and Measures to Fight it on the Declivitous Terrains Located in the Cornea Locality Perimeter Caraș-Severin County. Their Impact over the Locality

Abstract: In this paper are presented the erosion forms that led to the land slip from the Cornea locality, Caraș-Severin County, their impact over the locality and the solution for the area improving.

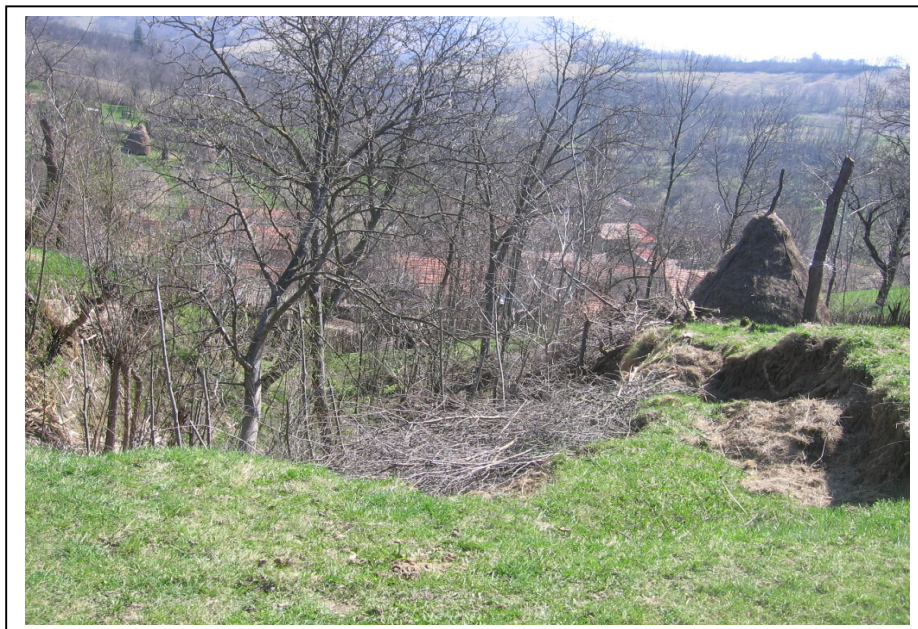
Fig. 2 The Cernilova land slip

- For the landslip (small depth and surface landslip), near "Cernilova" base flank we propose the next solution (figure 2):
 - To level away the slip surface
 - Execute a horizontal drain to the base of the slip, that will collect the water from the sandy horizon that are situated under the gliding clayey horizon, and will eject to the emissary situated at the flank base.
 - To level away the area above the slip (an area with micro-dislevelment and furrows from farm equipment circulation)
 - A declivous earth wall execution, which will collect the surface water and will eject in the natural outlet from around.

- The land slip from Cernilova affects the entire agrarian field, the house and communal road from the landfall basis;

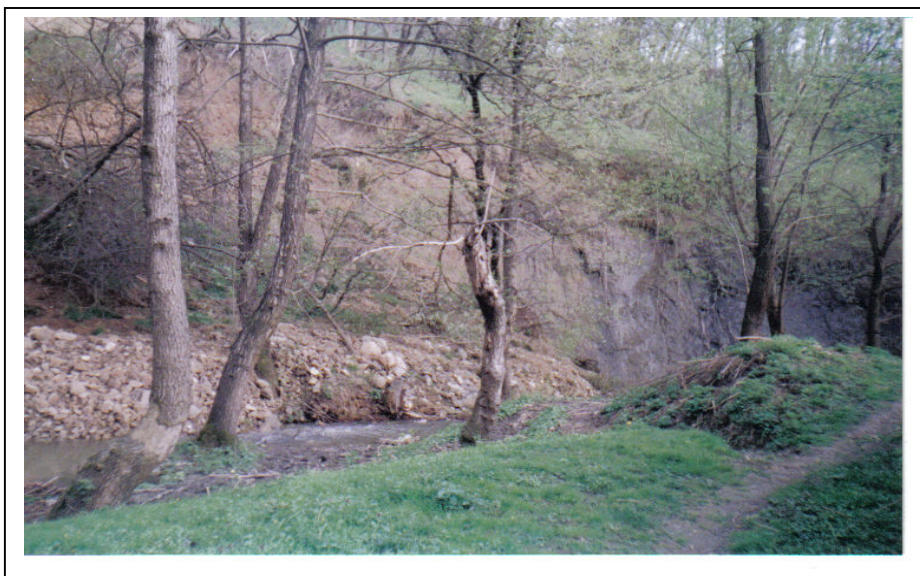
Fig. 3 The Cucuiului Hill land slip

- For the landslide situated in Cucuiului Hill we propose the next solution (figure 3):
 - Glen tip formation improvement, situated near the landslide, with an outlet collection channel form, that will undertake the surface water and will eject in “Chișăvăț” river.
 - A declivous earth wall execution, upon the landslide, that which conduct the surface water to this outlet.
 - Left bank consolidation of “Chișăvăț” River in the landslide area, by forest works, executing a tail board with 2 m height, for slope of thalweg modifying.
 -

- The land slip that currently affects the Cucuiului Hill may lead to major damages for the houses located at the base of the versant;

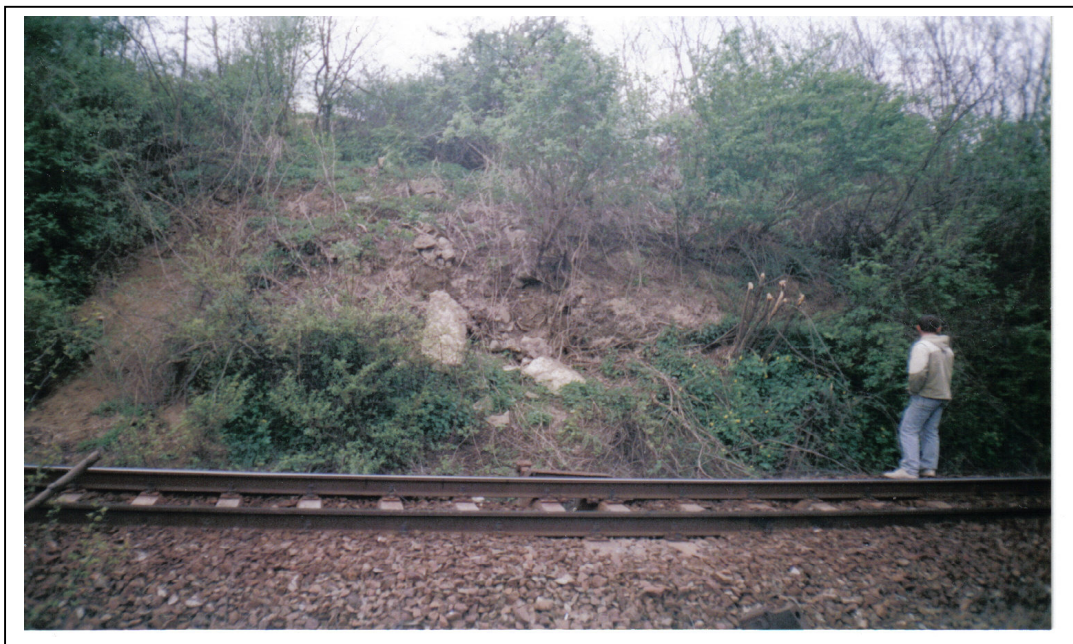
Fig. 4 The land slip near the rail road.

- For the landslide from figure 4, a landslide that affect the railroad that are situated at the base of the landslide we propose:
 - To execute an abutment from prefabricated pieces.

- The land slip near the veterinary dispensary affects the stability of the rail way at the base of the landfall.
