Rehabilitation of Drainage Multipurpose Arrangement and Soil Erosion Control Greoni-Ticvani, Caras-Severin County

Abstract: Multipurpose arrangement of drainage and soil erosion control Greoni - Ticvani, Caras-Severin County executed during 1988-1989, after 30 years of work still needs rehabilitation. This paper presents the design situation before and after rehabilitation. Based on observations in the field (see photos) have been established and proposed rehabilitation works carried out in 2008 and presented photographs of section 2, works financed by the state budget.

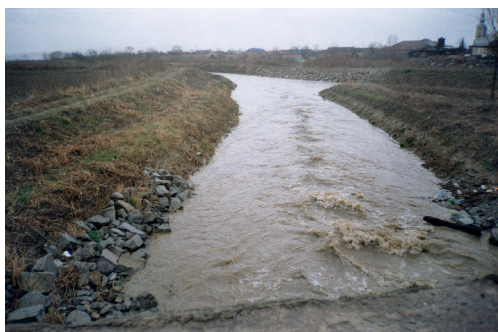
Photo 1 – Oravita Valley at the junction with Lisava Valley (2009)

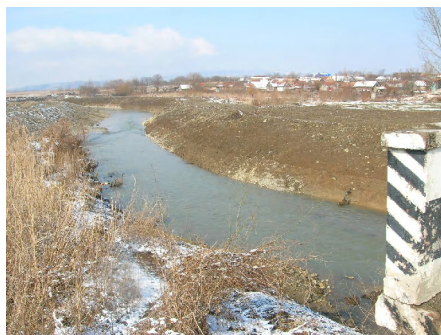
Photo 2 - Lisava Valley downstream of the DN 57 (2008)

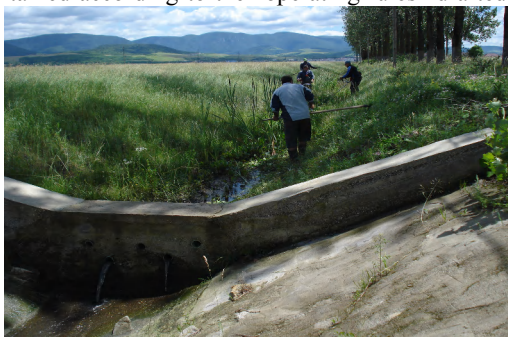
Photo 3 – Main drainage channel CP41 threshold drop of concrete, works for the destruction of aquatic vegetation and grassy (2010)

- herbaceous, water and wood vegetation destruction on the channels - handmade works and mechanical works by Stihl Motor mowers and chainsaws;

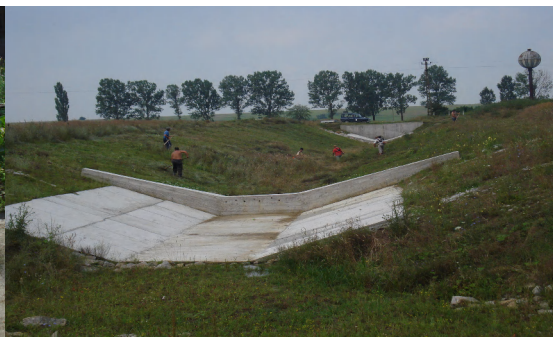
Photo 4 -Main drainage channel CP41 threshold drop of concrete, works for the destruction of aquatic vegetation and grassy (2010)

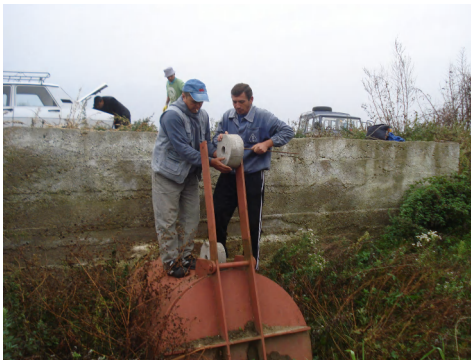
Photo 7 – Under-crossing the dike with metallic dampers Channel CCS42 Lisava Valley Maintenance and repairs works to the metallic damper counterweight (2010)

- maintenance of channels and hydraulic constructions (bridges, water drops, under-crossings the dikes with metallic dampers, etc.) - handmade works, consisting of cleaning mud in pipes and river

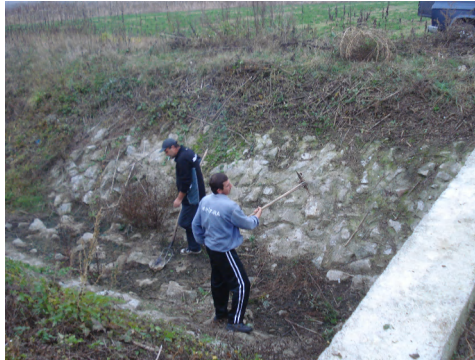
Photo 8 - Maintenance works on pipes at drainage channel CCS43 (2010)

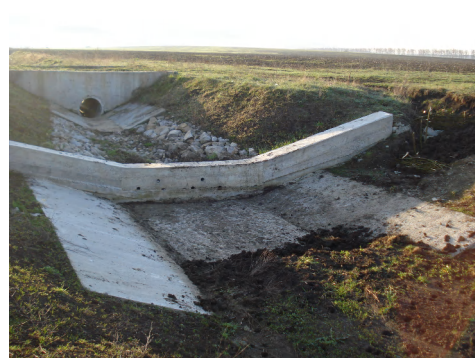
Photo 10 – Pipe culvert DN800 and threshold drop at drainage channel CS410 (2009)

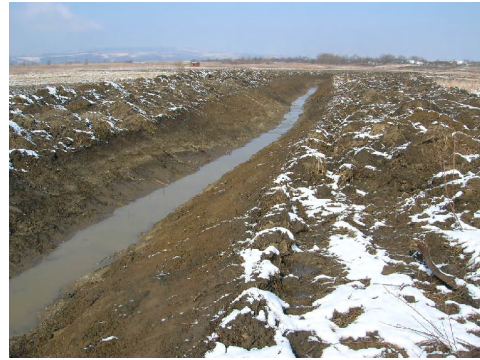
Photo 12 – Drainage channels CCS42 during execution (2008)

- 4 main drains: CCS41, CCS42, CCS43 and CS403, with a length of 10 250 m;

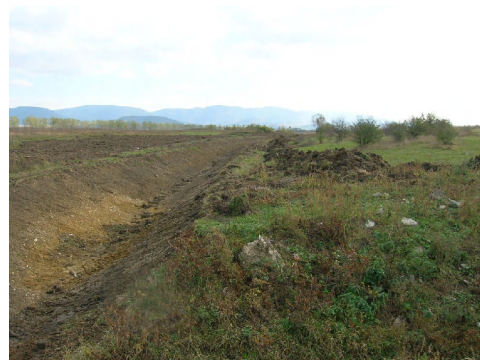
Photo 14 – Secondary drainage channel CT40321 (2008)

- 14 secondary channels: CT421, CT422, CT430, CS44, CT4034, CS4011, CS4010, CT4032, CT40321,

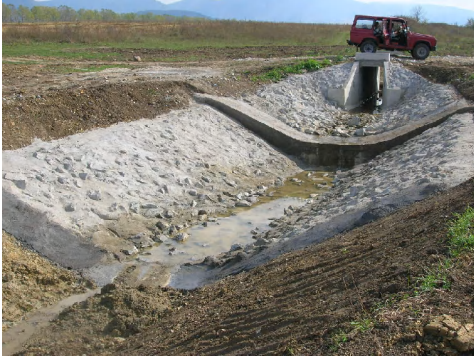
Photo 15 – Pipe DN1200 (of caissons) and drop of concrete and rough stone on drainage channel CS403 (2008)

- CT422, CS44, CS40, CS4011, CS4010 and CS405;
 - o 3 pipes culvert DN1000 on channels CCS42 and CCS41;
 - o 3 bridges DN1200, two bridges on the channel CS403 and a bridge on existing channel CP41, needed for equipment access to agricultural plots;

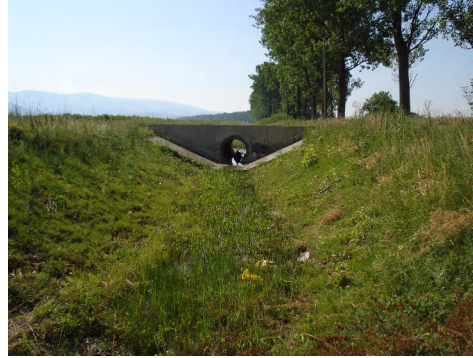
Photo 16 – Pipe DN1200 on drainage channel CP41 (2010)

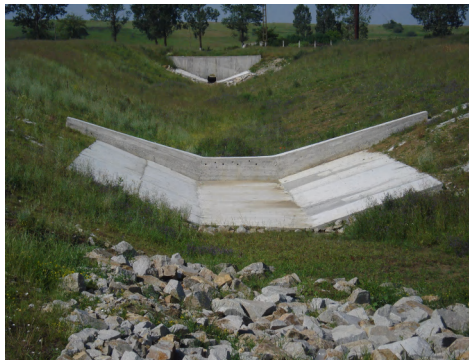
Photo 17 – Threshold drops, pipe DN1000 and consolidation at the junction with Lisava Valley of drainage channel CP41 (2010)

○ 27 threshold drops with weep holes of concrete: 13 drops on channels CCS42, CS403,

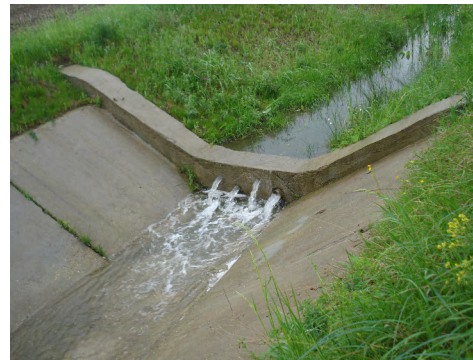
Photo 18 – Threshold drop of concrete on drainage channel CS403 (2010)

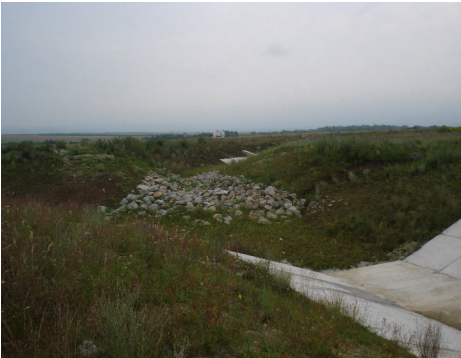
Photo 19 – Channel CP41 Consolidation with rough stone at the junction with channel CS410 (2010)

○ 4 Consolidation at the confluence of channels

CP41, CS410, CS207 and Lisava Valley;

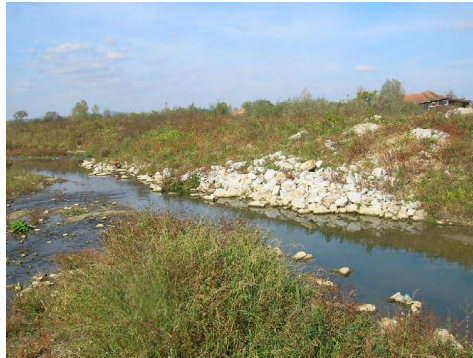
Photo 20 – Lisava Valley Consolidation with rough stone at the junction with cu Oravita Valley (2010)
Oravita Valley and three Lisava Valley;

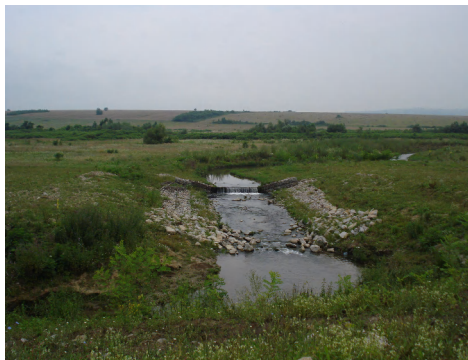
Photo 21 – Drop from gabions with rough stone on Lisava Valley at km 5+800 (2010)

○ 4 drops of gabions, filled with stone, one on

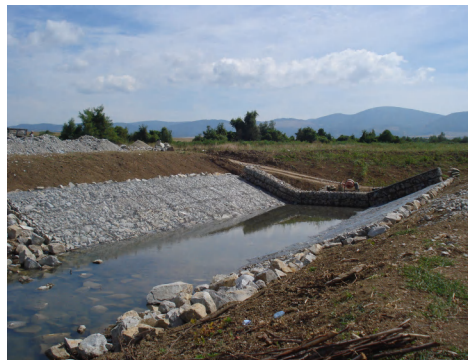
Photo 22 – Drop from gabions with rough stone on Lisava Valley at km 5+300 (2008)

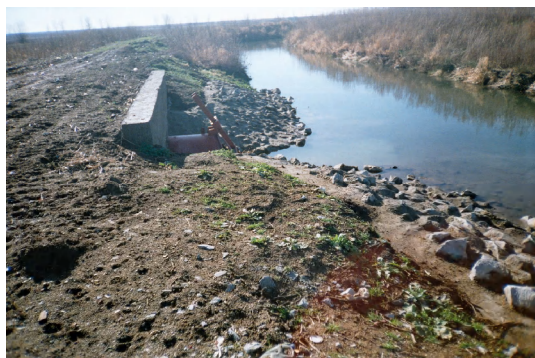
Photo 23 – Lisava Valley Under-crossing the dike with metallic damper on channel CCS42 (2008)

- 2 dike under-crossing, DN1000, metallic

dampers on channels CCS42 and CCS43 to escape in Lisava Valley.

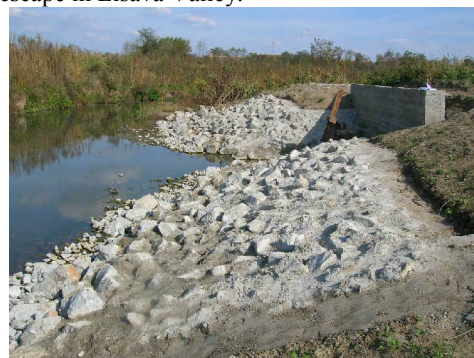
Photo 24 – Lisava Valley Under-crossing the dike with metallic damper on channel CCS43 (2008)
