Case of emergency effects due to meteorological phenomena in 10th of June 2012 and rectification solutions on DC 111 communal road, Pietroasa village, Timiș County

Abstract: This paper's aim is to present the negative effects of increased flow at Puștiul stream above the permissible limit near the Pietroasa village on communal road DC 111 near which it has its water course. DC 111 communal road crosses the Fărășești village and ensures the connection with DJ 684 B county road and is situated on the right shore of the Puștiul stream (branch of Bega River), which flows from Glodea mountain peak, to the mouth of the Bega River in Poieni. Also, the paper presents technical solutions recommended for removing disastrous effects produced by the flood and bringing communal road 111 to a corresponding state of viability. **Keywords:** stream, calamity, restoration, shore consolidation, state of viability.

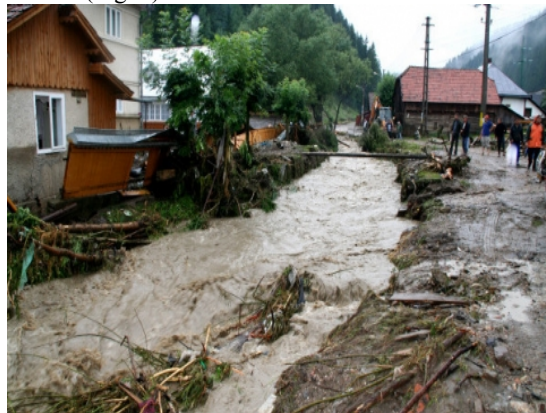
Figure 1.

Due to the floods from 6th of June 2012, DC 111 communal road, connecting DJ 648 B county road and Fărășești village, was affected, being flooding over a length of approximately 4.9 km (78% of the investigated sector length) and floods causing serious damage to the entire complex road on this road section (Fig. 1).

The floods destroyed several road sections, leaving the inhabitants of Fărășești village completely isolated. The flood gathered a large amount of alluvium (mud, gravel, boulders) and floating elements (trees, roots), that clogged the entire existing road structure, thus jeopardizing the bearing capacity of the road (Fig. 2). Regarding the transverse profile, the road platform became very narrow in some areas, reaching even a width of 3.0 ... 4.0 m and the carriageway reached a width of 2.0 ... 3.5 m.

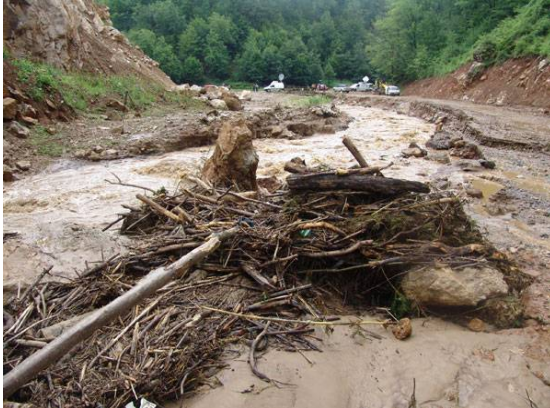
Figure 2.

Due to the rocky ground and narrow riverbed, the flood has broken the road body. The road has a sinuous routing and follows the creek stream, having the opportunity to increase its road territory due to delimitation by the water on one side and a rocky slope on the other side.

To assure the road stability and the carriageway width according to Romanian norms in force and to protect the road from possible floods, we recommend to protect the road with riverbank protection works, where circumstances so require.

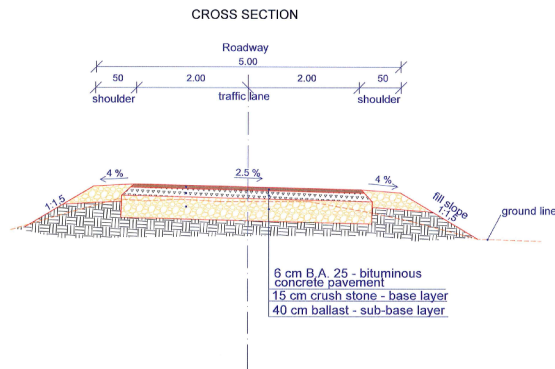
Figure 3.

In cross section (Fig. 3), regarding the situation of the existing ground and the importance of the analyzed road, the public road geometry will be performed corresponding to the Technical Class V with one lane, according to the "Technical Norms regarding the design, construction and modernization roads" (Order of the Ministry of Transport no. 45/06.04.1998 published in the Official Gazette of Romania, part I, No. 138 bis/06.06.1998).

In plan and in the longitudinal profile, will be performed geometric elements corresponding to a design speed of 25 km / h (region of hills and a Technical Class V), fully preserving the existing road routing, planning and fitting out the curves, according to STAS 863 - 85.

In that direction, all curves in plan with radiuses below 250 m will be provided with all necessary overwidening and all the curves with the radius less than the recommended one will be arranged by conversion or by increasing height, according to current regulations. In isolated cases to avoid the demolition of existing buildings, relocation of facilities, the expropriation of land or because the terrain is rocky and the road territory requirement cannot be increased, the design speed is reduced for solving some plan junctions.
