Study concerning the cause of degradation in a road section in the proximity of the town of Oravița

Monica Mirea¹, Cristina Otilia Voicu²

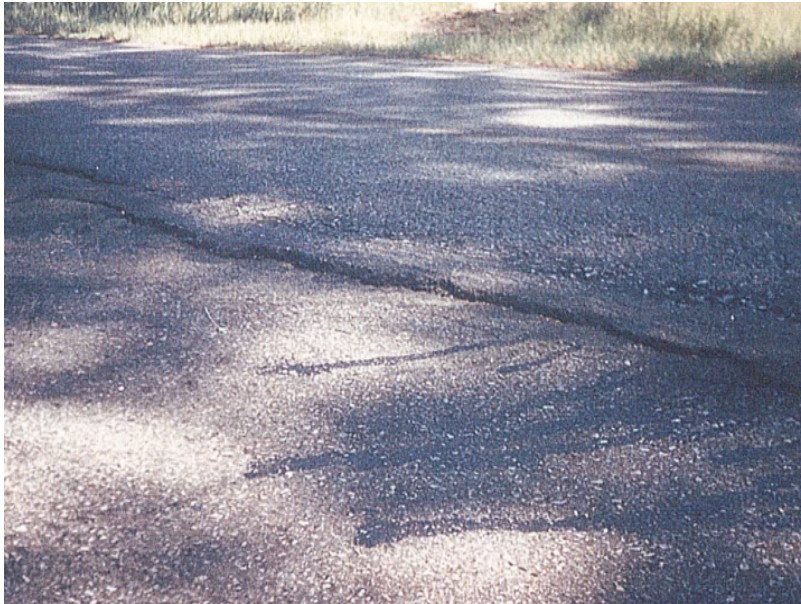
Several degradations and damages of the road pavement have occurred on the analyzed road section in the proximity of the town of Oravița (Fig. 1), especially longitudinal cracking, both on the edges (Fig. 2) and on the road axis (Fig. 3). Also, in many places on this section, severe local settlements and rutting have occurred (Fig. 2 and Fig. 3). On several areas of the analyzed section the water collection and evacuation systems were found to be damaged or even missing, the water drainage being not ensured longitudinally in places where the road is at grade or in light embankment.

Fig. 2. Cracking with settlement

The correlation of the high activity potential of the clay layer found immediately beneath the road pavement, with the preponderance of the road degradations such as longitudinal cracking, leads to the conclusion that at high pluviometric and temperature variations the active and very active character of the clay in the road bed represented one of the main causes of the occurrence and development of the degradations on the investigated road section.

The lack of water collection and evacuation systems on certain areas of the road section, respectively the faulty functioning of the existing ones, have accentuated the activity of the clay soil

under the road pavement and the loss of its bearing capacity, representing another main cause of the aggravating damage occurring in the road pavement. Therefore, a primary mandatory condition in the rehabilitation of this road section would be to find and apply adequate and efficient technical solutions to evacuate the water in the road area.

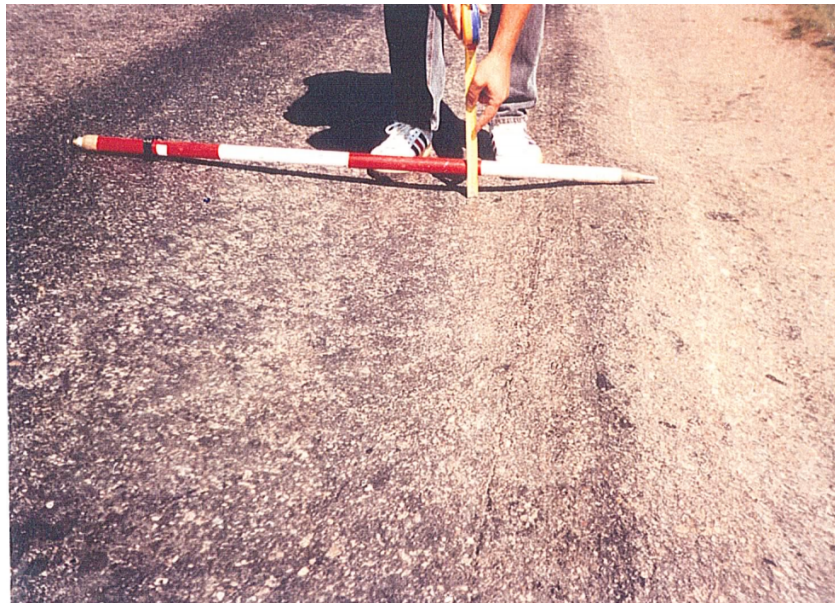
Fig. 3. Local settlement and rutting

higher porosity values and lower linear deformation modulus values is found on certain depth intervals, certainly contributing to the severe degradations, such as cracking, settling and rutting, occurring on certain areas on the road.
