FEDERICO M. MAZZOLANI

University of Naples “Federico II”, Italy

**STRUCTURAL RESTORATION OF 19th
CENTURY BRIDGES**

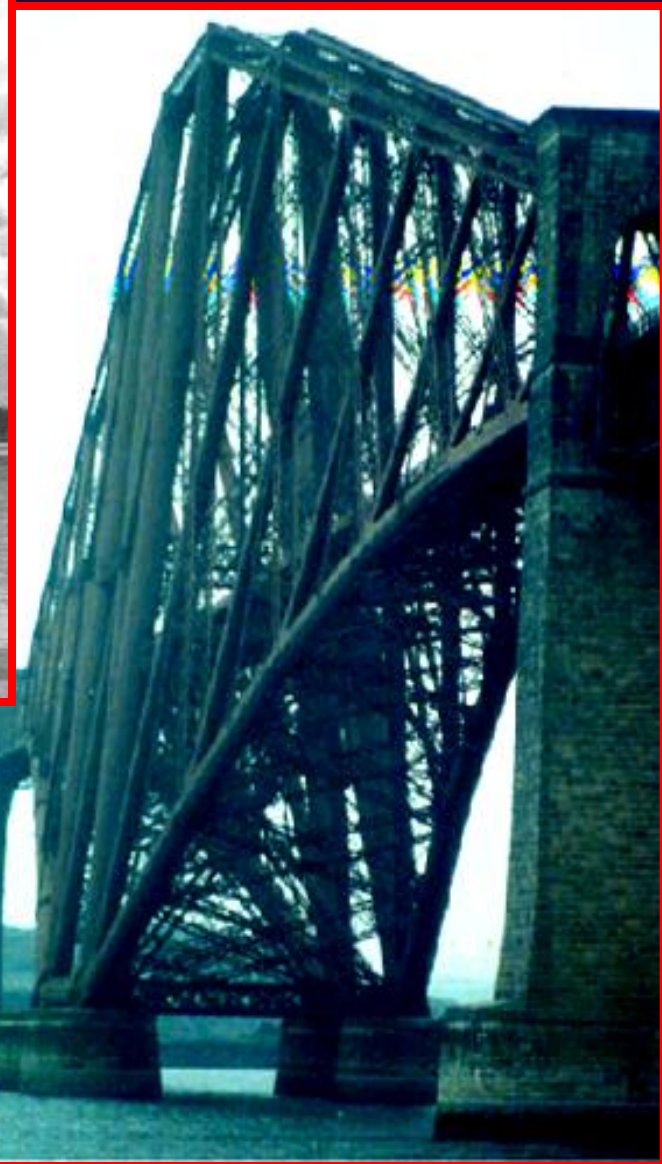
FIRTH OF FORTH BRIDGE (1889)

$L=521$ m

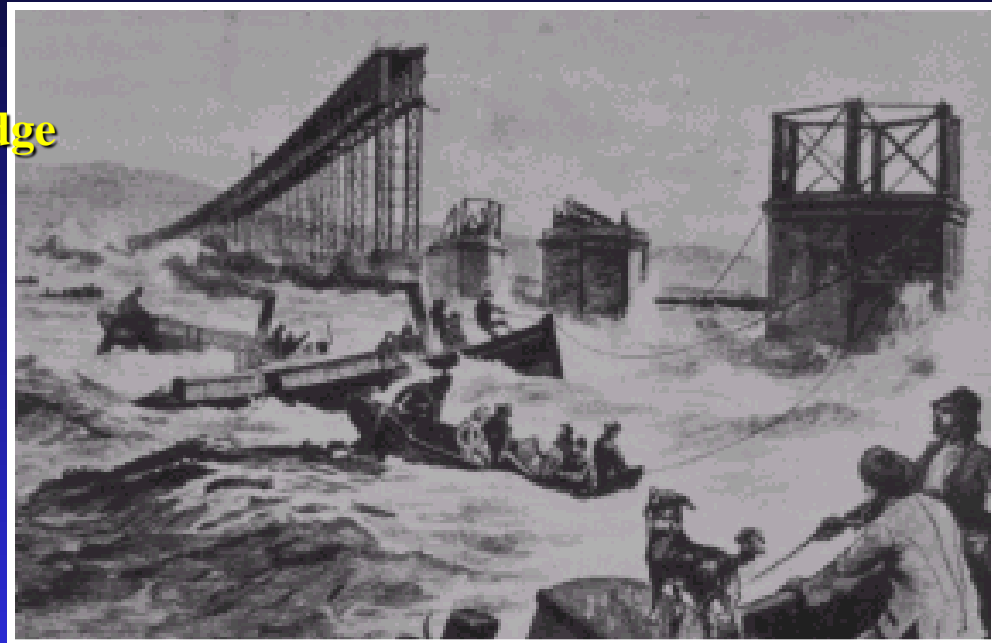
The greatest disaster to befall Victorian engineering was the failure of the Tay Bridge in 1879, unique amongst British railway accidents to this day in that there were no survivors.

This failure still retains the dubious distinction of being the worst structural failure to have occurred in Britain in terms of both lives lost and the size of the failed structure. On the wild and stormy night of 28 December 1879, the central part of the two mile long Tay Bridge, at the time the longest in the world, collapsed leaving a gap of well over half a mile (almost exactly one kilometer). (Rolt , 1955).

The collapse took with it an express train from Edinburgh and resulted in the **deaths of 75 passengers and staff**, although many of the bodies were never found. Much was made of the fact that the collapse happened whilst a gale was blowing and the structure was condemned at the subsequent Court of Inquiry. The bridge was “**badly designed, badly constructed and badly maintained ... For these defects... Sir Thomas Bouch is, in our opinion, mainly to blame.**” Bouch, the designer of the bridge, died a few months later. The exact cause of the collapse was not however specified.

Over the intervening years, the evidence presented at the Inquiry has been pored over and many theories of the causes have been proposed. The most recent of these, by a team from the Open University, Lewis & Reynolds (2002), has looked at contemporary Photographs and found convincing evidence of **fatigue cracking** in the lugs of the cast iron joints holding the bridge together.

The **bridge was rebuilt** to a new design, with wrought iron and steel replacing the cast iron of the original.

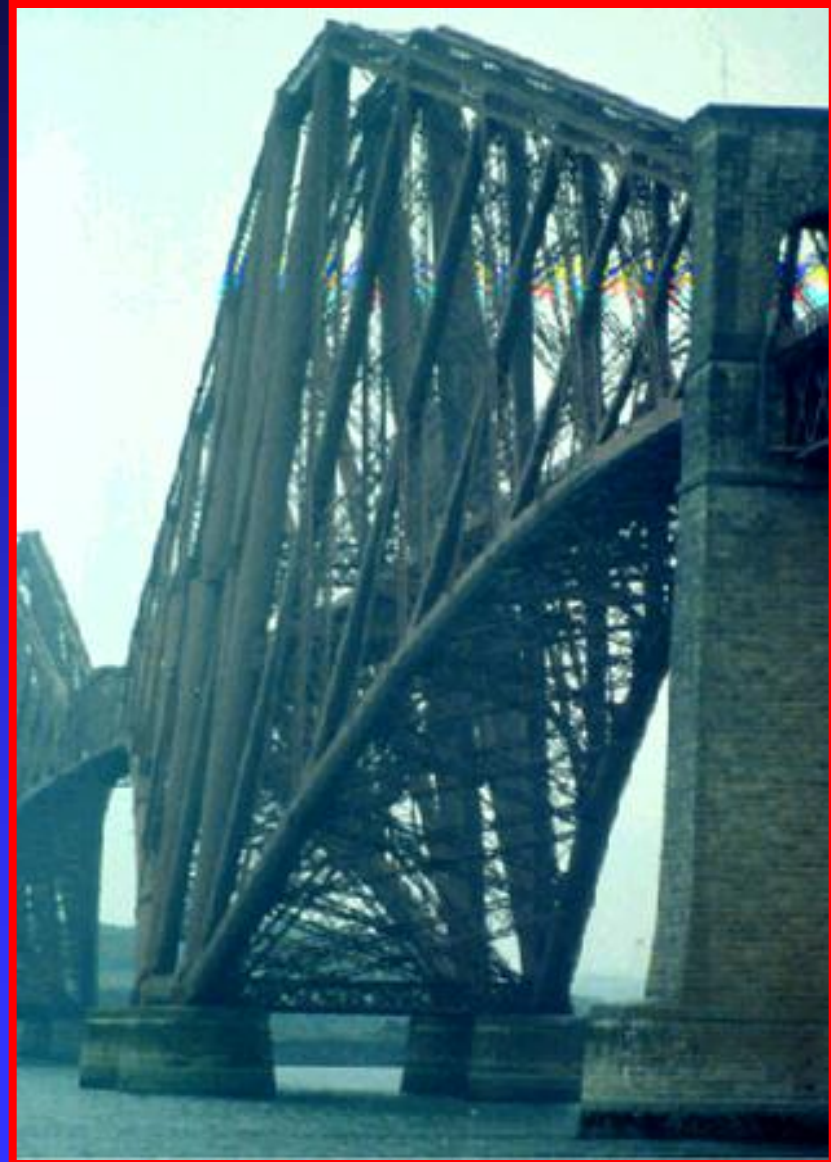
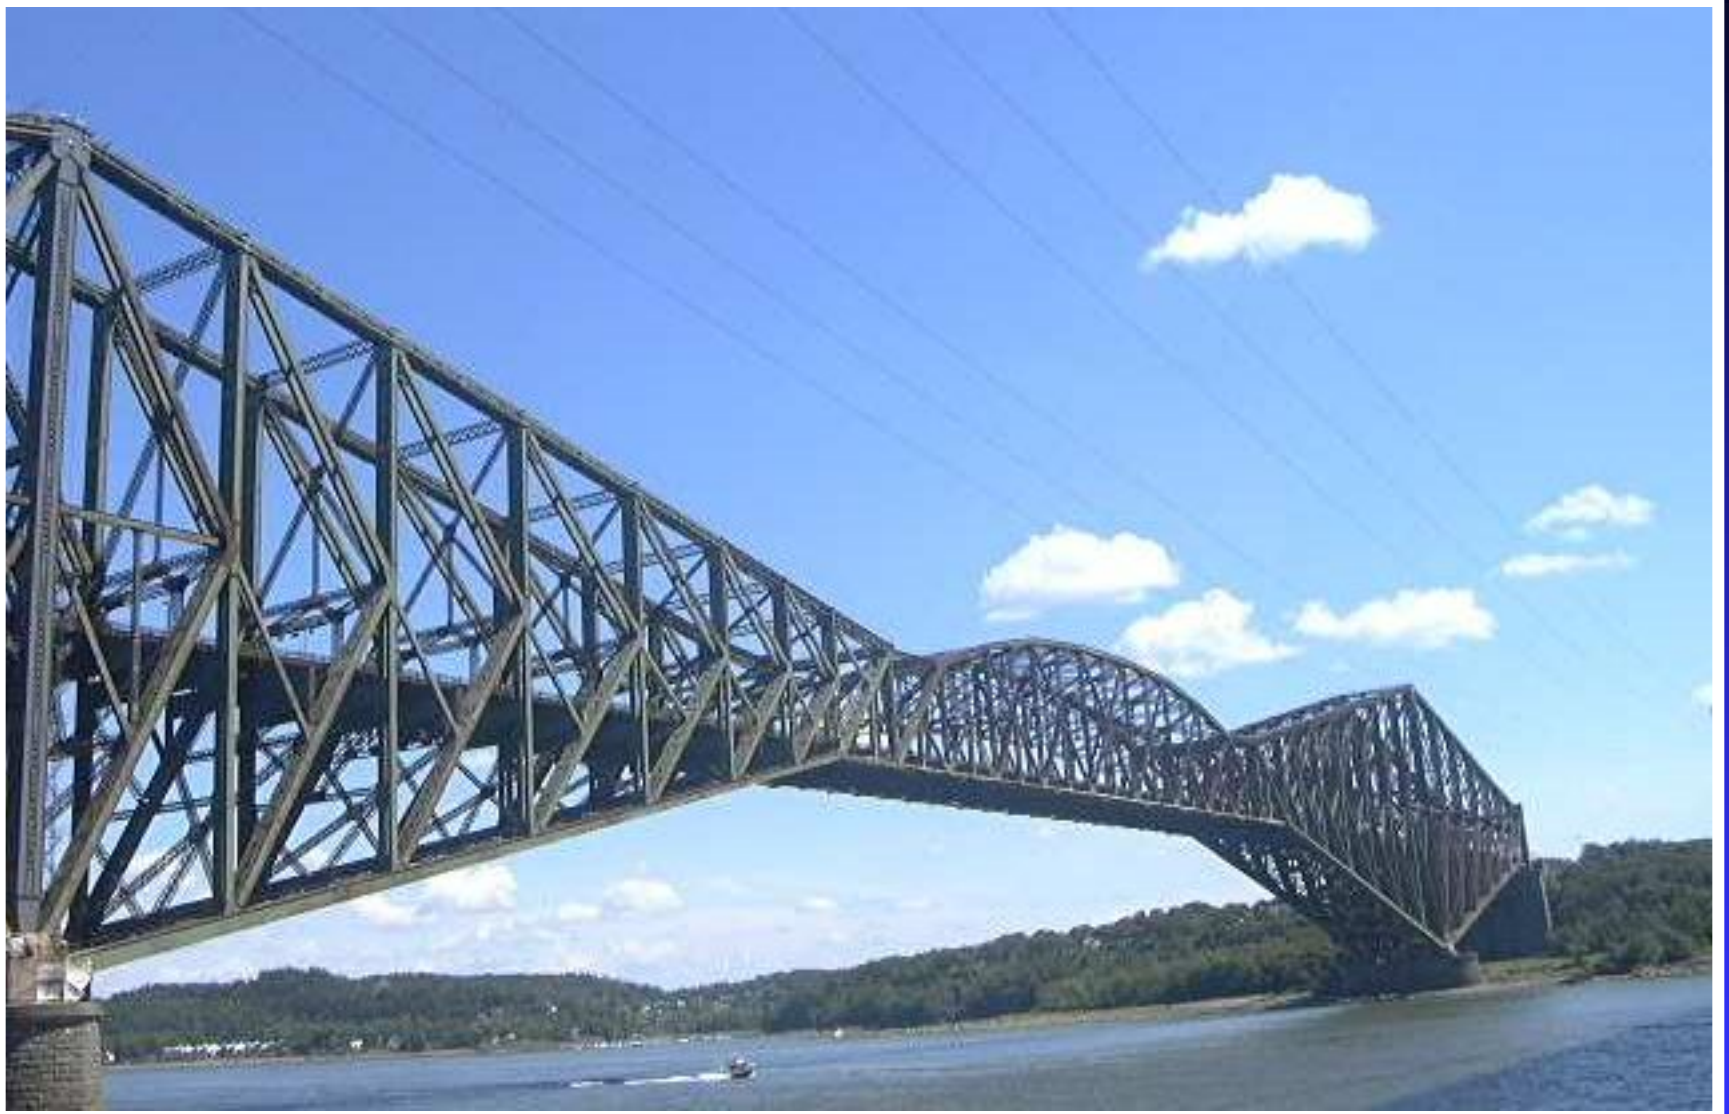
This bridge, opened in 1890, was the first major bridge in Britain to be built of steel, closely following the steel pioneering Brooklyn suspension bridge in New York, opened in the early 1880's.

$L=521 \text{ m}$

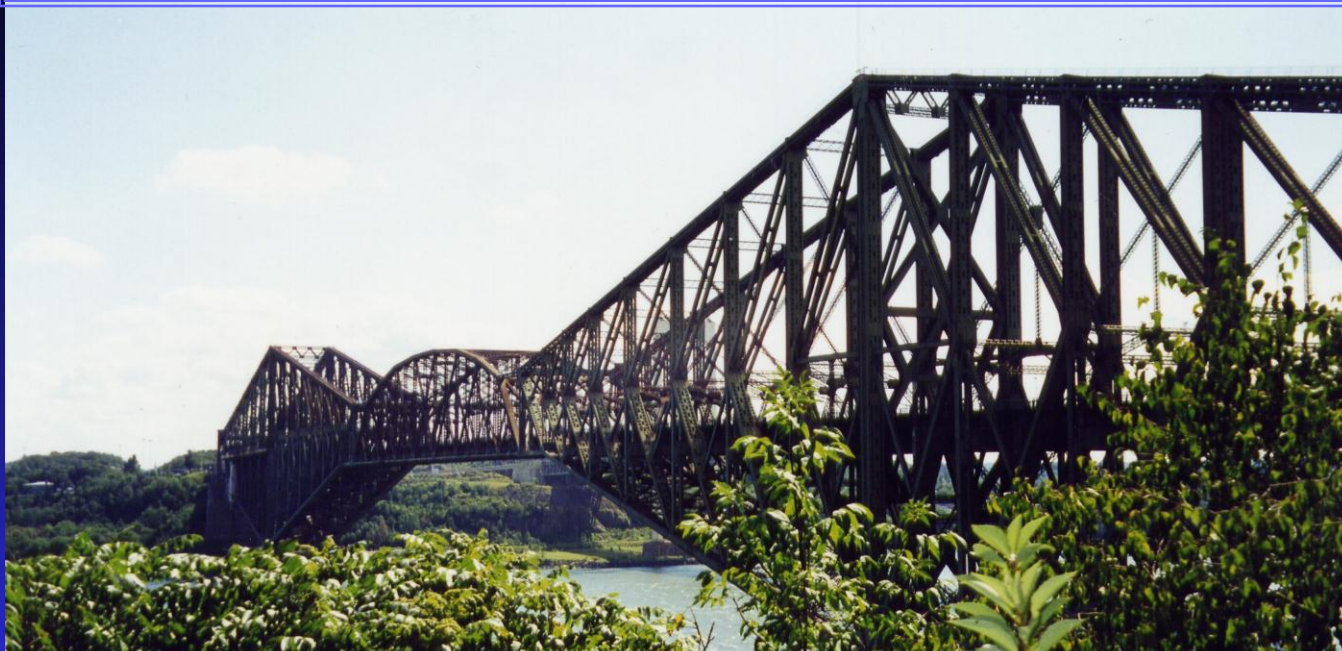
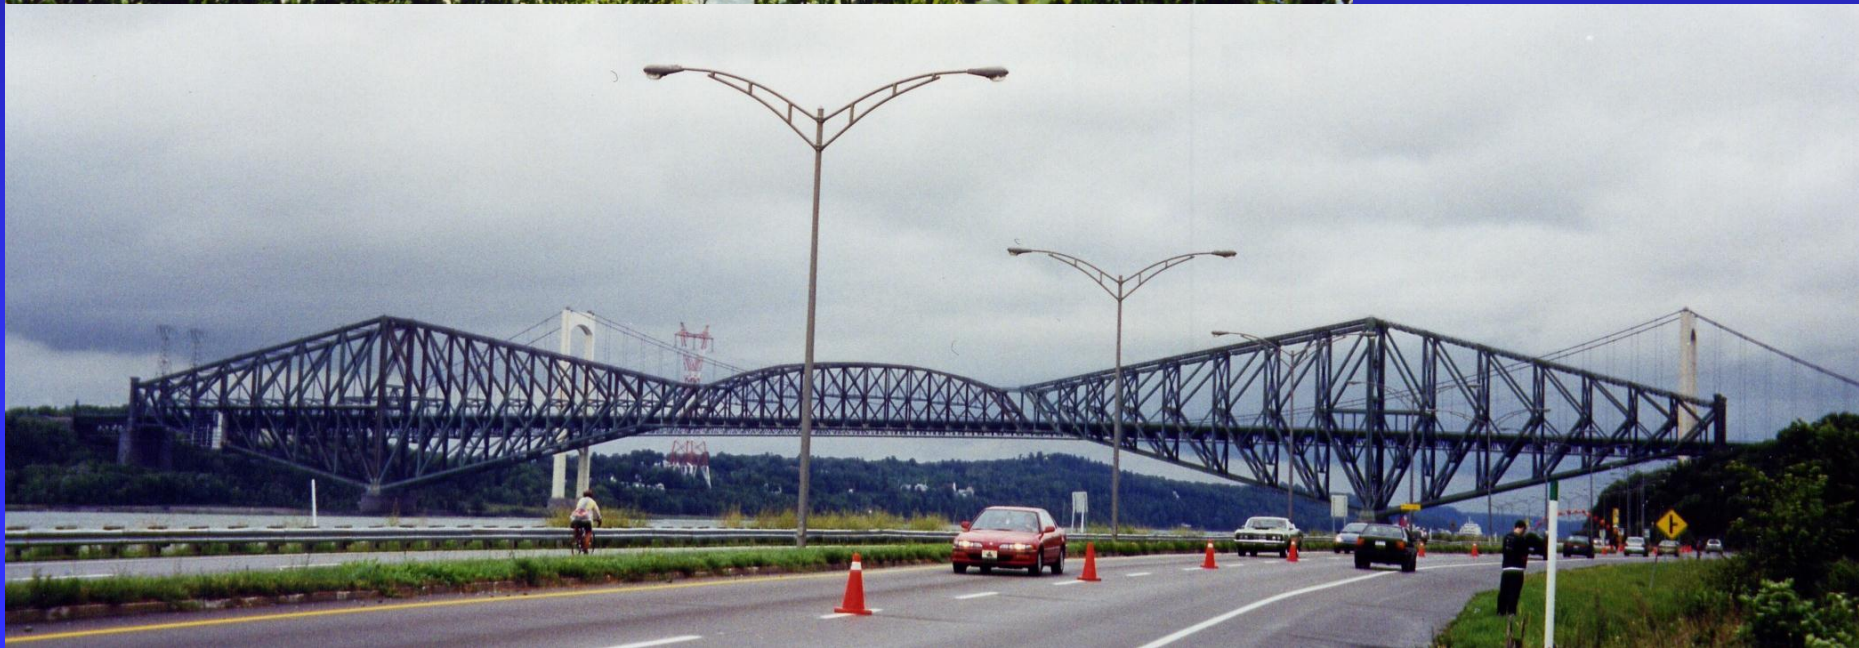
THE QUEBEC BRIDGE (CANADA, 1917 ; $L = 549$ m)

August 1907 : the bridge collapsed during erection ; 75 workers died.

The inquiry Commission stated the impossibility to erect the whole central part of the bridge with 375 m span by means of the cantilever system.

A new erection design was done based on the lifting of the whole central part of the bridge by using jacks supported on pontoons.

During the new erection , when the 2500 tons of the central part of the bridge were lifted of 4 m , the bridge collapsed into the river ; 13 workers died.

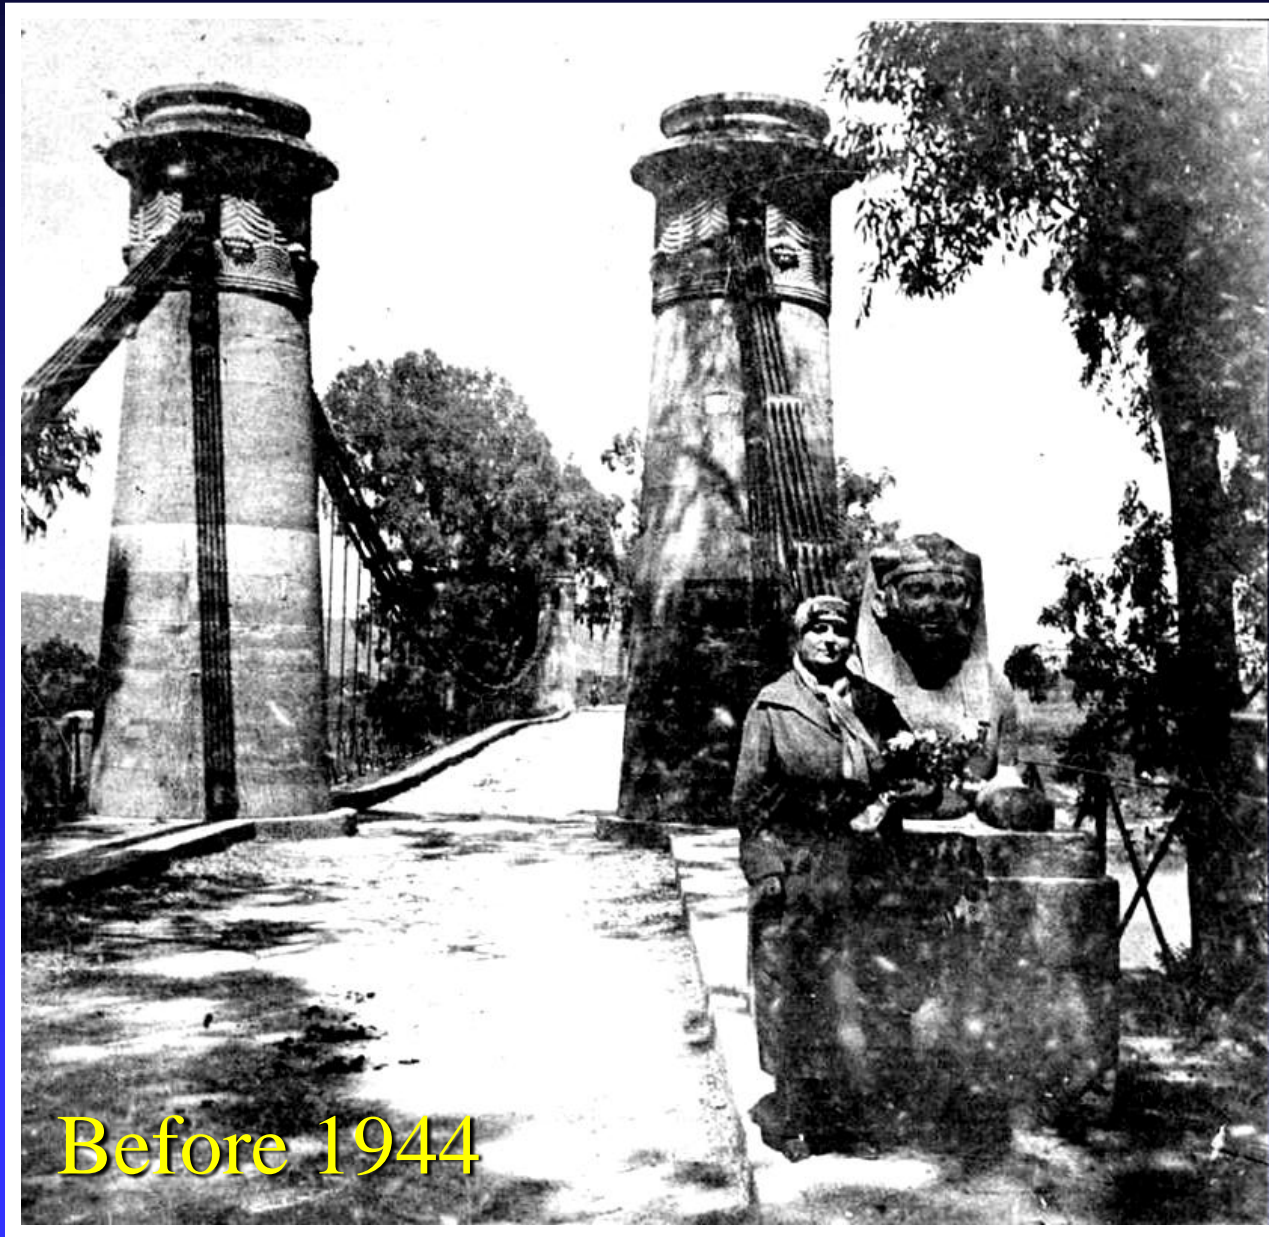
Before 1944

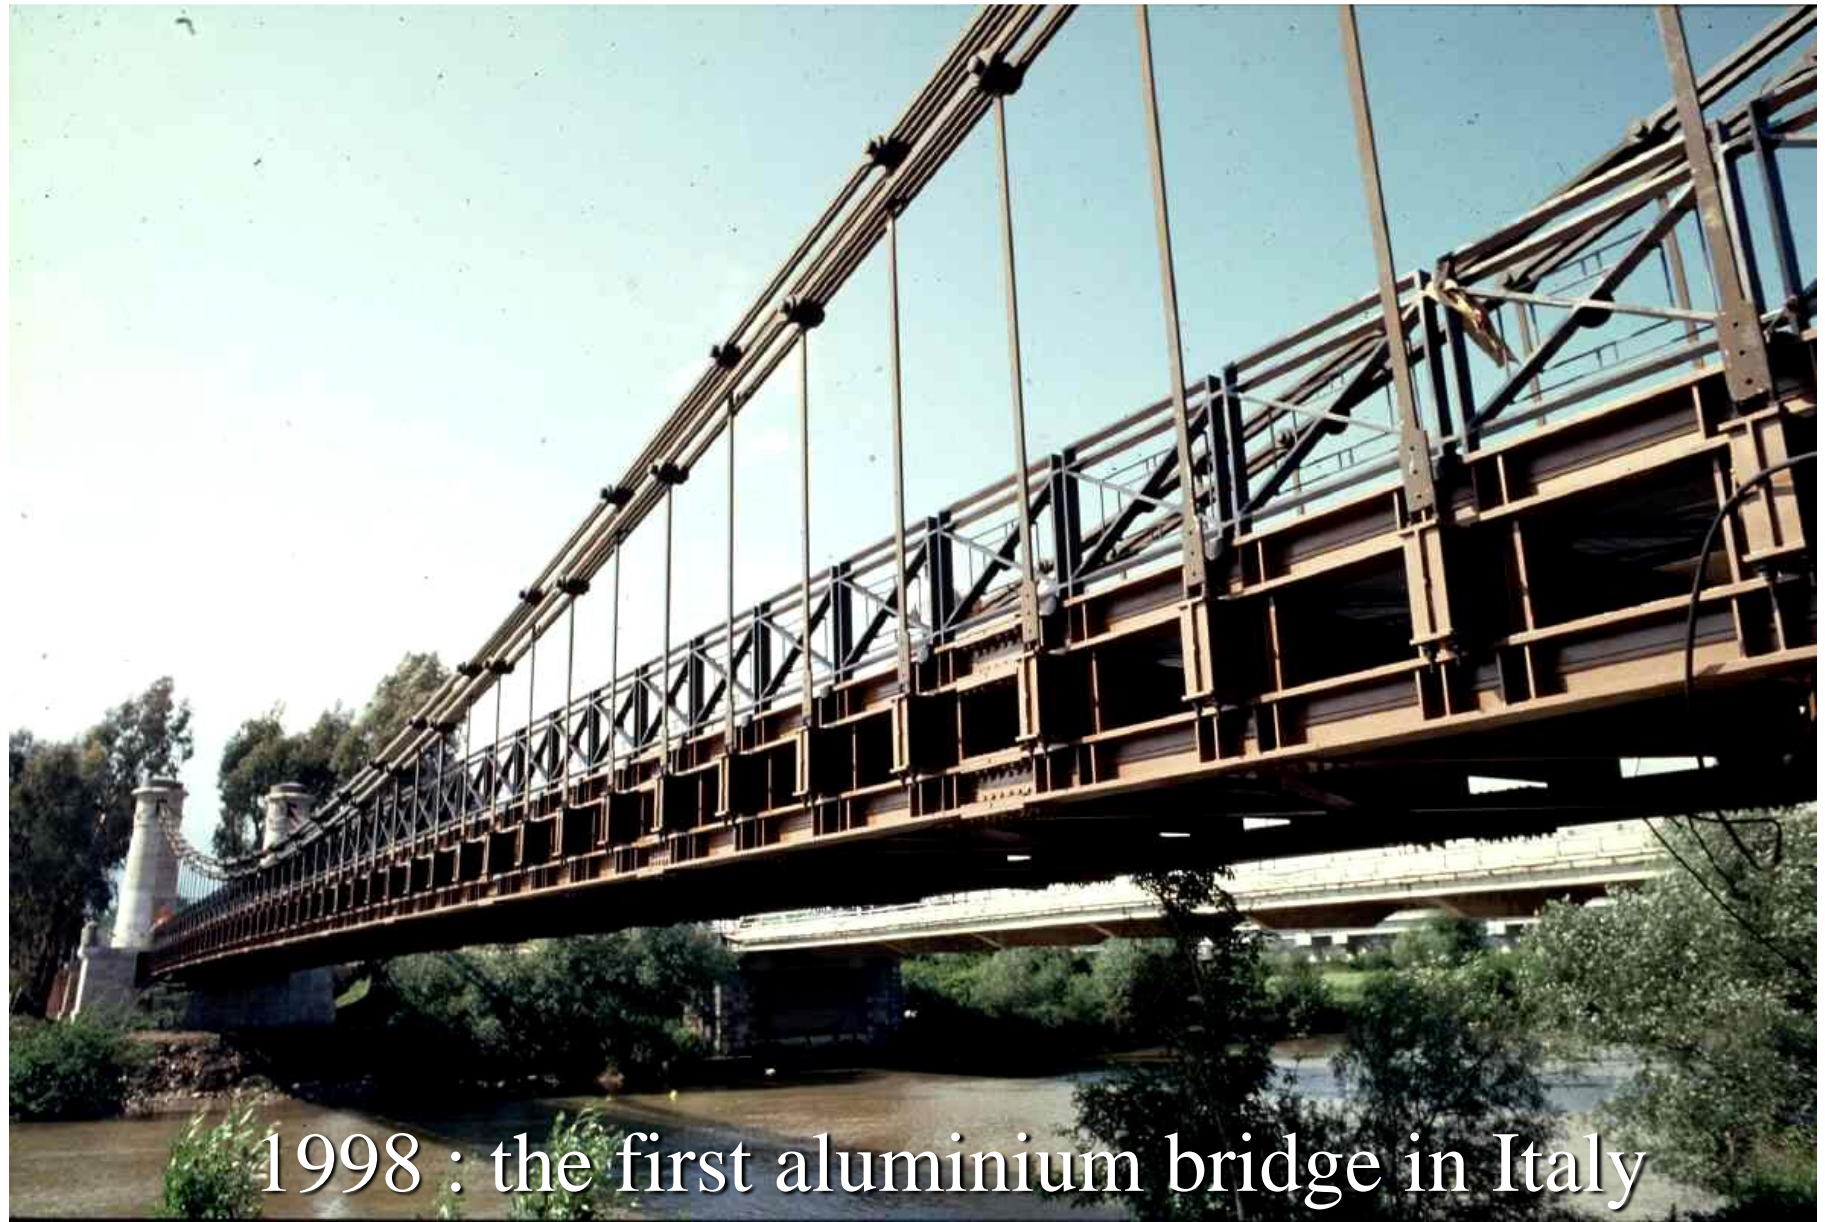
1998 : the first aluminium bridge in Italy
