Rehabilitation and Maintenance of Buildings

Valeriu STOIAN

Lecture : 19/06/2014 – 8.30-10.00/10.30-12.00

European Erasmus Mundus Master Course

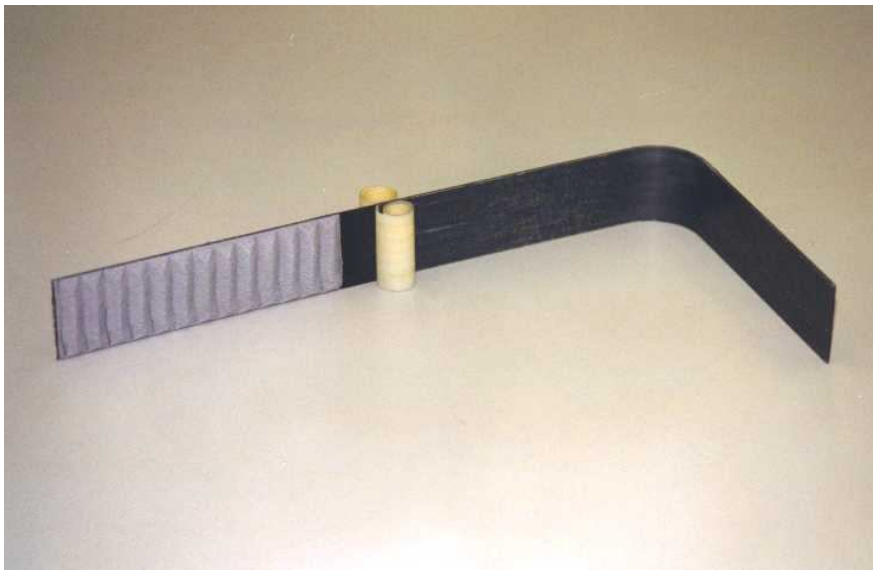
1. STRENGTHENING

- FABRIC
- LAMELAS (STRIP)
- REINFORCEMENT

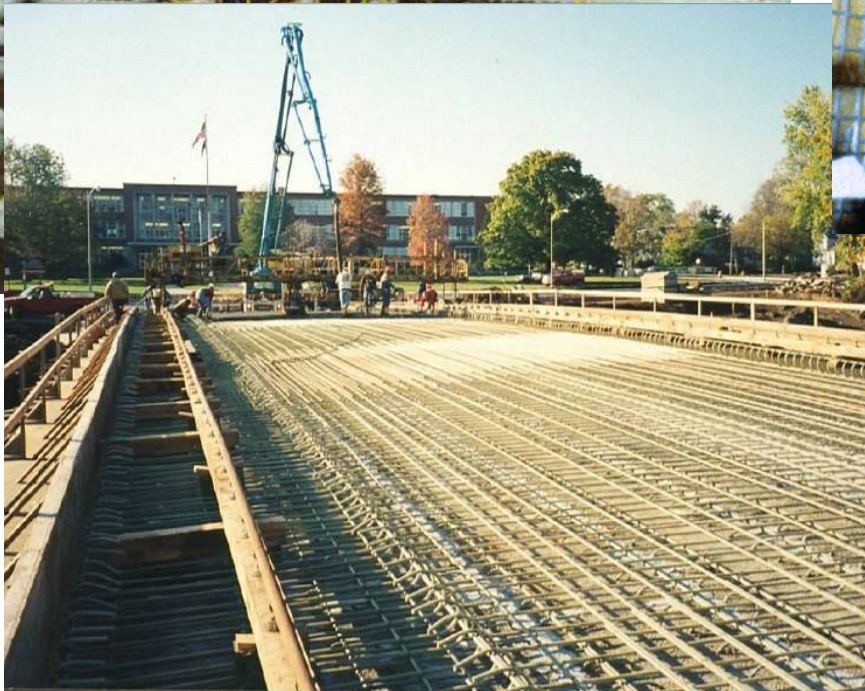
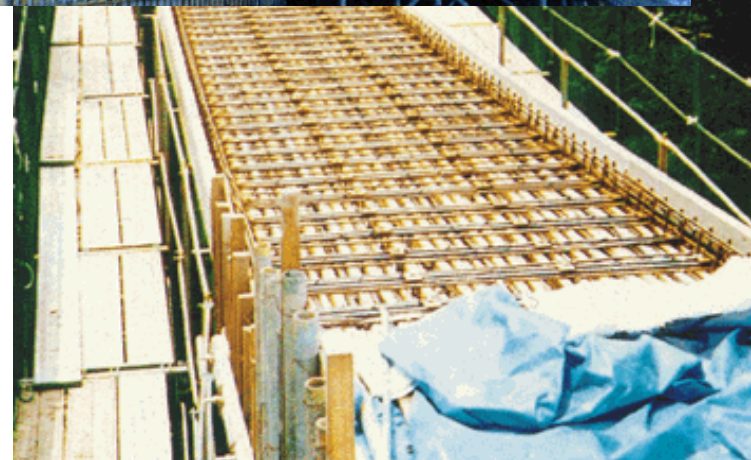
2. REINFORCEMENT → IN CONCRETE

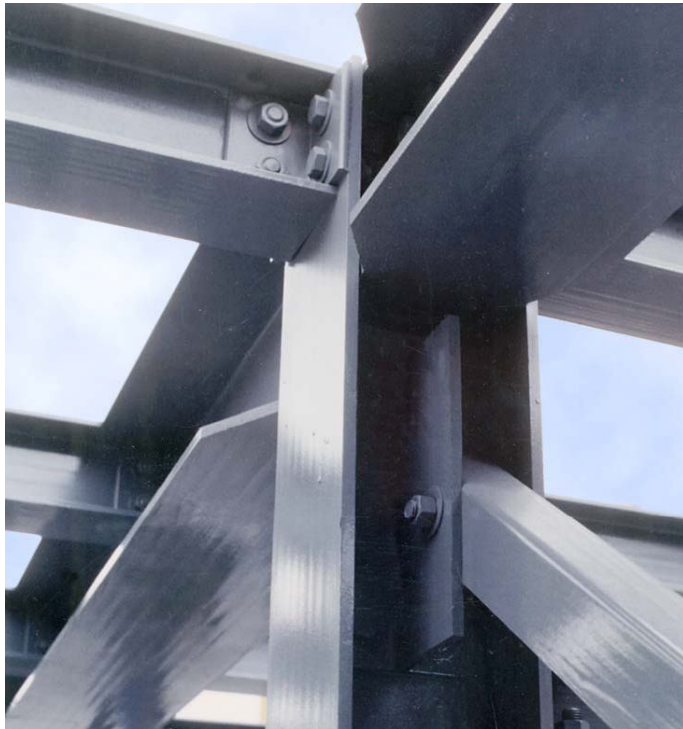
3. PROFILE

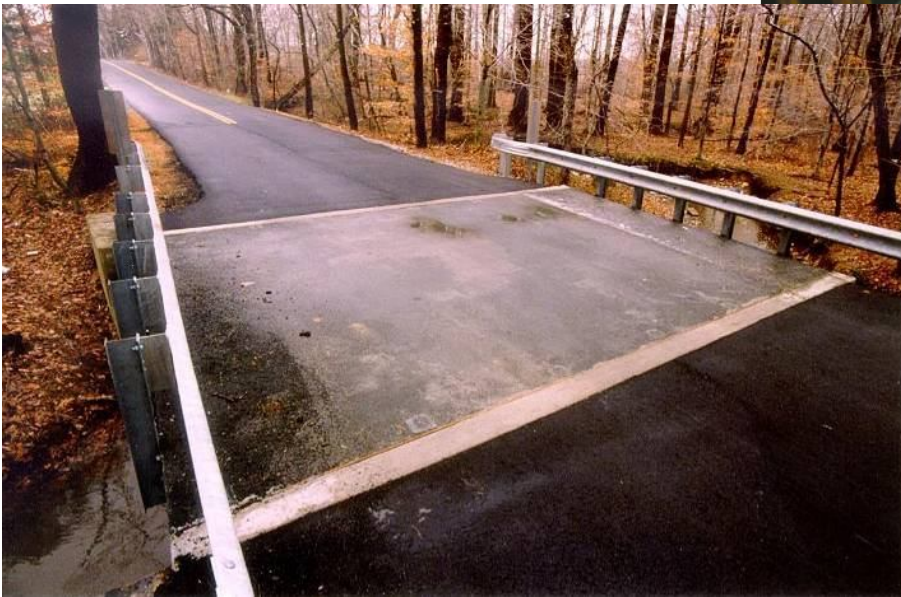
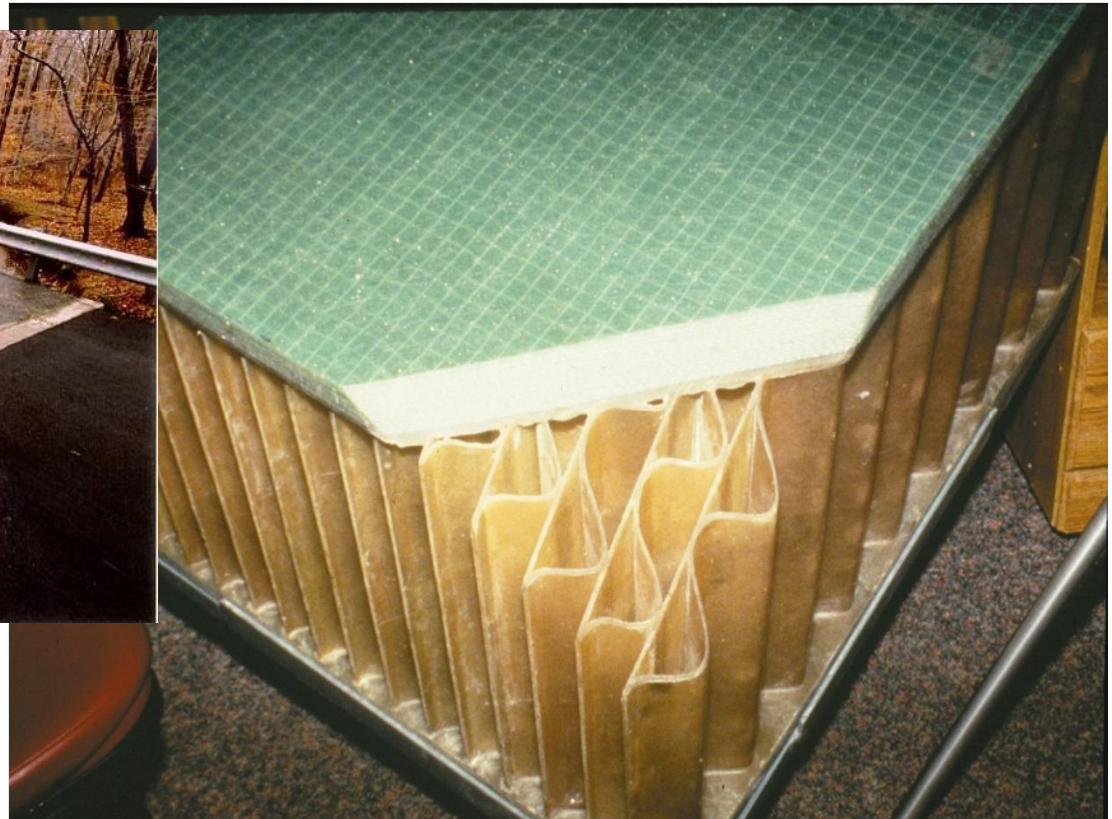
4. SANDWICH PANELS

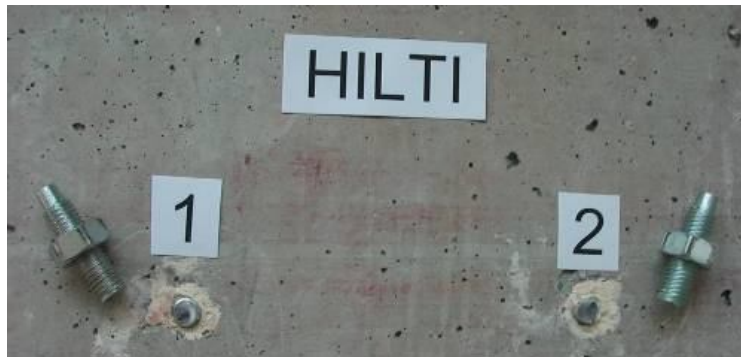
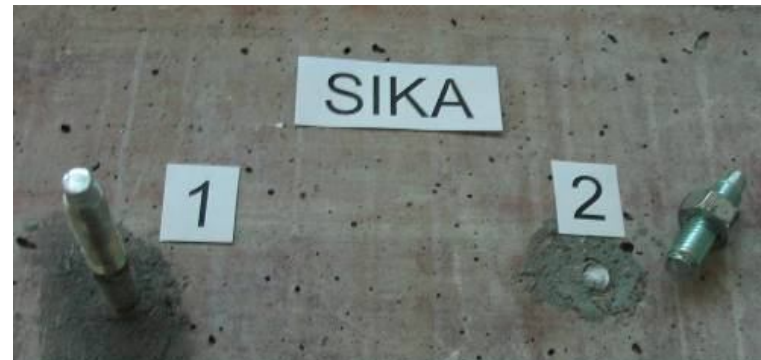
In order to choose the most adequate epoxy resin used for anchoring the bolts into concrete, a series of pull out tests have been carried out using two different types of resins.

Resistant torque [Nm]	Failure mode
SI KA	1	over 54	tear out of bolt
	2	over 54	break of bolt
HI LT I	1	over 54	break of bolt
	2	over 54	break of bolt

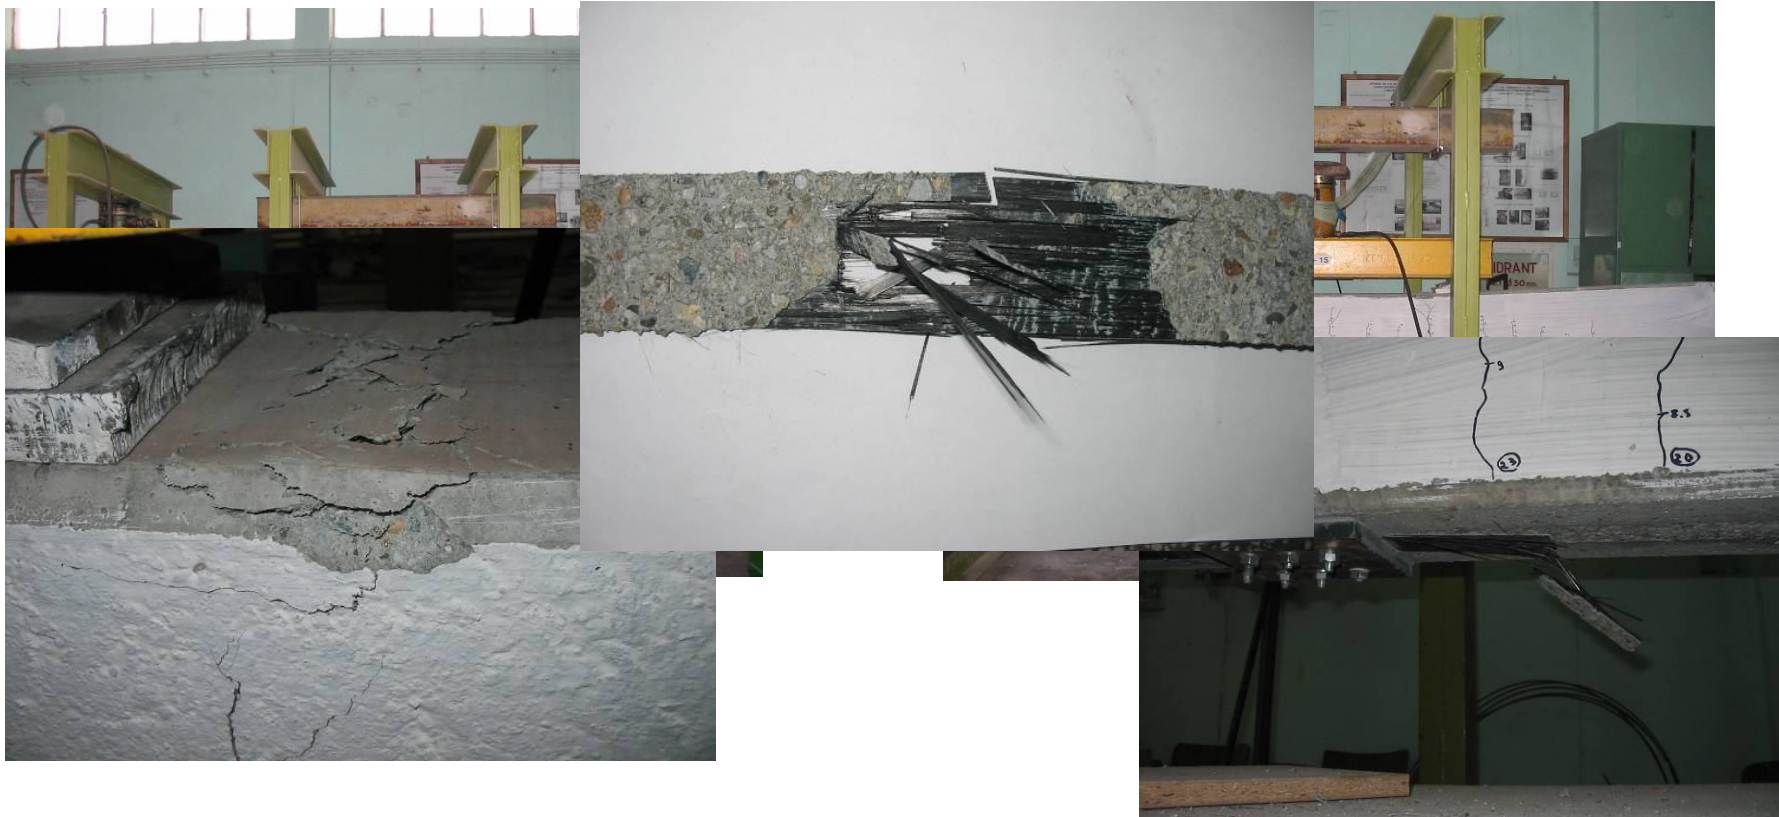
= R-1S =

The failure mode of the element began with the composite debonding between the anchorages, followed by concrete crushing in the compression zone, and finally by the sliding out of the FRP from the anchorage simultaneous with the failure of the strip.

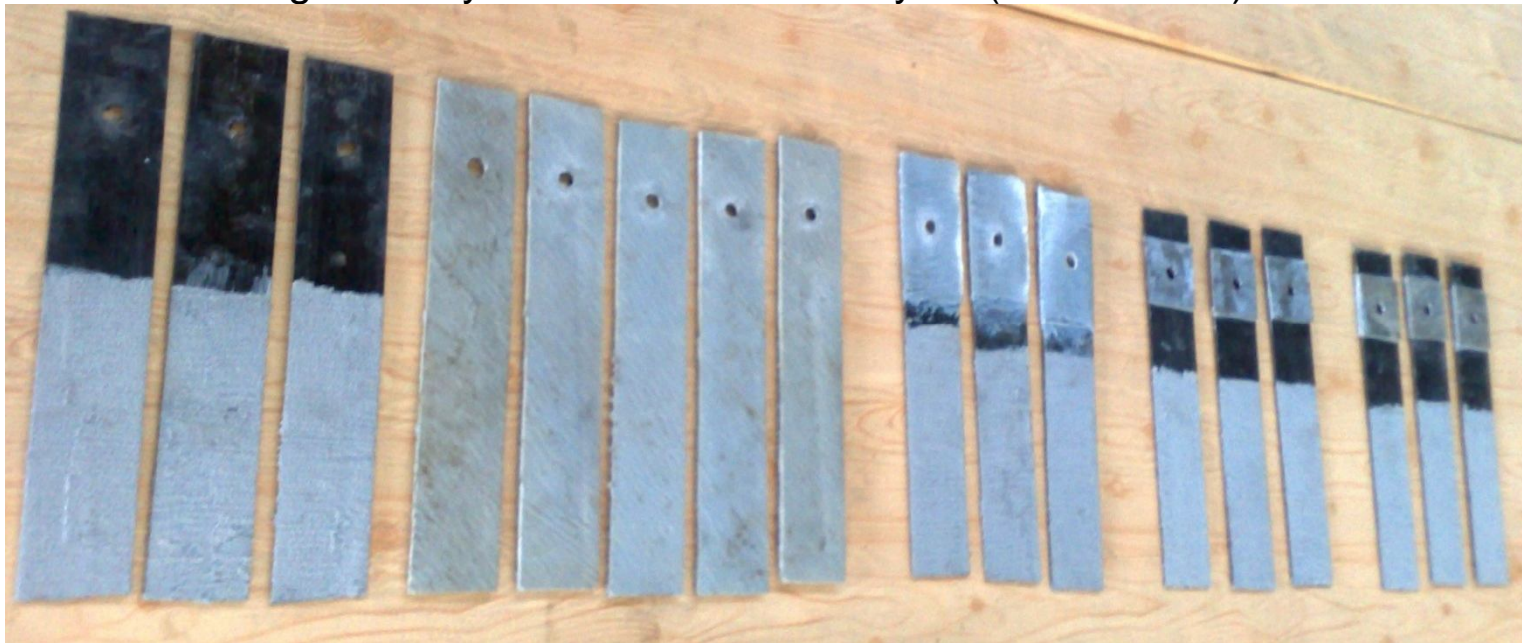
In order to verify the resistance of the lamella to local pressure on the hole, a series of tension tests have been carried out :

- solely the lamella – for reference
- with steel plate of 2 mm in thickness glued with resin on one face
- with steel plate of 2 mm in thickness glued with resin on one both faces
- with GFRP fabrics wrapped around the lamella in a double layer
- with GFRP fabrics glued only on one face in four layers (0-90-45-135)

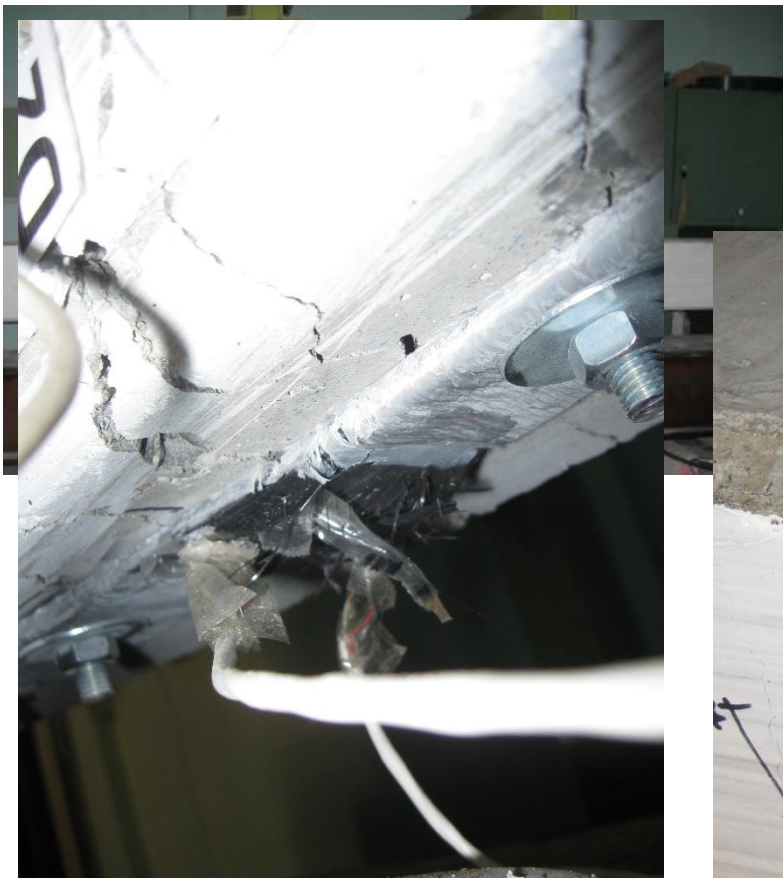
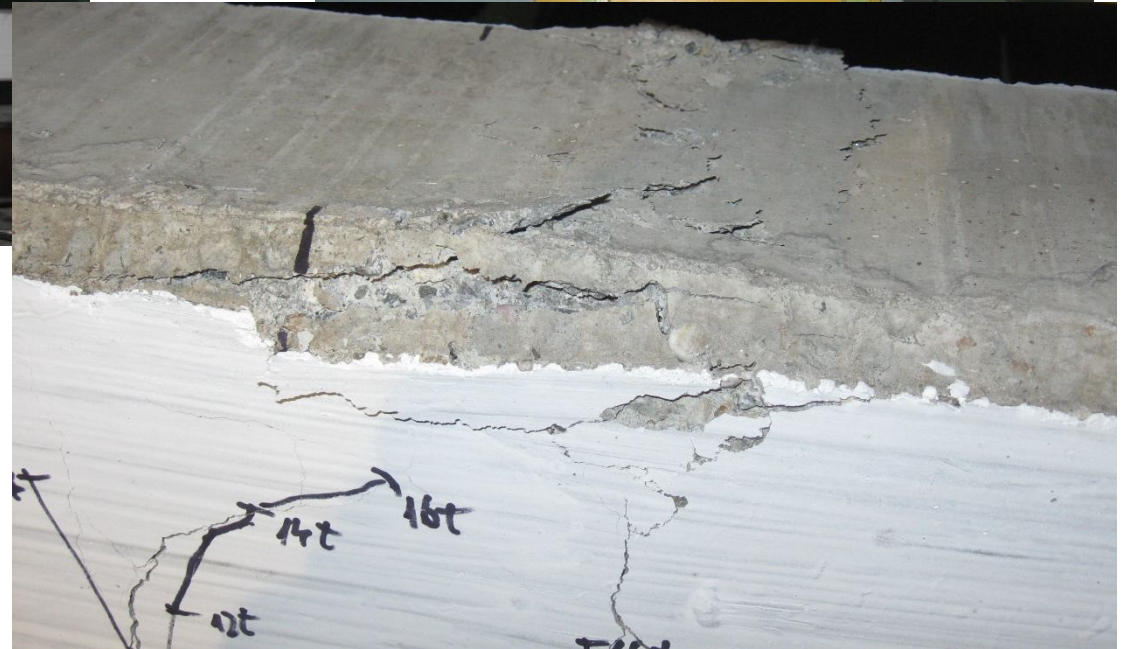
= R-CA-1S =

The element failed by concrete crushing in the compressed zone simultaneously with the rupture of CFRP lamella at the mid span.

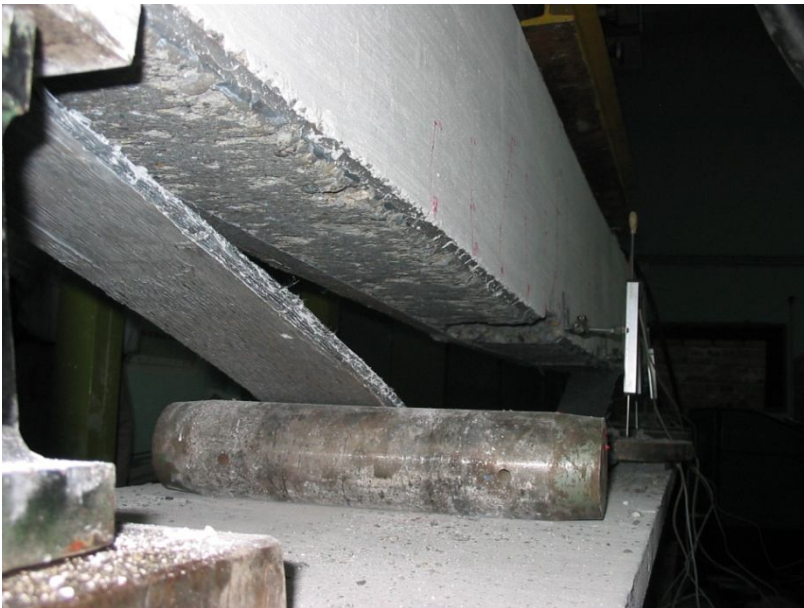
R-2W → strengthened with 2 layer of 18cm wide unidirectional carbon FPR fabric in the bottom part, without any anchor system.

→ The failure of the element was through debonding of the FRP.

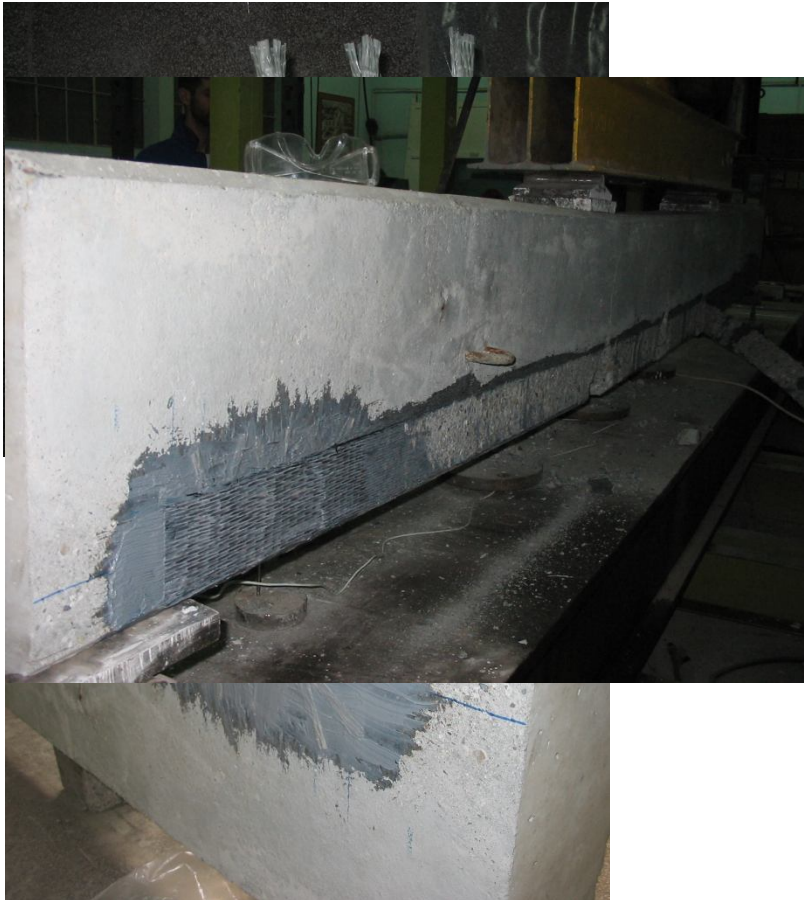
RL-2W-A → strengthened with 2 layer of 9cm wide unidirectional carbon FPR fabric applied in the lateral part of the both side, anchored with three spikes/end/side.

→ The failure of the element was debonding inside the FRP.

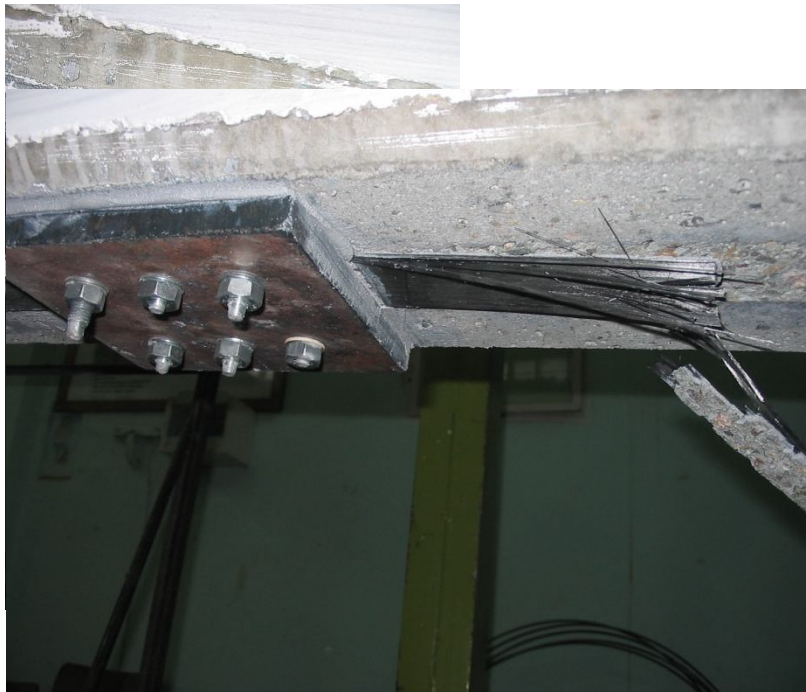
R-1S → strengthened with 1 layer of 5cm wide carbon FPR strip applied in the bottom part and anchored at the ends with steel plates.

→ the failure began with the composite debonding between the anchorages, followed by concrete crushing in the compression zone, and finally by the sliding out of the FRP from the anchorage simultaneous with the failure of the strip.

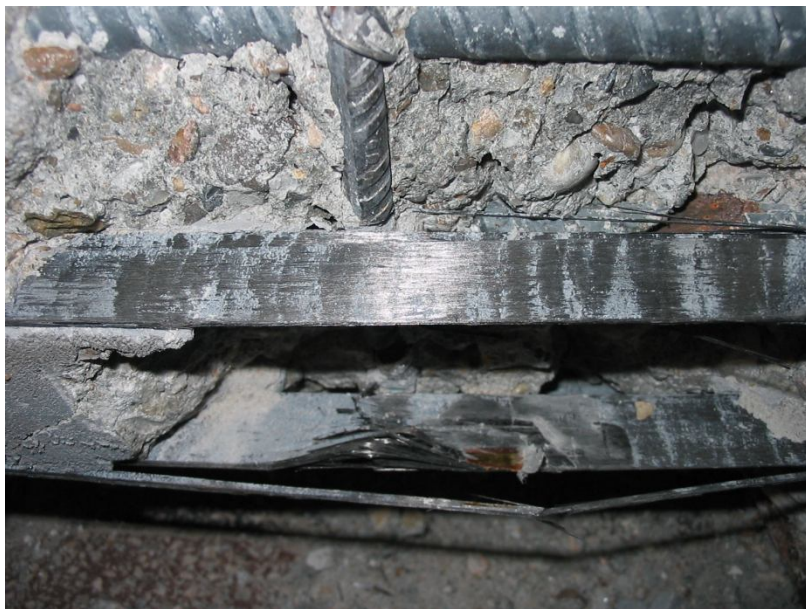
R-2NSMS → strengthened with two 20mm wide carbon FPR strip, in the bottom part of the beam, applied in cut grooves (NSM technique).

→ The failure began with the composite debonding in the grooves, followed by concrete crushing in the compression zone, and finally by the tensile failure of the FRP strip in the middle region of the beam.

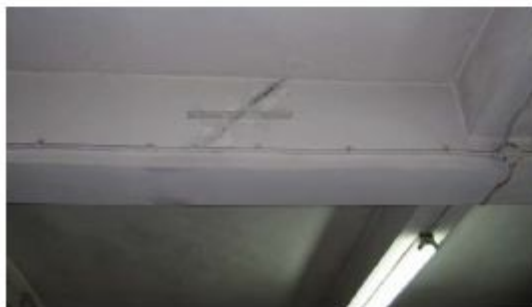
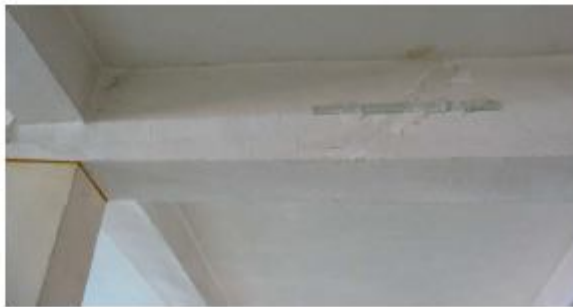
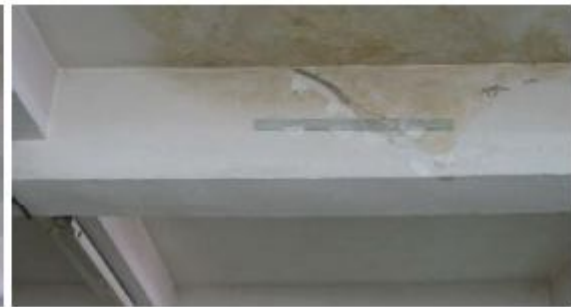
- RC FRAME STRUCTURE
 - DESIGNED IN 1964-1981 (1978)
 - LEVEL NR.: 3
 - FUNCTIONALITY: TYPOGRAPHY
- ⇒ **PROBLEMS: SHEAR CRACKS IN SEVERAL BEAMS**

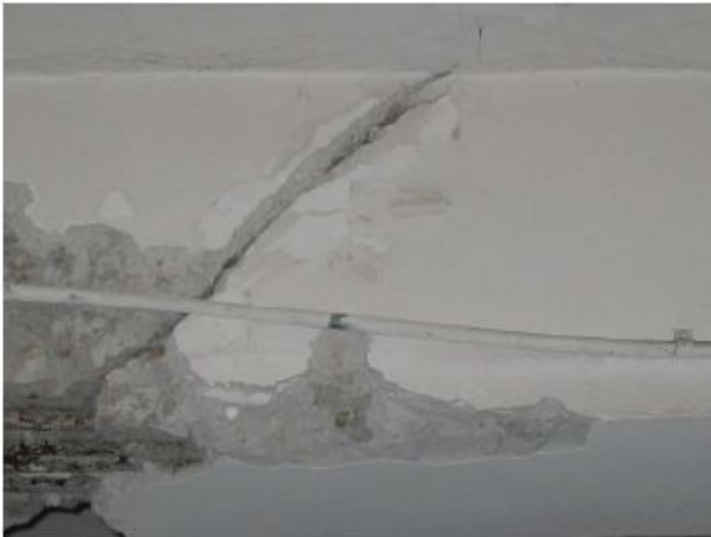
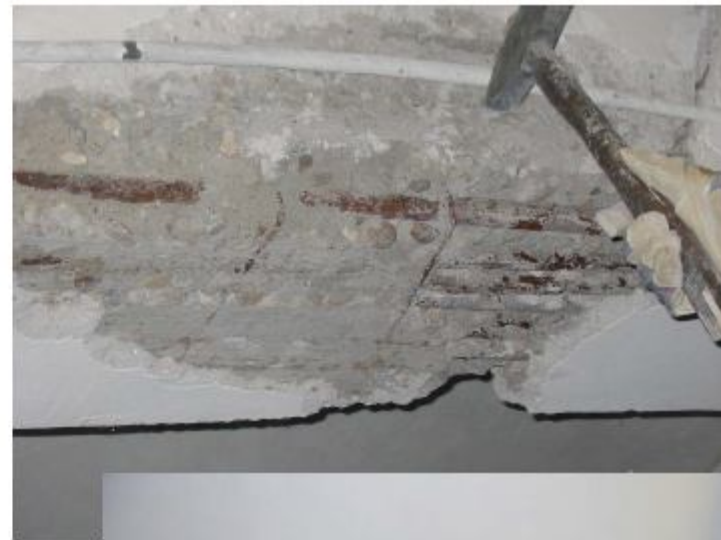
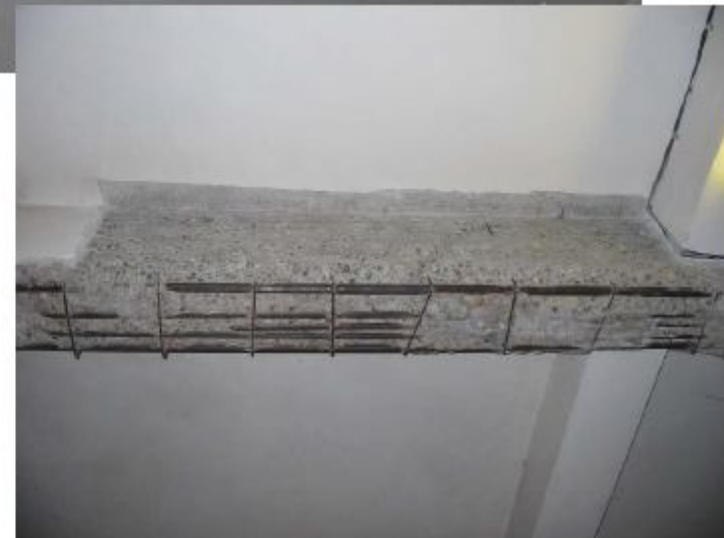
Surface cleaning

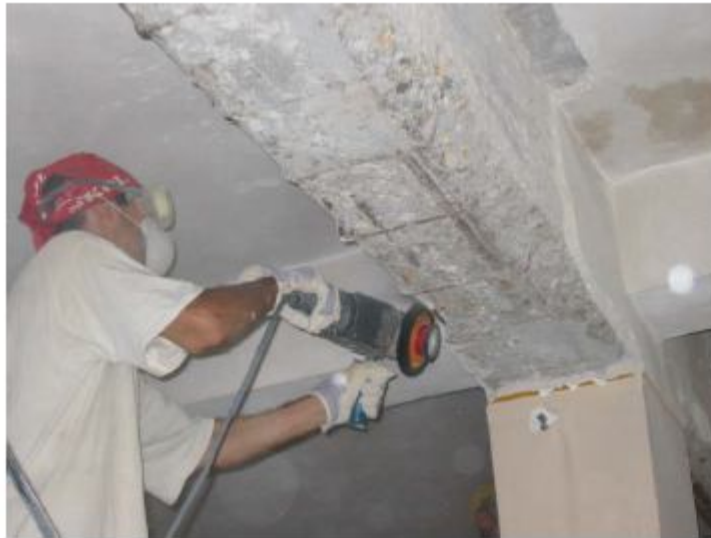
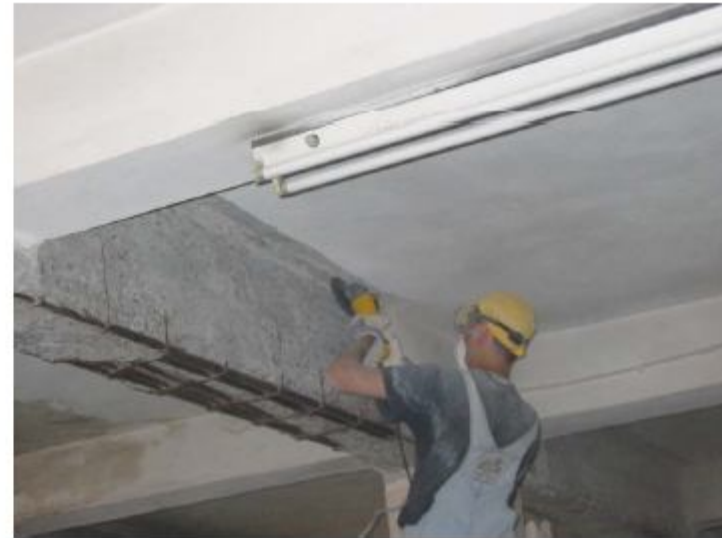
Surface cleaning

Preparing the
anchorage zone

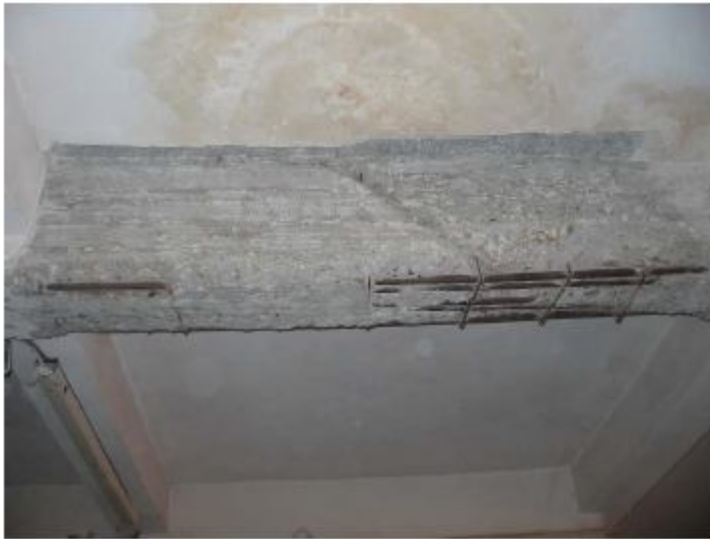
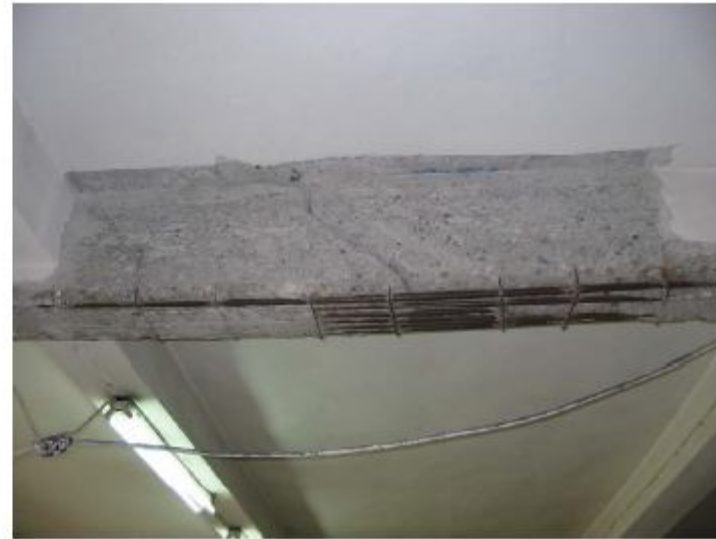
The clean surface ready to strengthening

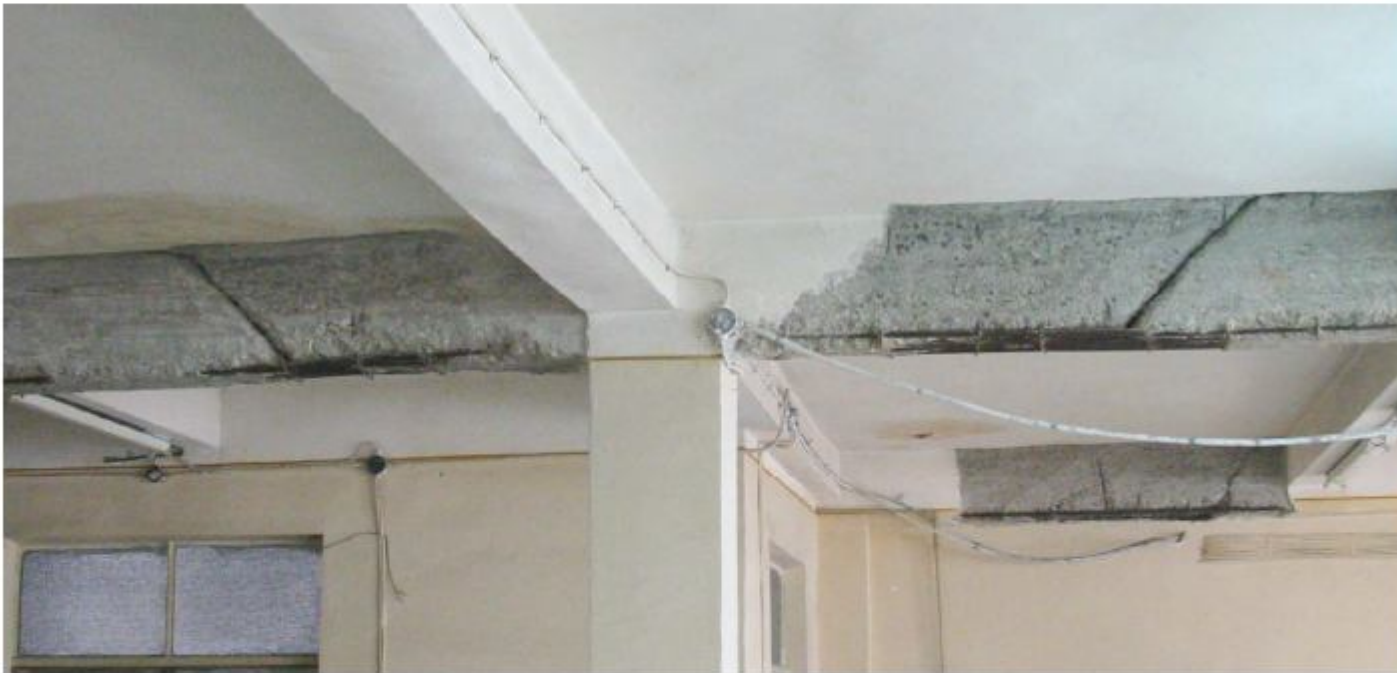
The clean surface ready to strengthening

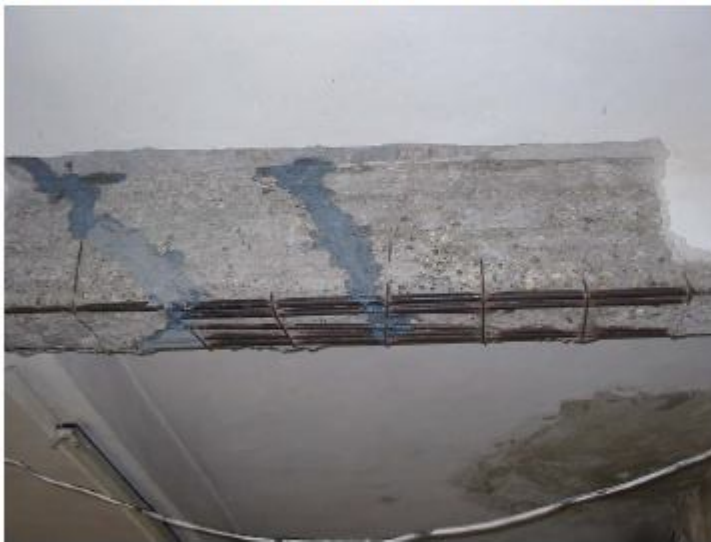
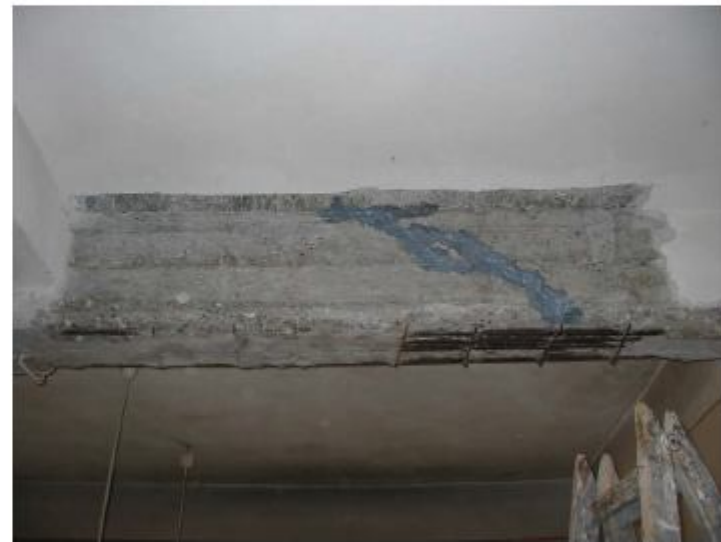
Crack injection

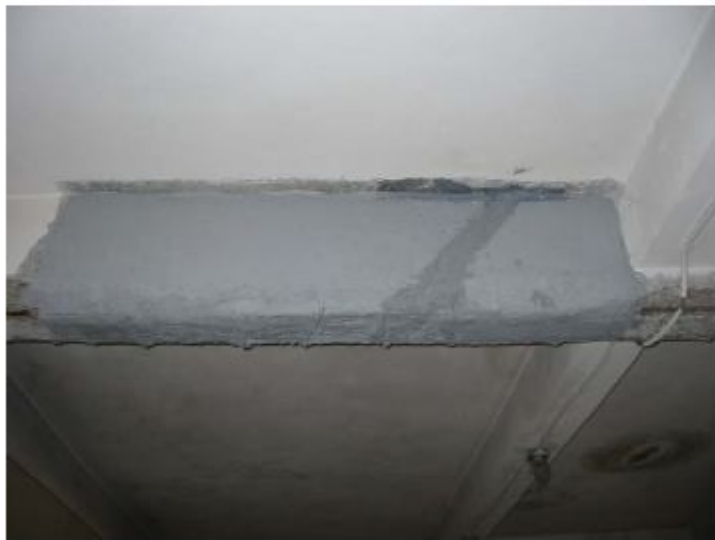
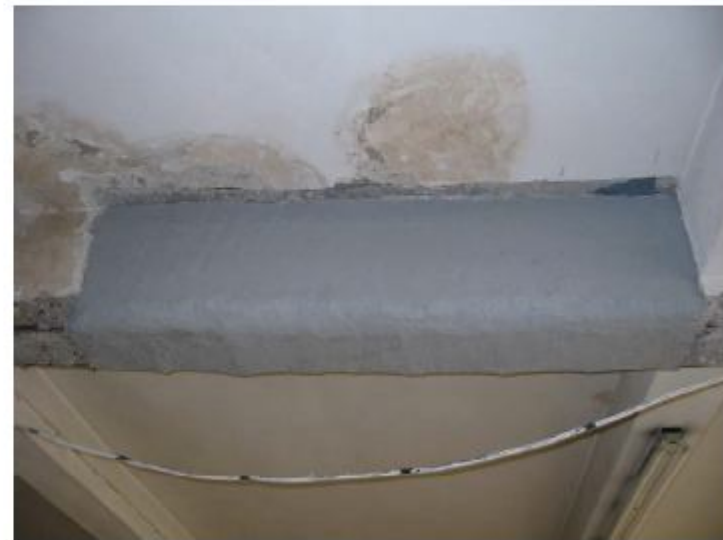
Surface preparation

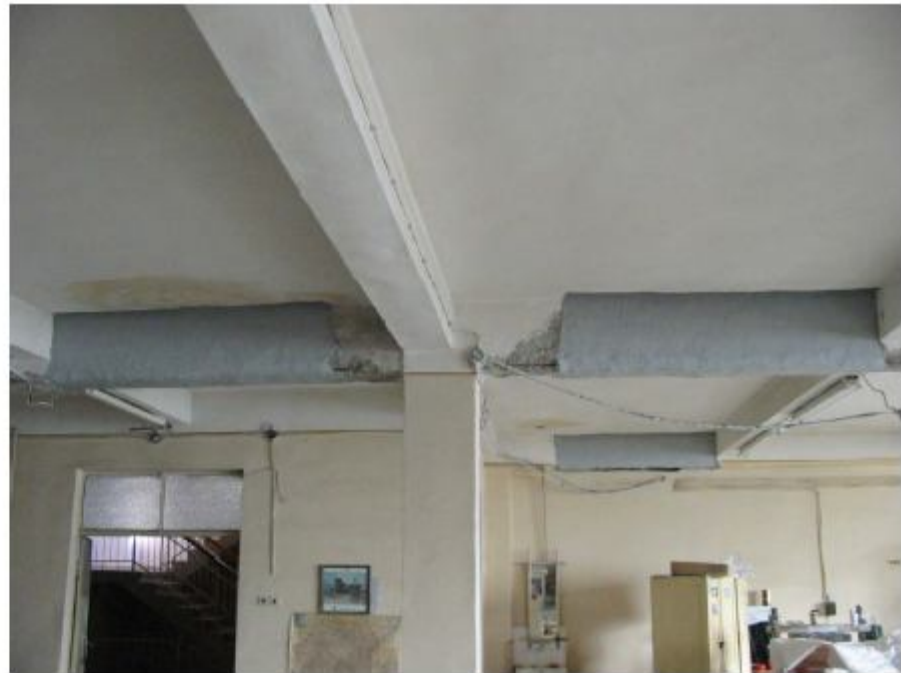
Surface preparation

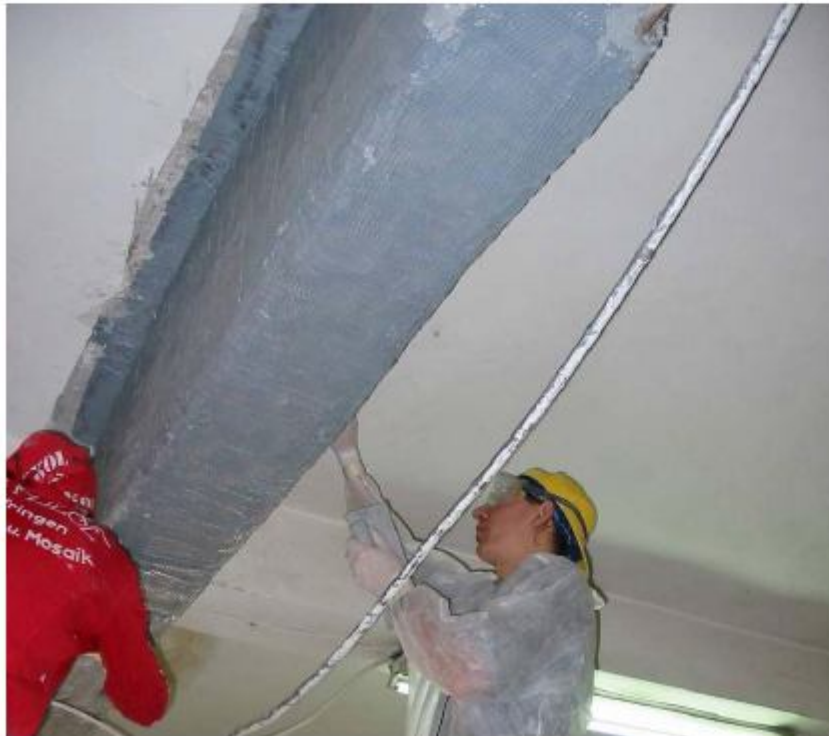
Sealing and saturating the surface

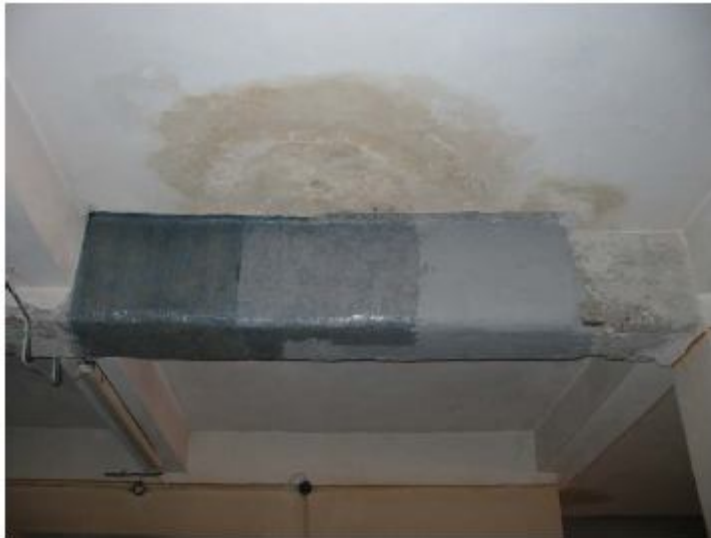
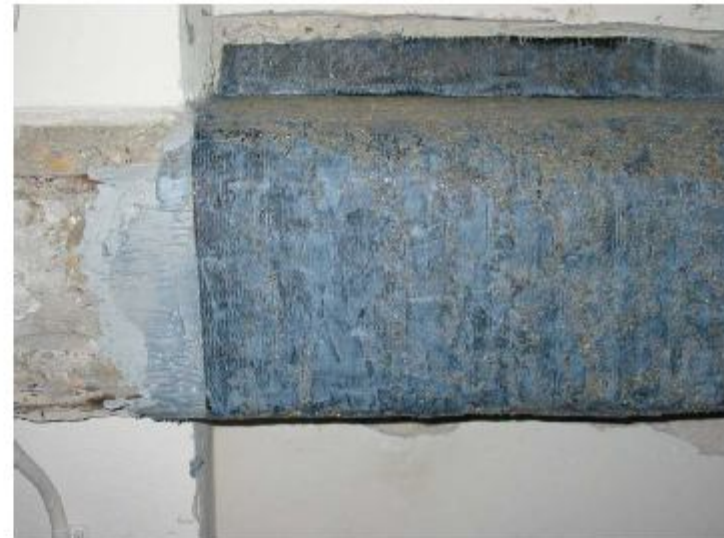
Applying the fibers

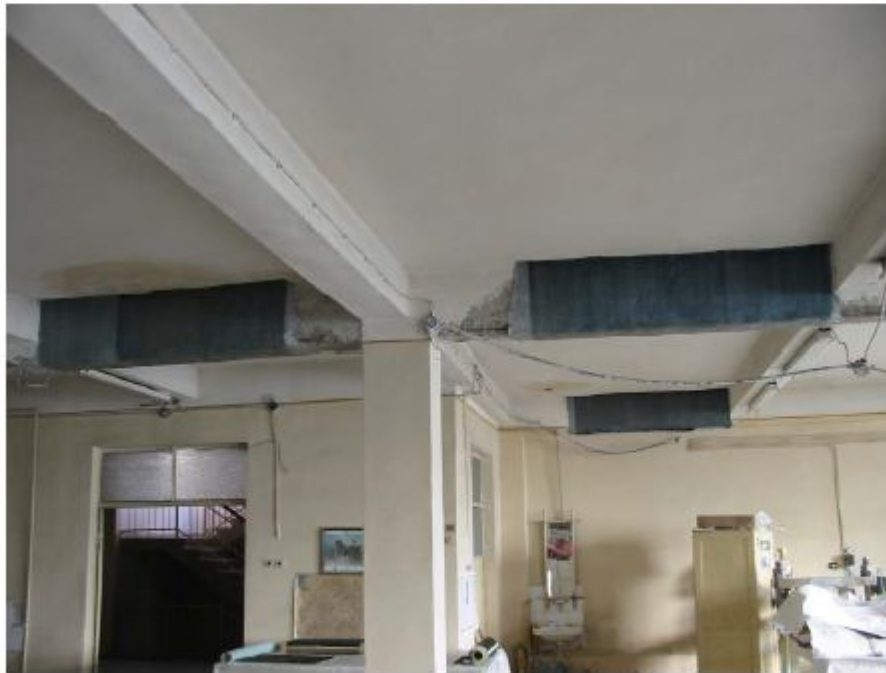
Applying the fibers

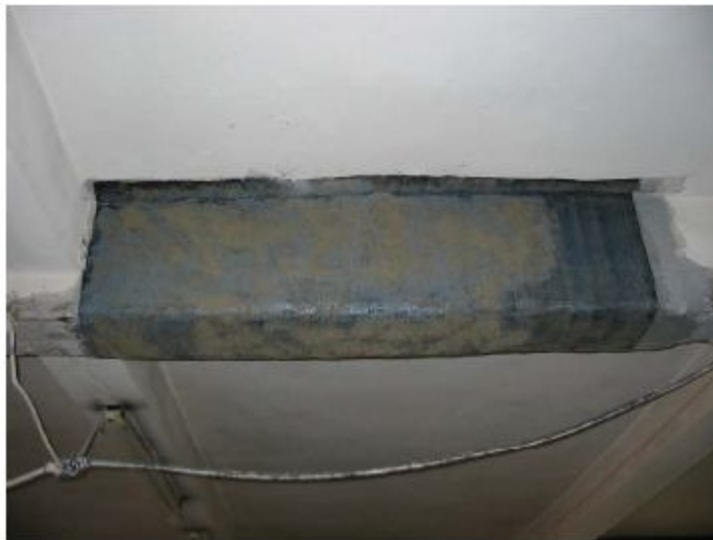
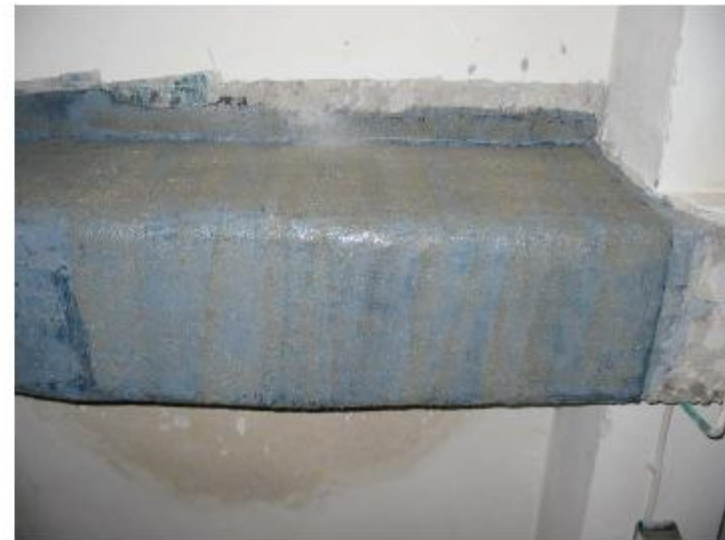
Applying sand
to improve bond between the FRP and the finishing mortar

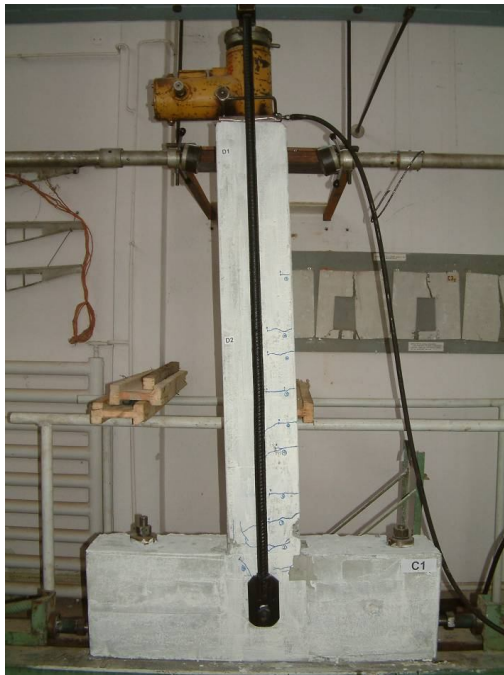
Reference specimen [C1M] Monotonic testing

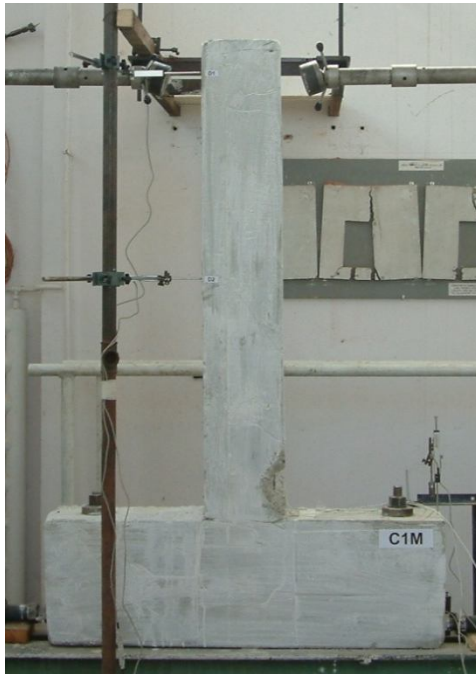
Reference specimen [C1C]

Cyclic testing

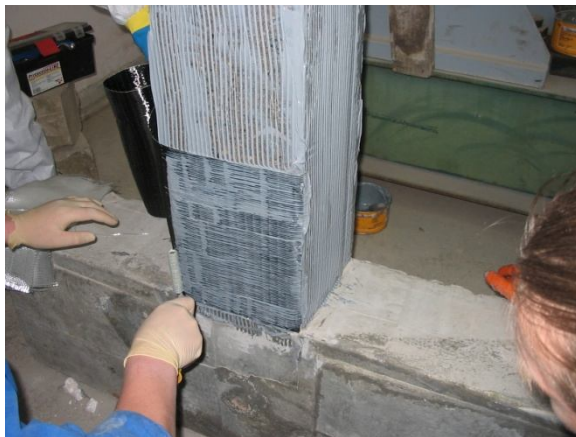
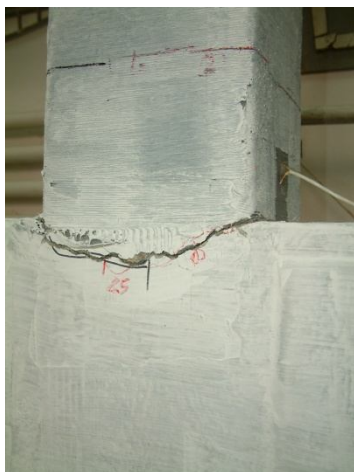
Specimen strengthened using metallic rods anchored into the foundation. [C3M-BM-AF] Monotonic testing

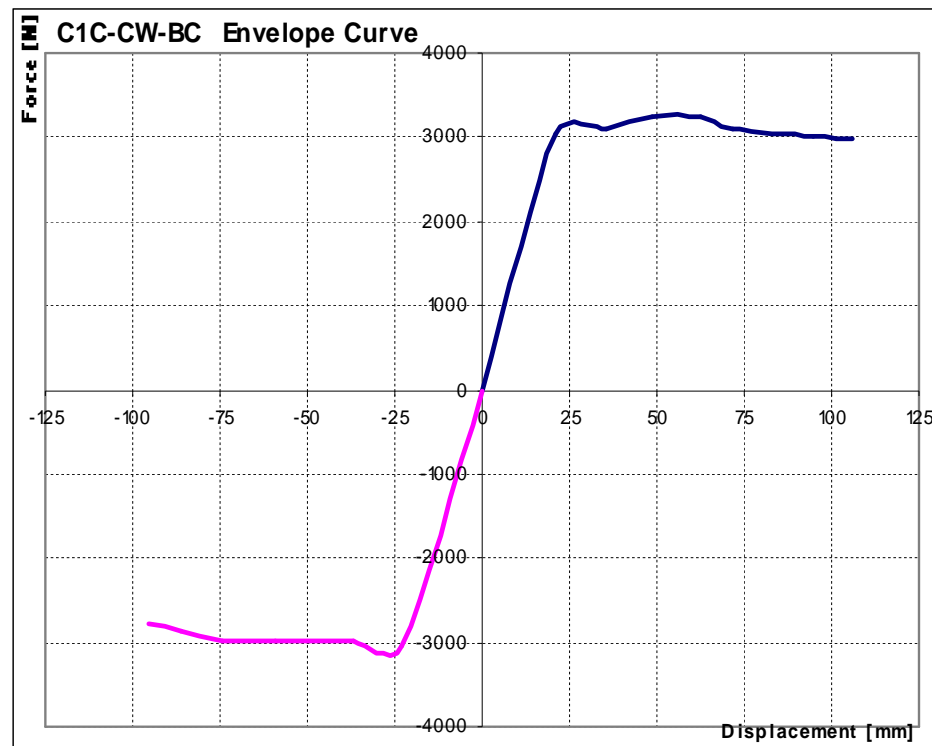
Specimen strengthened by a carbon fiber wrap base confinement [C1C-CW-BC] Cyclic testing

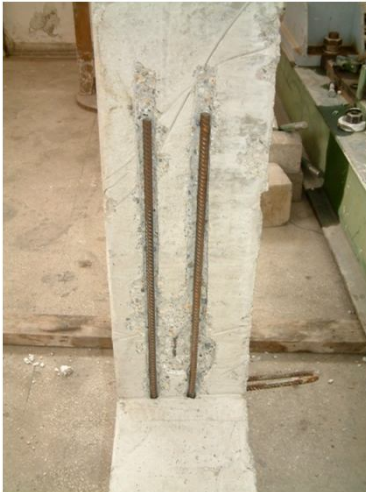
Specimen strengthened using metallic rods anchored into the foundation and a carbon fiber wrap base confinement [C4M-BM+CW] Monotonic testing

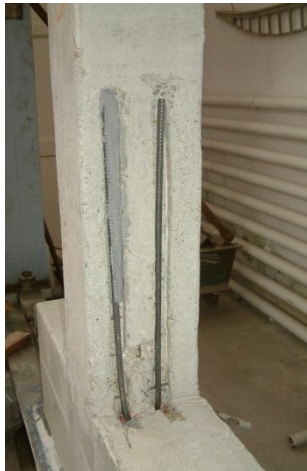
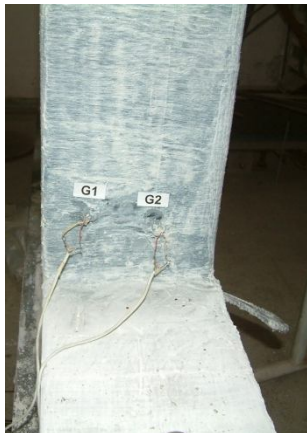
Specimen strengthened using metallic rods anchored into the foundation and a carbon fiber wrap base confinement [C4C-BM+CW] Cyclic testing

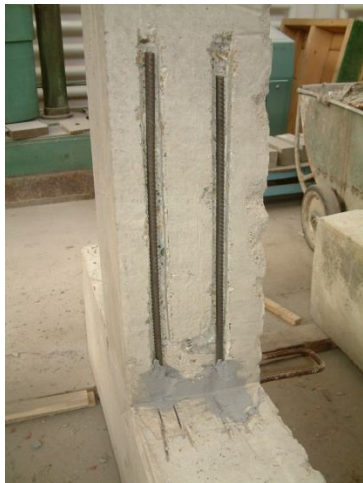
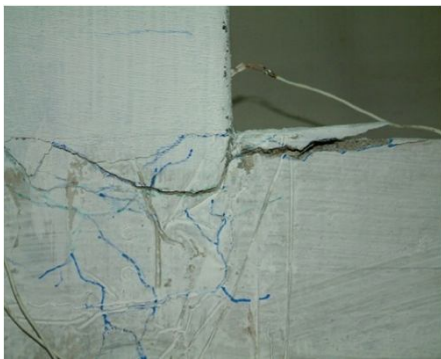
Superposition of the individual monotonic tests
