Rehabilitation and Maintenance of Buildings

Valeriu STOIAN

Lecture : 19/06/2014 – 8.30-10.00/10.30-12.00

European Erasmus Mundus Master Course

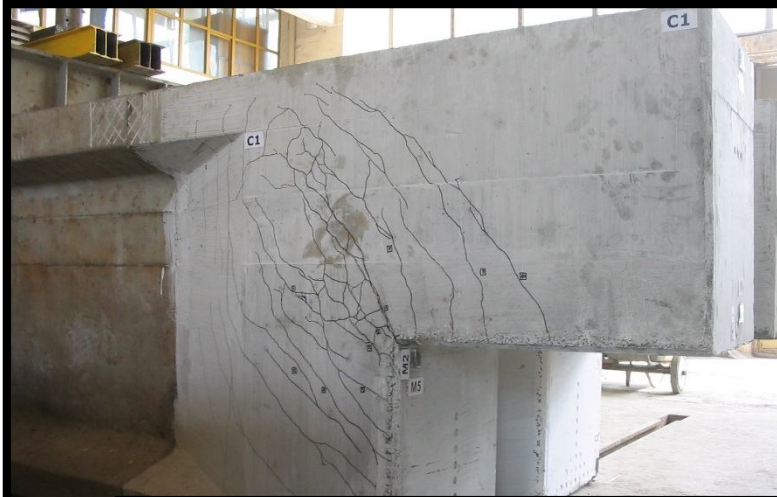
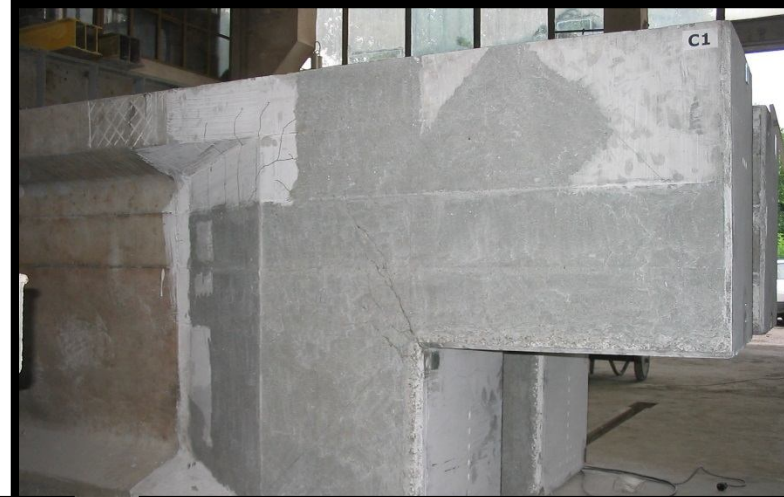
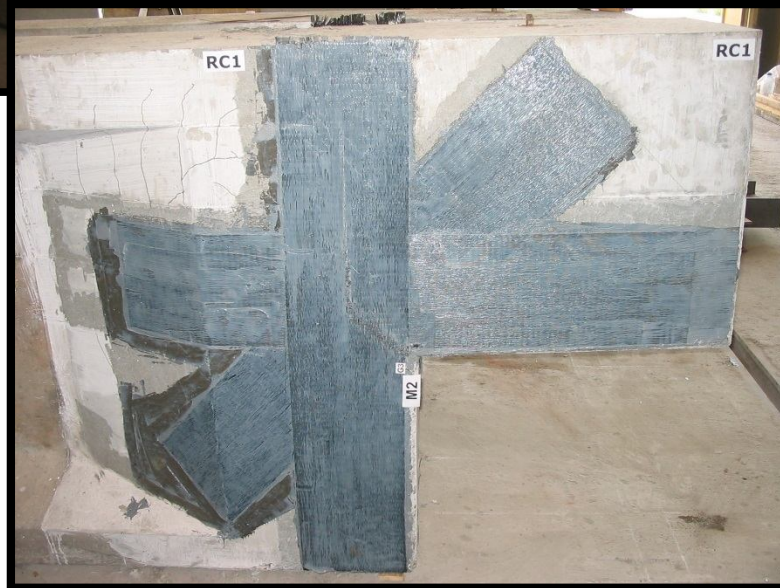
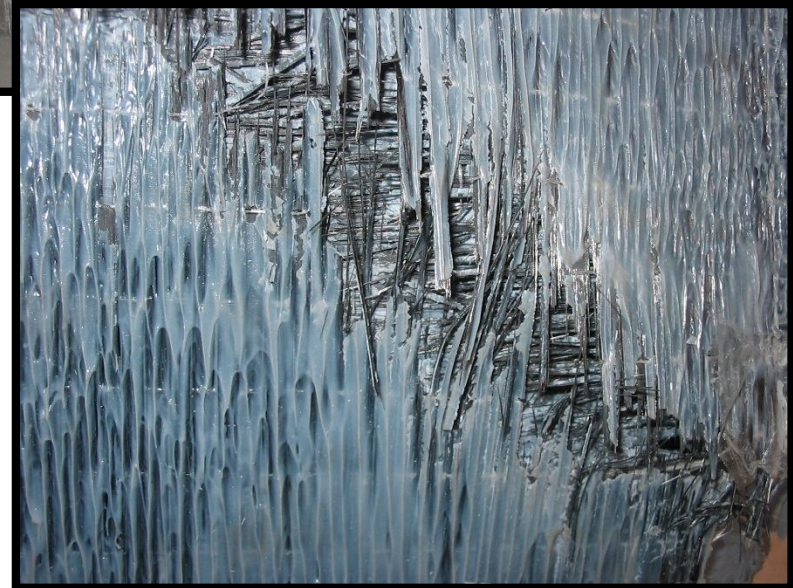
Test results–rehabilitated specimen (RC2)

- Specimen C2 was tested up to 80 t.
 - the first crack started at a 42°
 - at 65 t appear four major cracks
 - the maximum displacement was 6 mm
 - strain gages in steel 1.87 ‰ (yielding)
- Specimen RC2 had a linear behaviour up to 130 t
 - at 143 t appear the peeling-off of the horizontal plates
 - maximum load at 176 t when also the vertical plates failed through peeling-off; the failure was brittle
 - the maximum strain in steel was 2.59 ‰ at 148 t
 - the maximum strain in composite 7 ‰, which correspond to 41 % of the composite's ultimate value.

Crack patterns, load-displacement curves and strains in steel reinforcement (S) and composite (G) of the C2 and RC2 elements

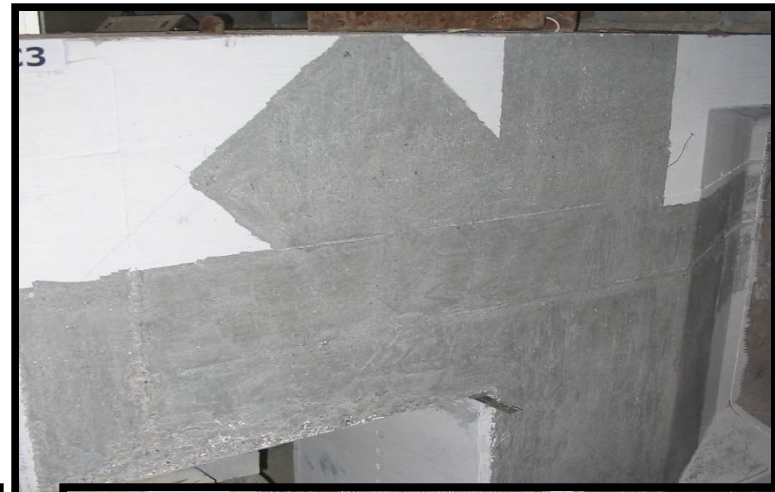
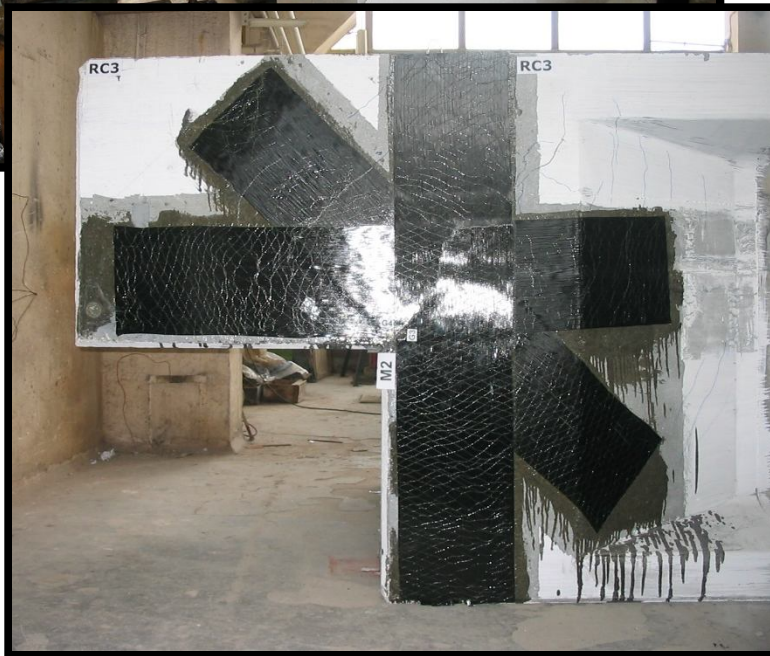
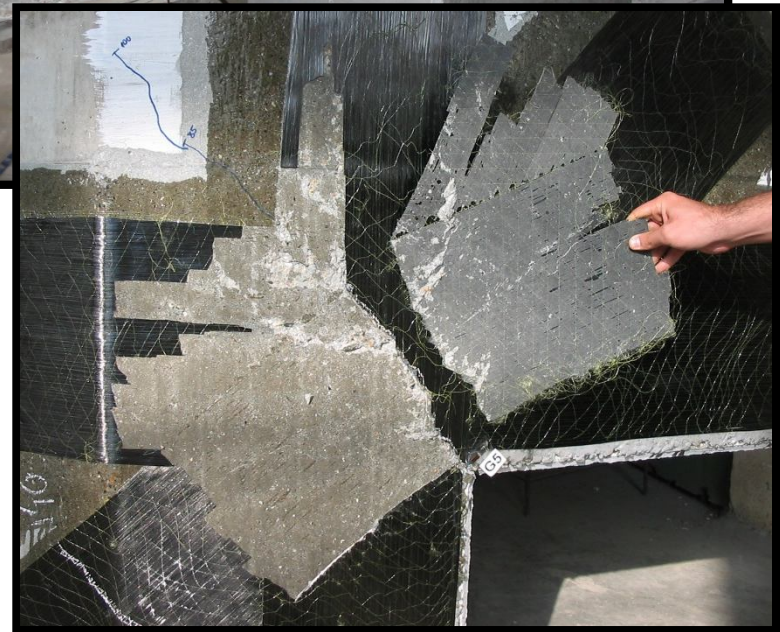
Test results – rehabilitated specimen (RC4)

- Specimen C4 first crack at 46°
 - after 80t four new major cracks developed
 - strain in steel 1.44 ‰
- Specimen RC4 had a linear behaviour up to 98 t
 - at 119 t a crack developed around the horizontal plates.
 - the element failed at 169 t through debonding of vertical plates with an immediate peeling-off of the horizontal plates; the failure was brittle
 - strain in steel 3.78 ‰ at 153 t
 - strain in composite reached 6.72 ‰, which corresponded to 40 % of the composite's ultimate value.

Crack patterns, load-displacement curves and strains in steel reinforcement (S) and composite (G) of the C4 and RC4 elements

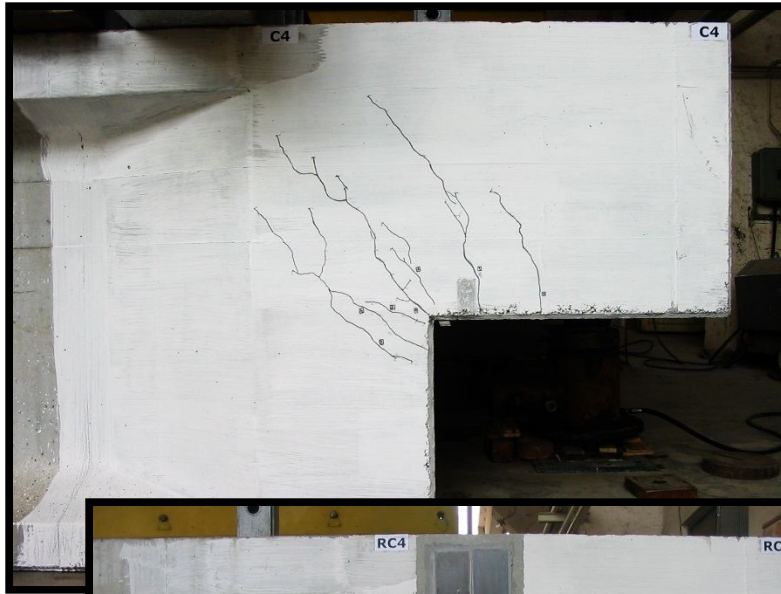
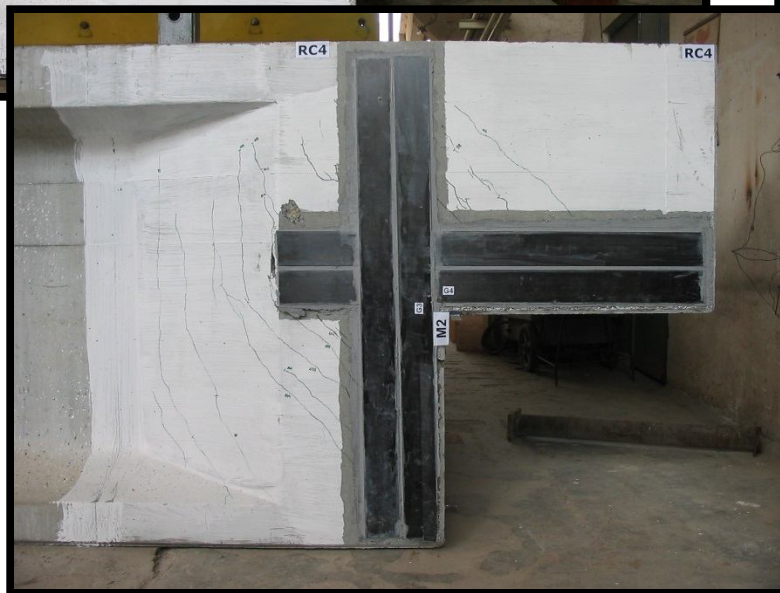
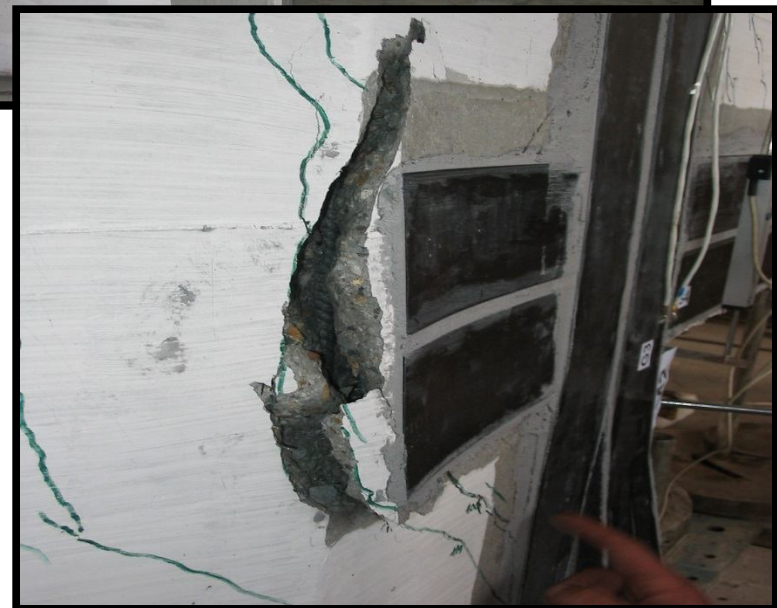
- The used theoretical models approximate with sufficient accuracy the elements' behaviour
- The FRP systems used increase the service load (compared with the reference strain in steel reinforcement at 80t)
- The maximum load bearing capacity of the elements increased

Specimen	+ ΔSL (%)	+ ΔUL (%)	Δ_{max} (mm)
RC1	-	11	34
RC2	45	10	18
RC3	25	0	27
RC4	40	6	19

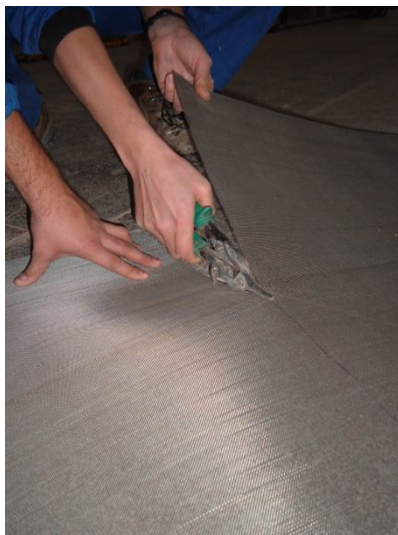
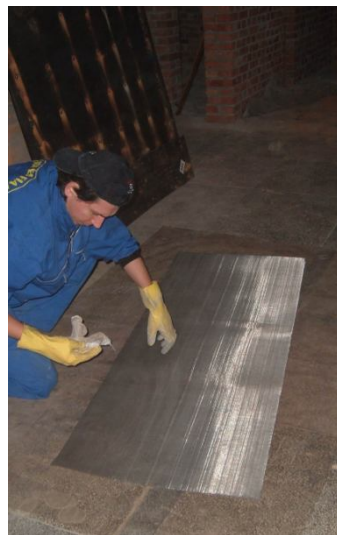
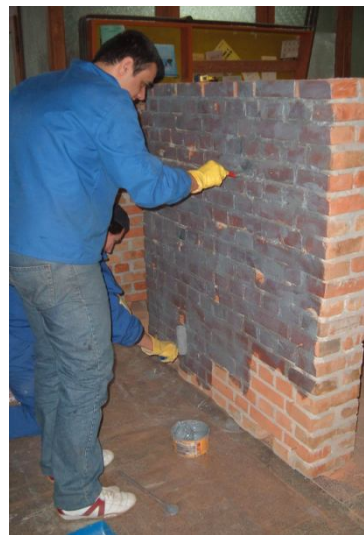
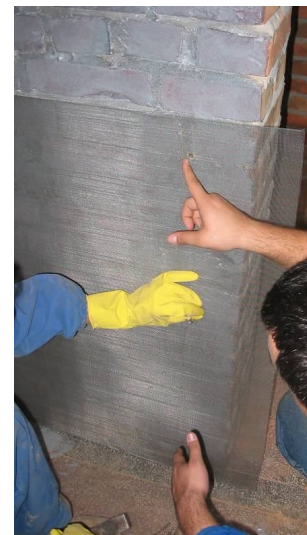
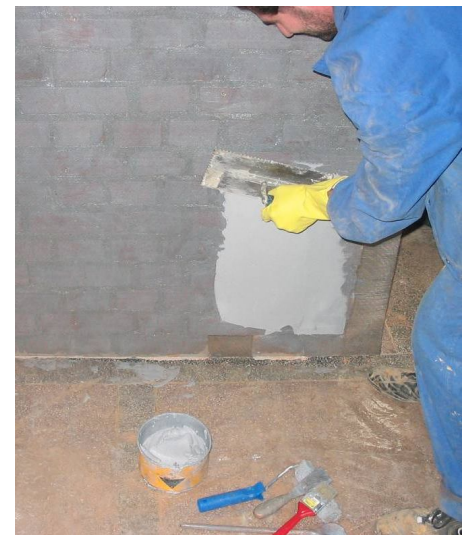
→ **STAINLESS STEEL BIDIRECTIONAL FABRIC** (WIRE MESH) WITH 0.4 mm DIAMETER AND 1.0 mm SPACING, APPLIED WITH AN EPOXY BASED MORTAR.

→ STRENGTHENING PROCEDURE **SIMILAR AS THE USED FOR FRP SYSTEMS**

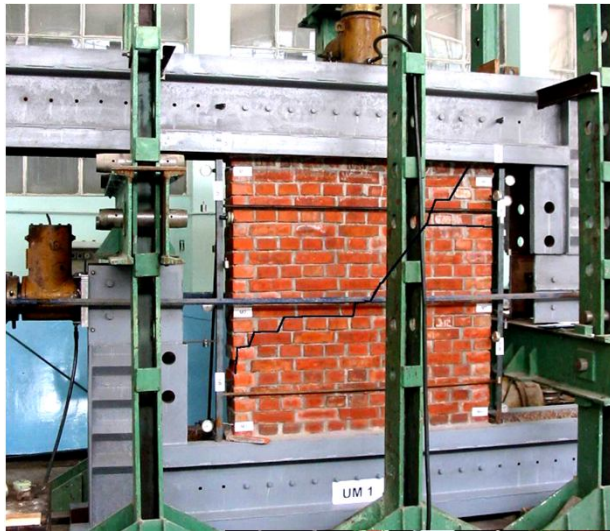
TEST RESULTS

Differences in capacity : - 23%

Difference in displacement : + 131%

FAILURE

→ EXTENSIVE OPENING OF THE EXISTING CRACK
FOLLOWED BY COMPOSITE DEBONDING AT THE CRACKS

$$\varepsilon_{frp} = 0.50\%$$

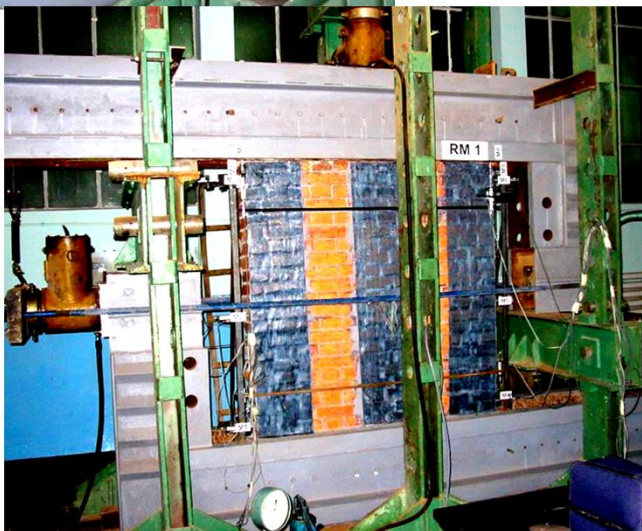
TEST RESULTS

FAILURE

→ DEVELOPMENT OF A NEW CRACK AND THROUGH ITS
EXTENSIVE OPENING

→ THE COMPOSITE WAS DEBONDED JUST IN THE CRACK
ZONE

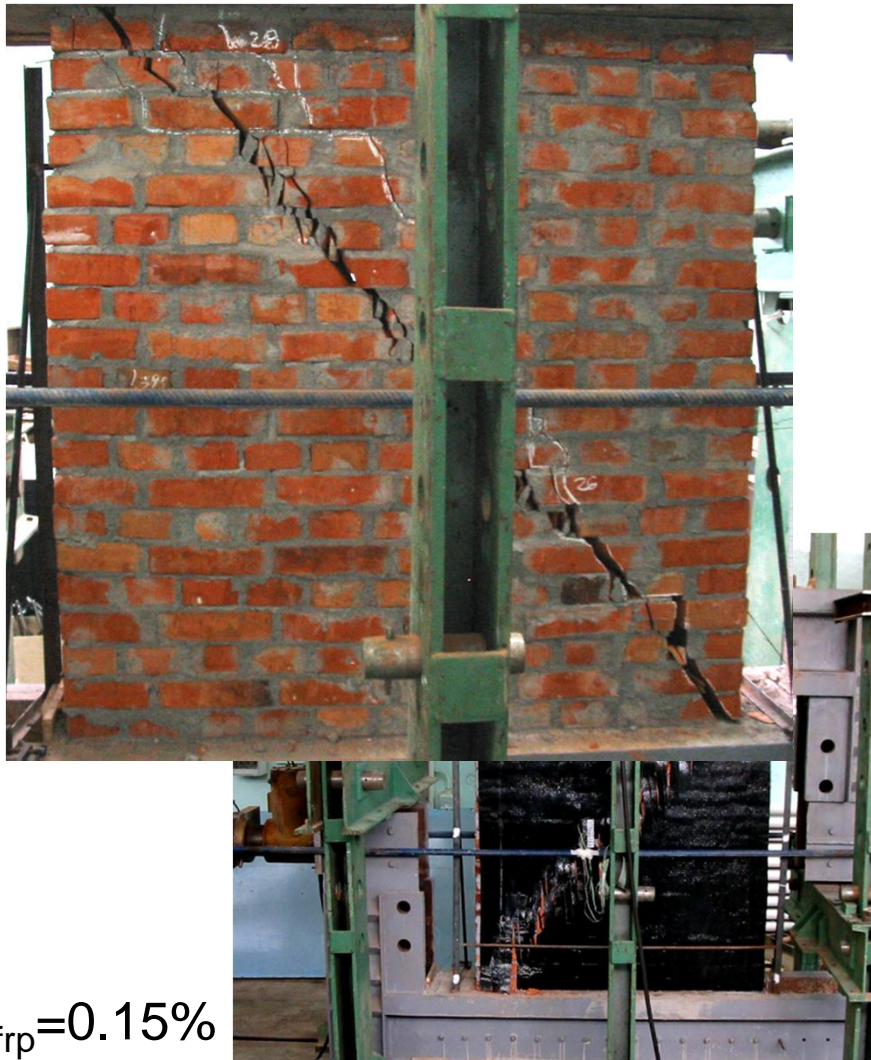
$$\varepsilon_{frp} = 0.15\%$$

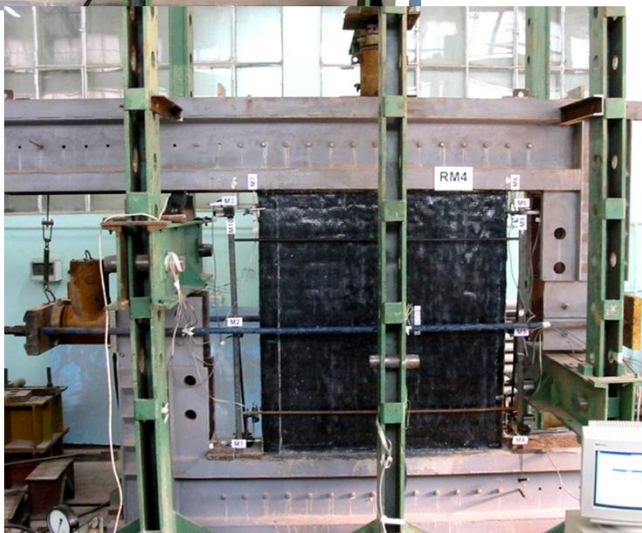
TEST RESULTS

Differences in capacity : - 16%

Difference in displacement :
+239%

FAILURE

→ EXTENSIVE OPENING OF THE EXISTING CRACK
FOLLOWED BY COMPOSITE DEBONDING JUST IN THE
CRACK ZONE

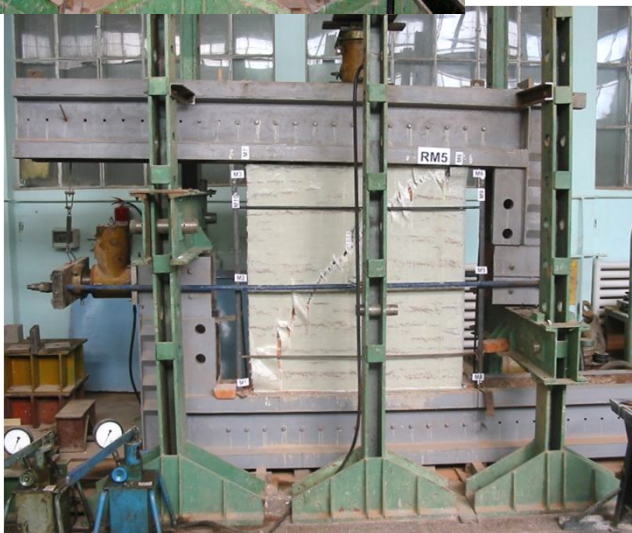
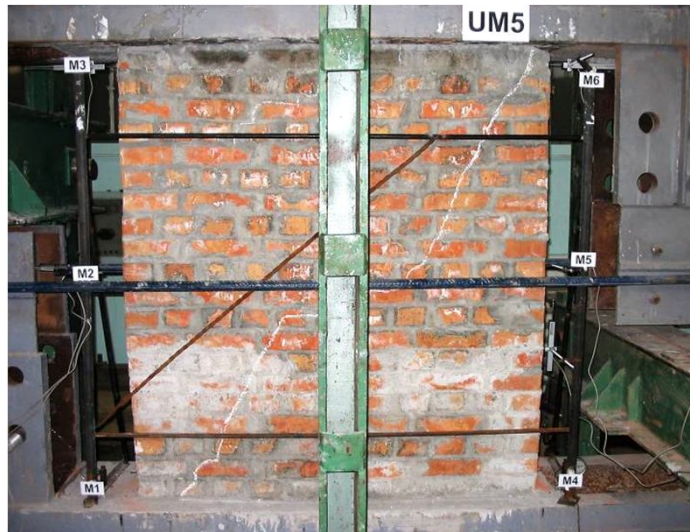
TEST RESULTS

$$\varepsilon_{frp} = 1.78\%$$

Differences in capacity : + 10%

Difference in displacement :

FAILURE +175%

→ FORMING OF MANY NEW CRACKS AND THROUGH THE EXTENSIVE OPENING OF THE EXISTING ONE

→ THE COMPOSITE DEBONDED ON LARGE AREAS, NEAR THE CRACK ZONE

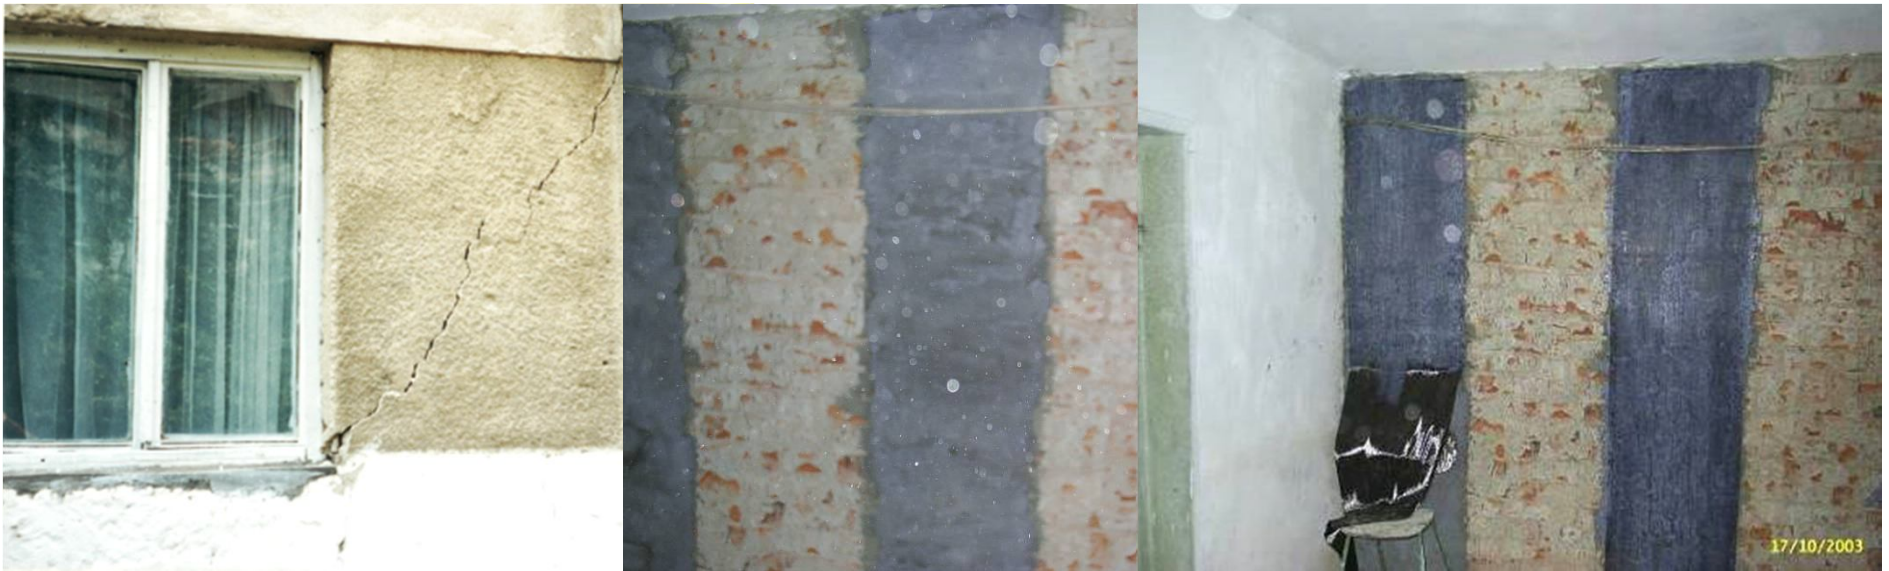
(courtesy of Sika Romania)

- In 2002, after an earthquake, two residential buildings with masonry structure, built in 60', situated in town Moldova Nouă, Romania, were damaged

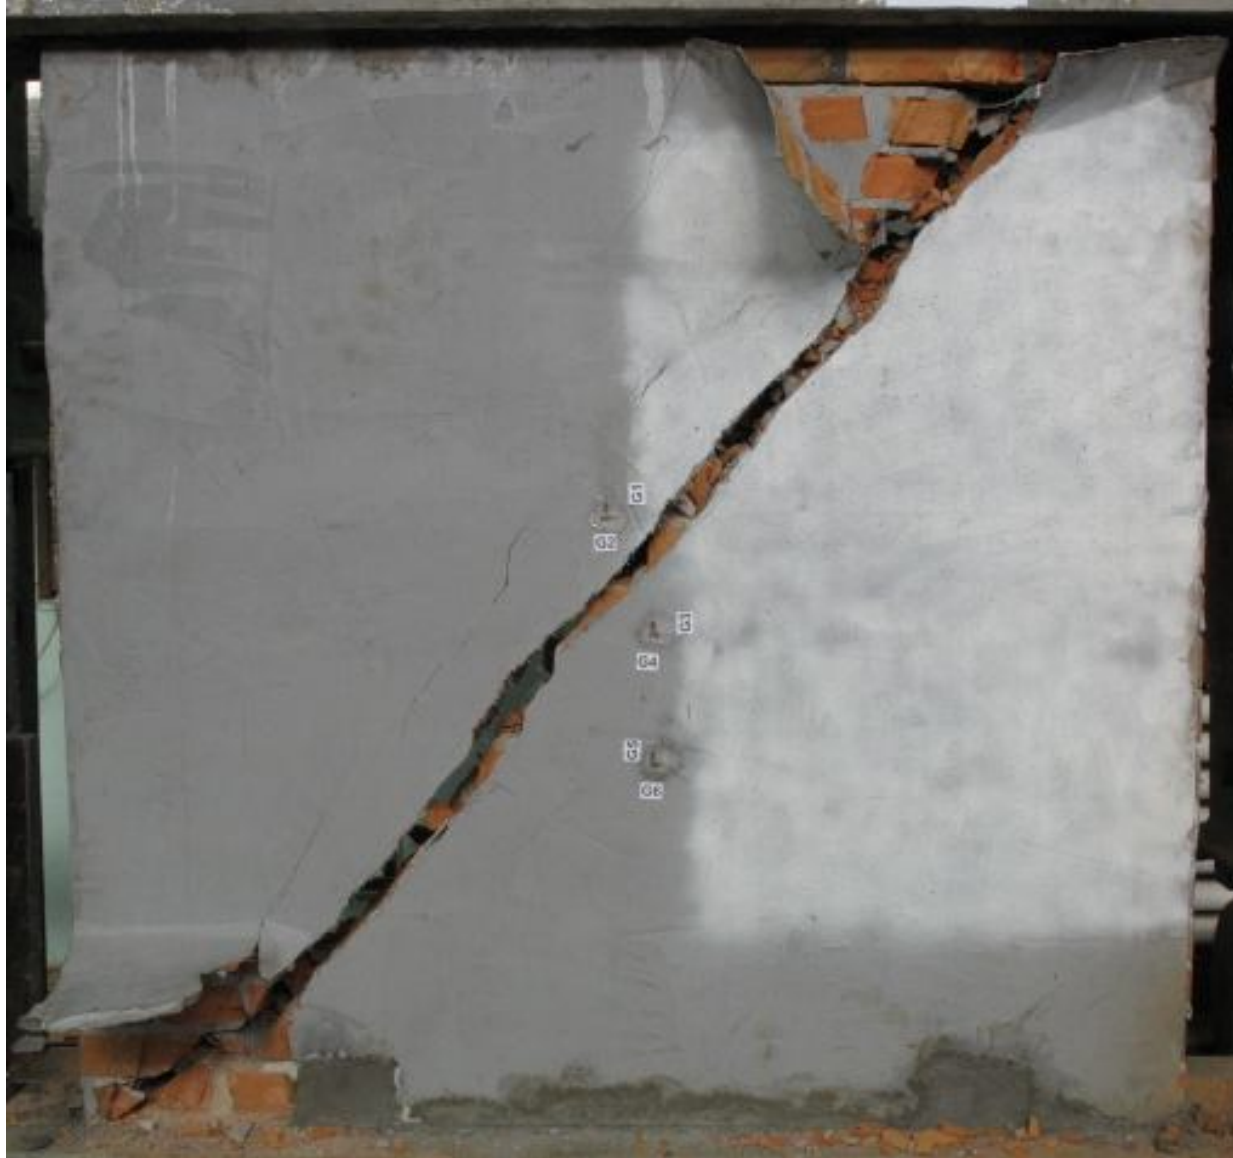
SMEARED CRACKS

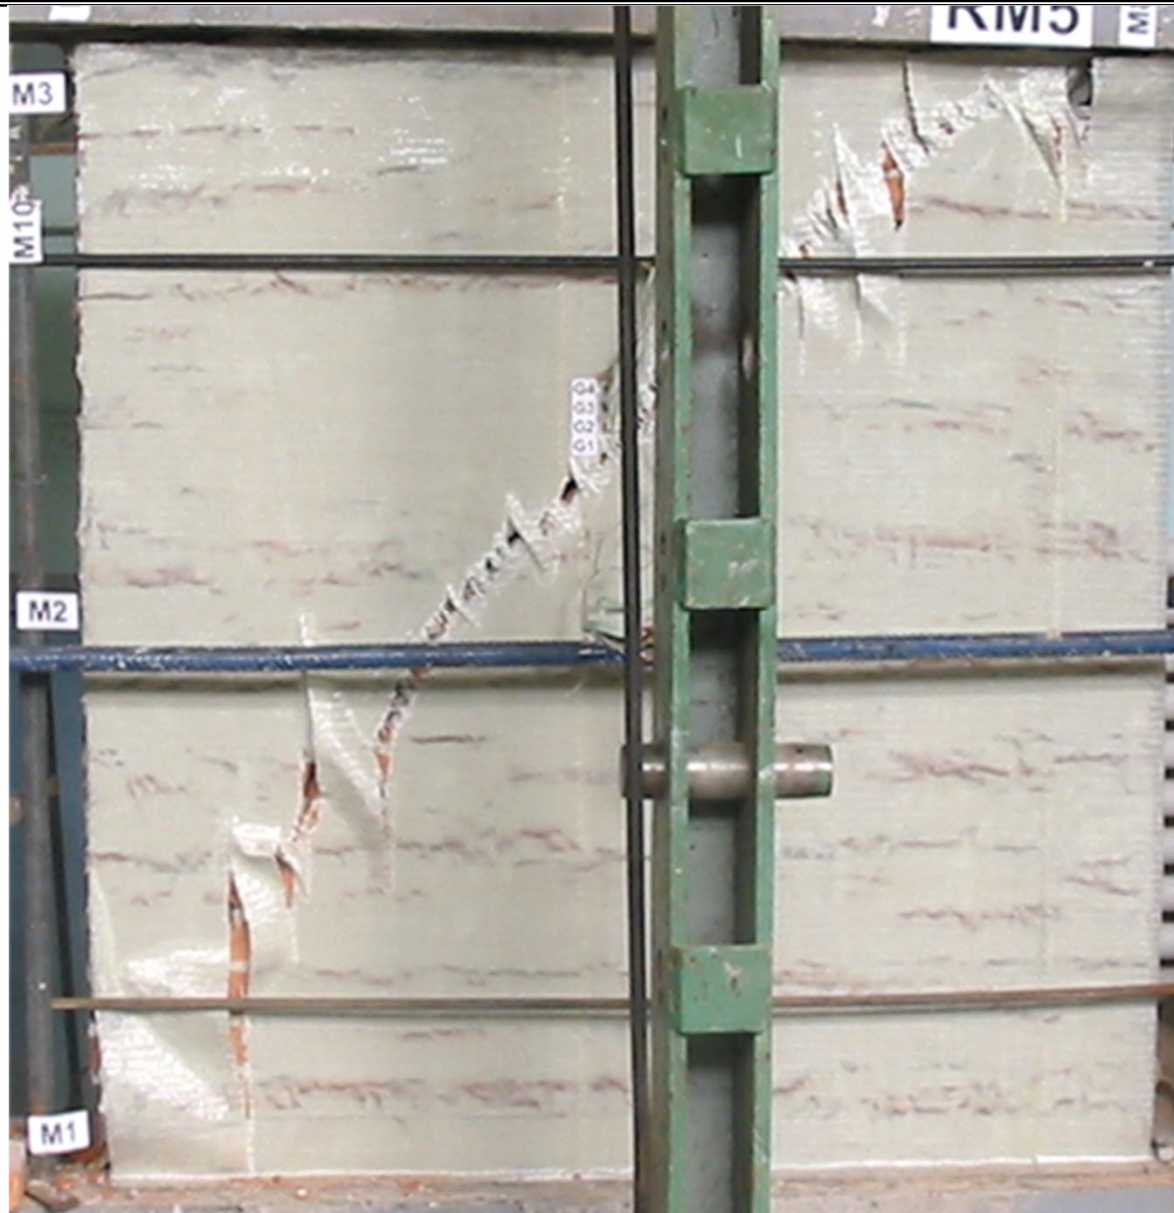
DEBONDING GFRP

- **full displacement compatibility** between the retrofitting material or system and the masonry up to collapse
- **different damage process** of the retrofitting system:
 - debonding** of the **GFRP** or **CFRP**
 - yielding** of the **SFRP**
 - plastic bearing** of **Steel Sheet** accompanied by vanishing the composite character (equivalent to debonding)

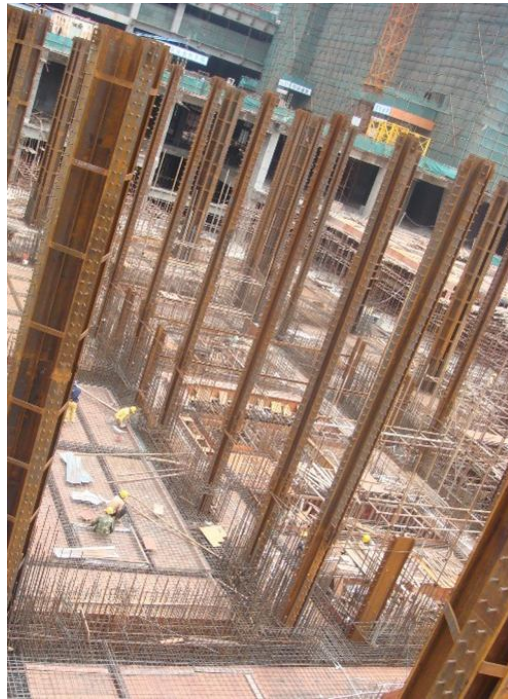
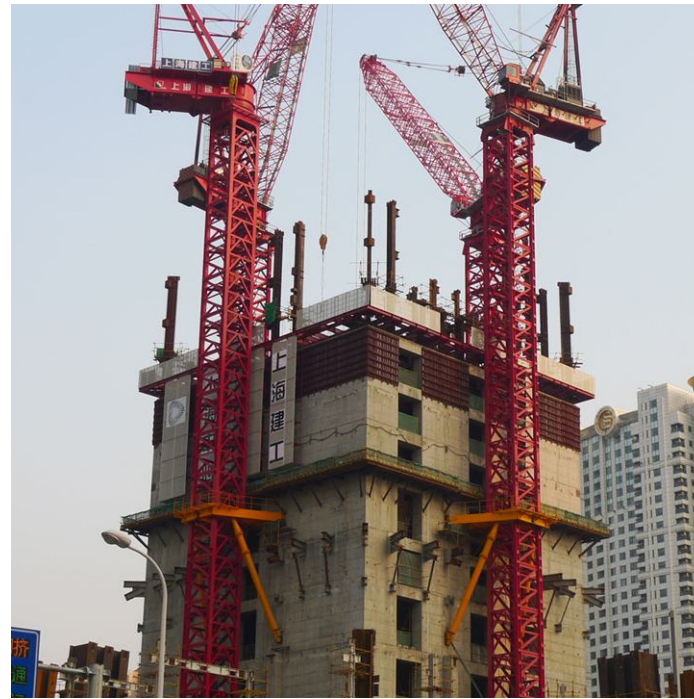
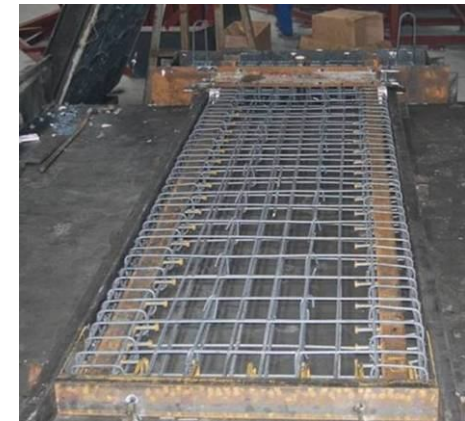
COMPOSITE STEEL-CONCRETE SHEAR WALLS ARE REINFORCED CONCRETE WALLS OBTAINED BY REPLACING THE VERTICAL REINFORCEMENTS FROM THE EDGES BY STEEL ENCASED PROFILES

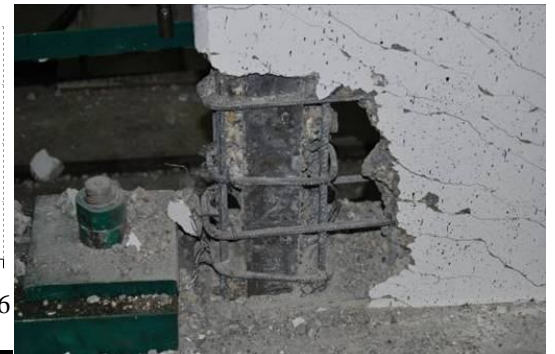
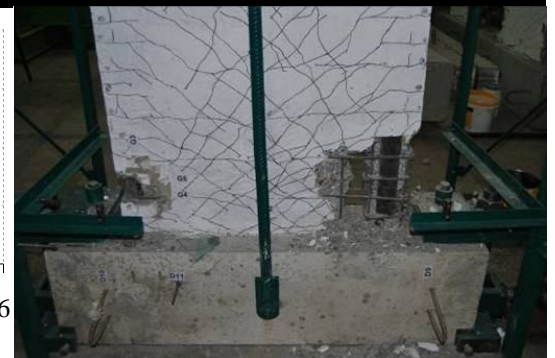
- EXPERIMENTAL RESULTS ON **CSRCW2** SPECIMEN

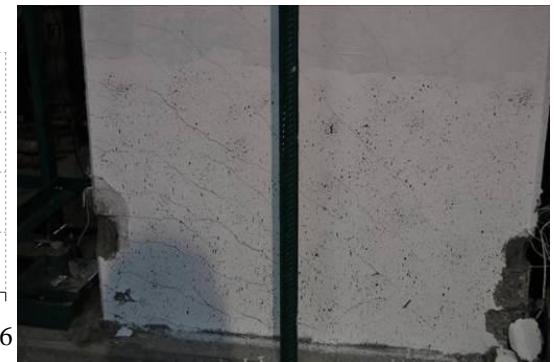
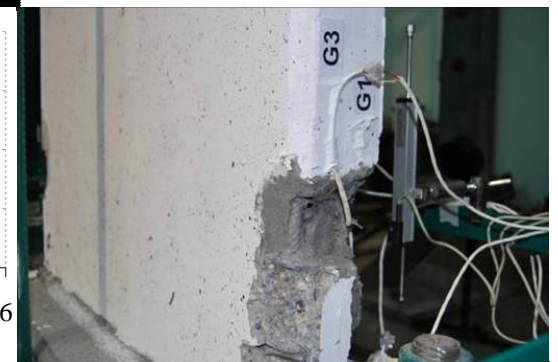
- EXPERIMENTAL RESULTS ON **CSRCW4** SPECIMEN

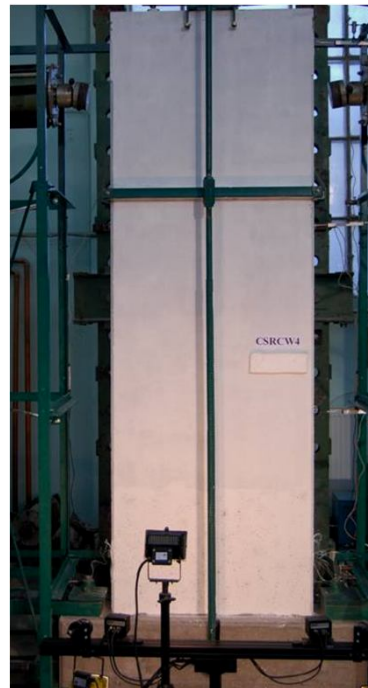
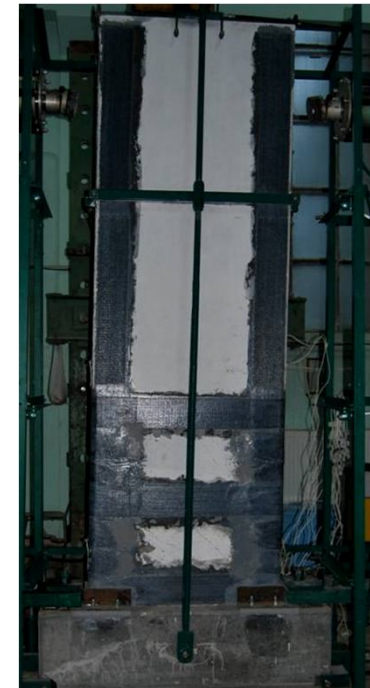
- Experimental investigation on the overall behavior of the damaged and retrofitted composite steel-concrete walls
- Restore the load bearing capacity caused by damages
- Investigate the effectiveness of retrofitting by using externally bonded CFRP composites

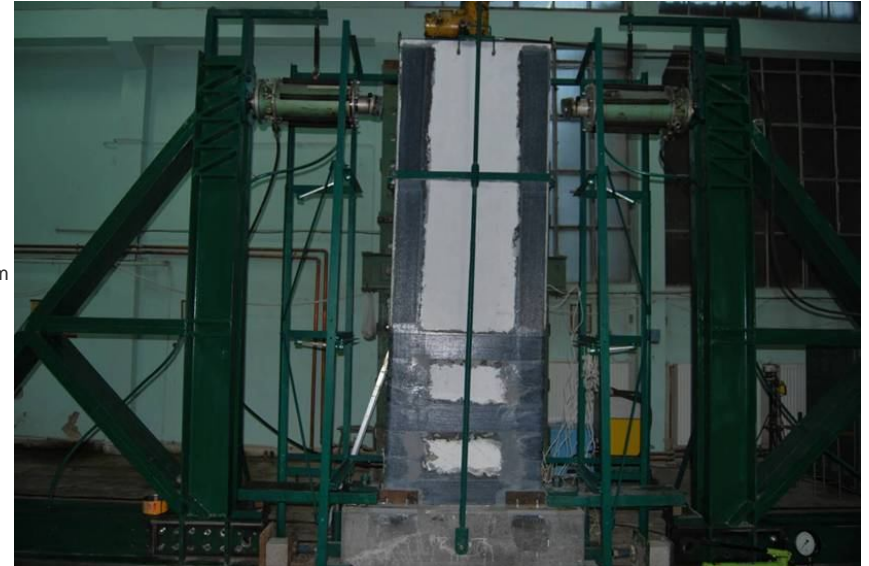
Experimental program TEST SET-UP AND LOADING STRATEGY

AXIAL

- $N = 100 \text{ kN}$

- Drift increment: ECCS procedure
- Cycles: 3
- Failure: -15%

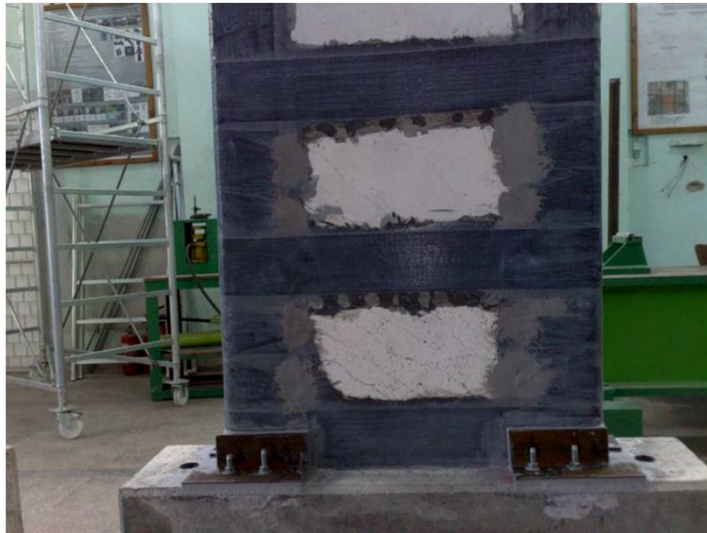
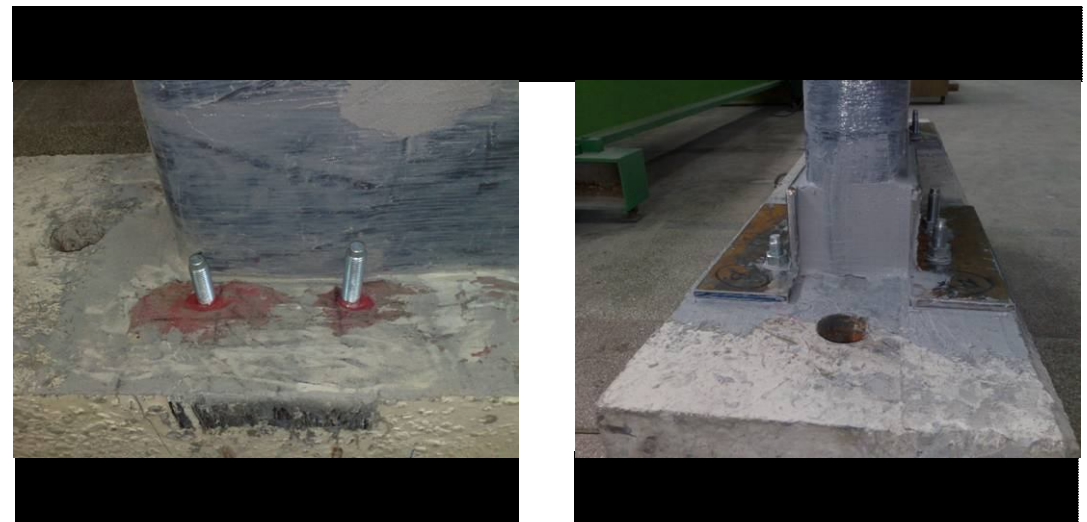
RETROFITTING

- REPAIRING OF THE CRUSHED CONCRETE
- PREPARING OF THE CONCRETE SURFACE

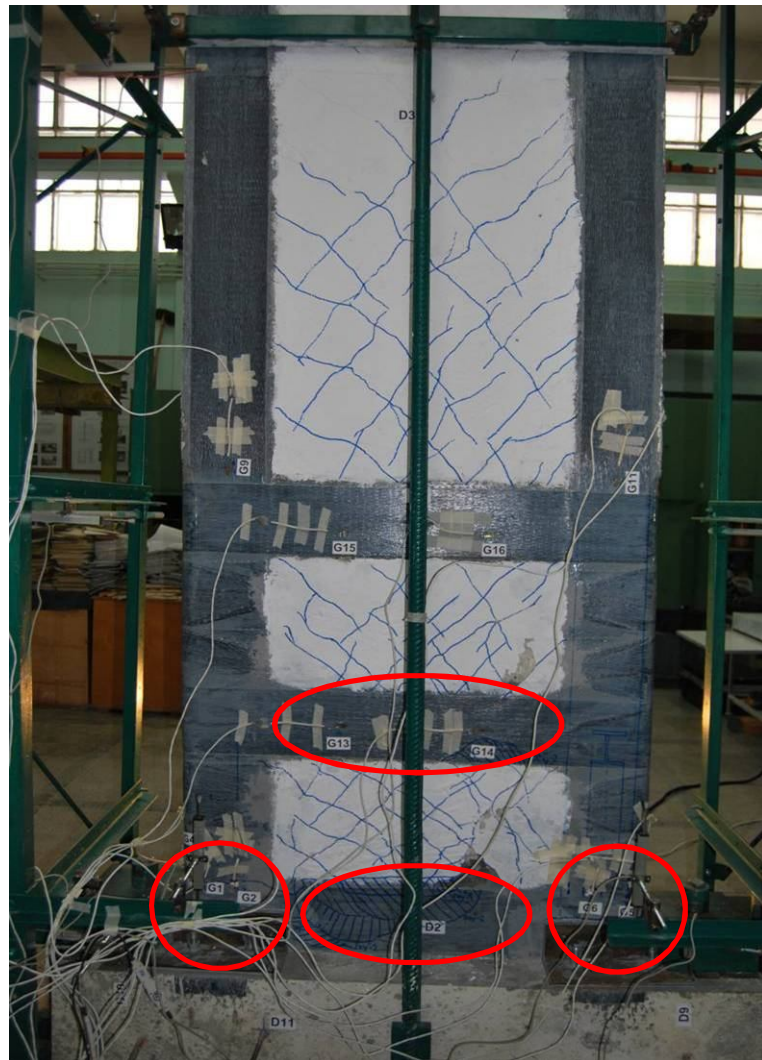
BEHAVIOR AND FAILURE MODES CSRCW2_R

1. FLEXURAL AND SHEAR CRACKS
2. FRP DEBONDING
3. FRP FRACTURING
4. REINFORCEMENT FRACTURE
5. CONCRETE CRUSHING

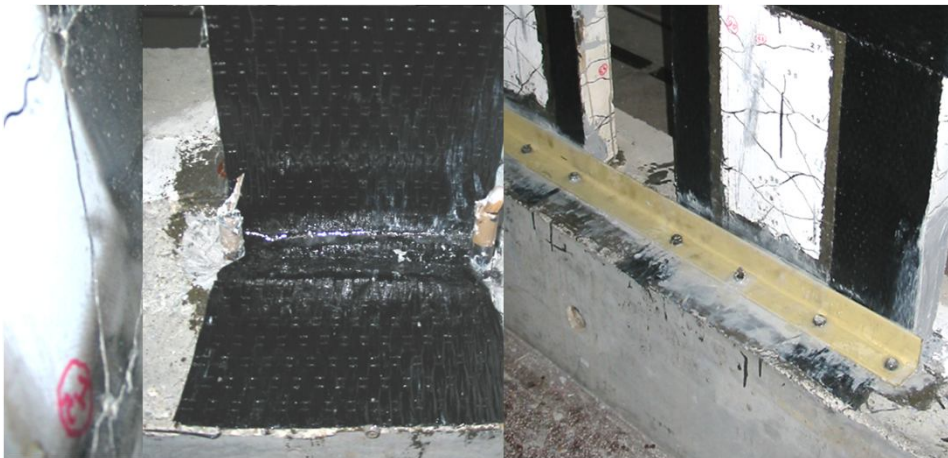
2. RETROFITTING OF THE WALLS → UNIDIRECTIONAL CFRP FABRIC ON ONE SIDE

- REPLACE THE DAMAGED PARTS WITH EPOXY MORTAR
- FILLING CRACKS WITH AN EPOXY RESIN
- CLEANING THE SURFACES
- ANCHORAGE OF THE CFRP

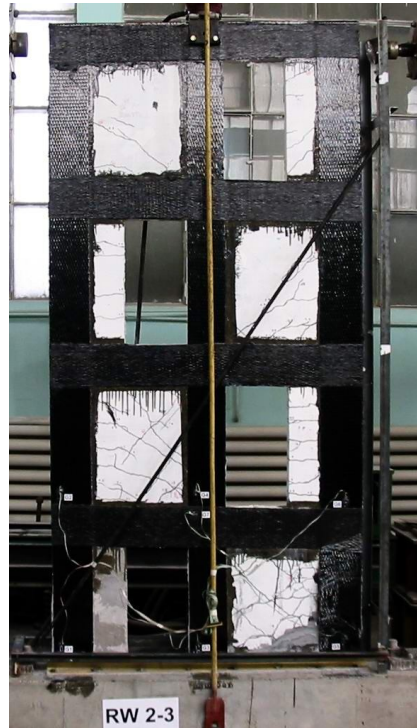
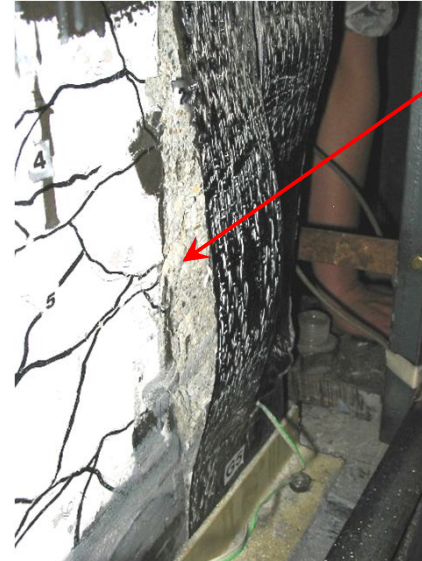
- RW23 :**
- GRADUALLY OPENING OF THE CRACKS
 - CFRP DEBONDING & CRACKING IN COMPRESSION
 - CFRP TENSION FAILURE

DEBONDING

**CRACKING IN
COMPRESSION**

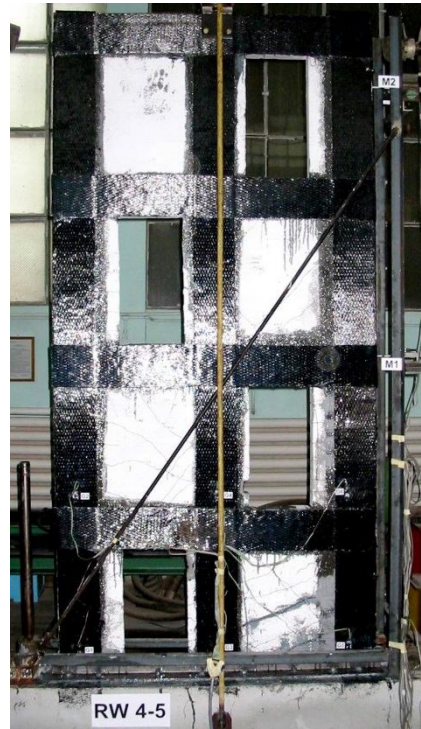
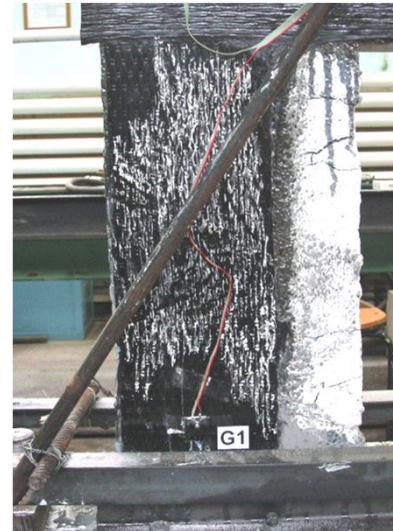
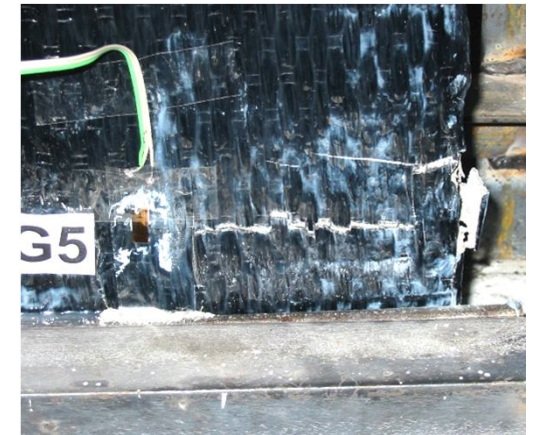
DEBONDING

**TENSION
FAILURE**

- RW45 :**
- GRADUALLY OPENING OF THE CRACKS
 - CFRP DEBONDING & CRACKING IN COMPRESSION
 - CFRP TENSION FAILURE & CONCRETE CRUSHING

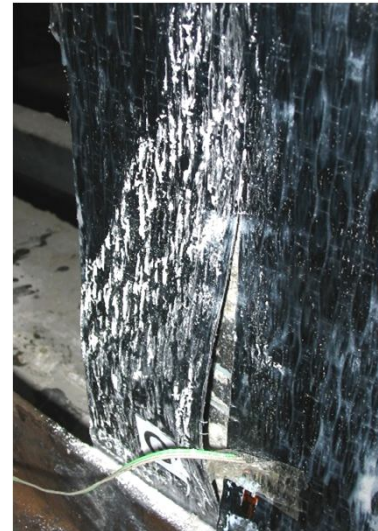
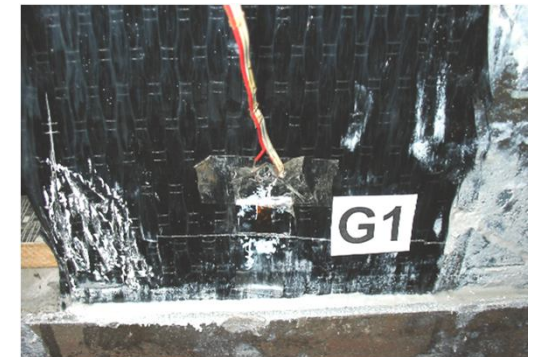
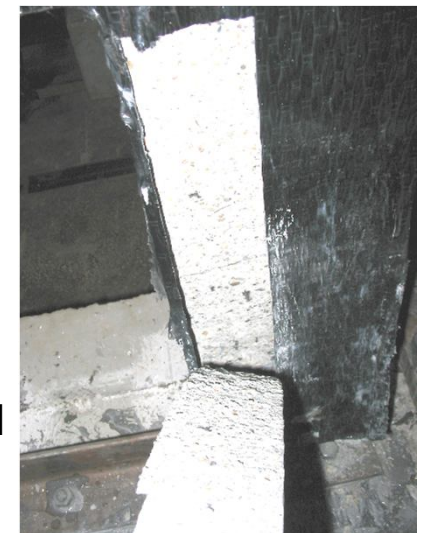
DEBONDING

**CRACKING IN
COMPRESSION**

- RW67 :**
- GRADUALLY OPENING OF THE CRACKS
 - CFRP DEBONDING & CRACKING IN COMPRESSION
 - CFRP TENSION FAILURE & CONCRETE CRUSHING

**TENSION
FAILURE**

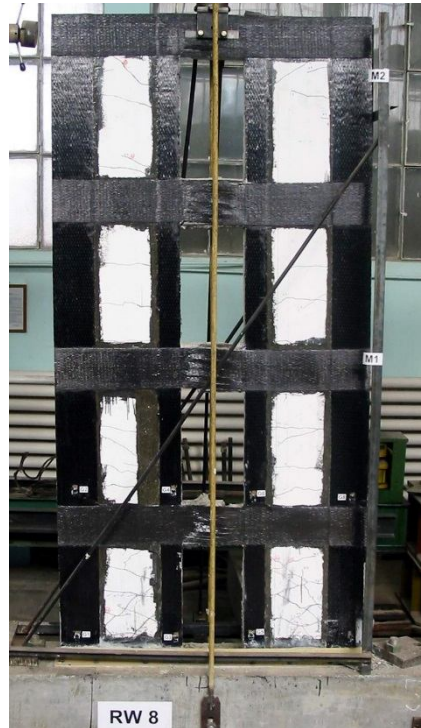
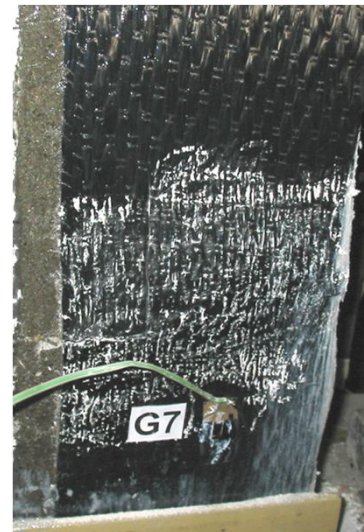
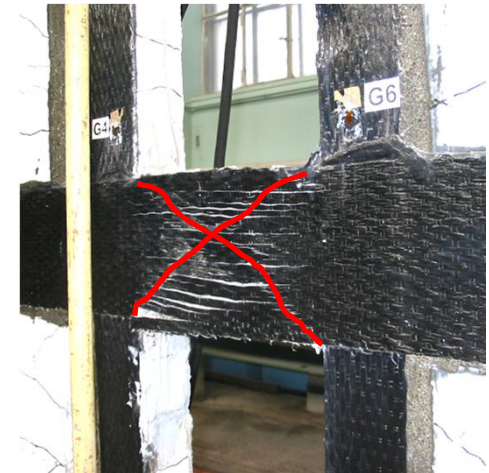
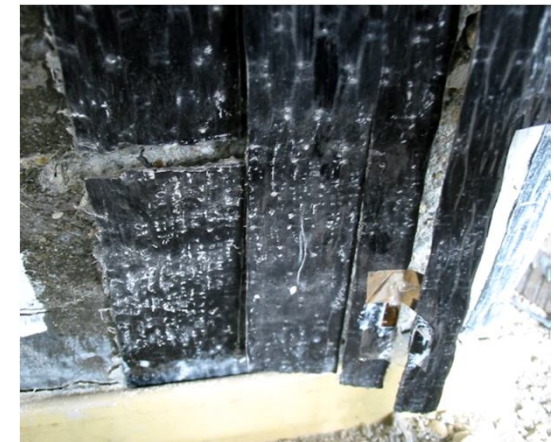
DEBONDING

**TENSION IN
COUPLING BEAM**

**TENSION
FAILURE**

- RW8 :**
- GRADUALLY OPENING OF THE CRACKS
 - CFRP DEBONDING IN COMPRESSION
 - CFRP TENSION FAILURE
 - CRACKING & FAILURE OF COUPLING BEAMS

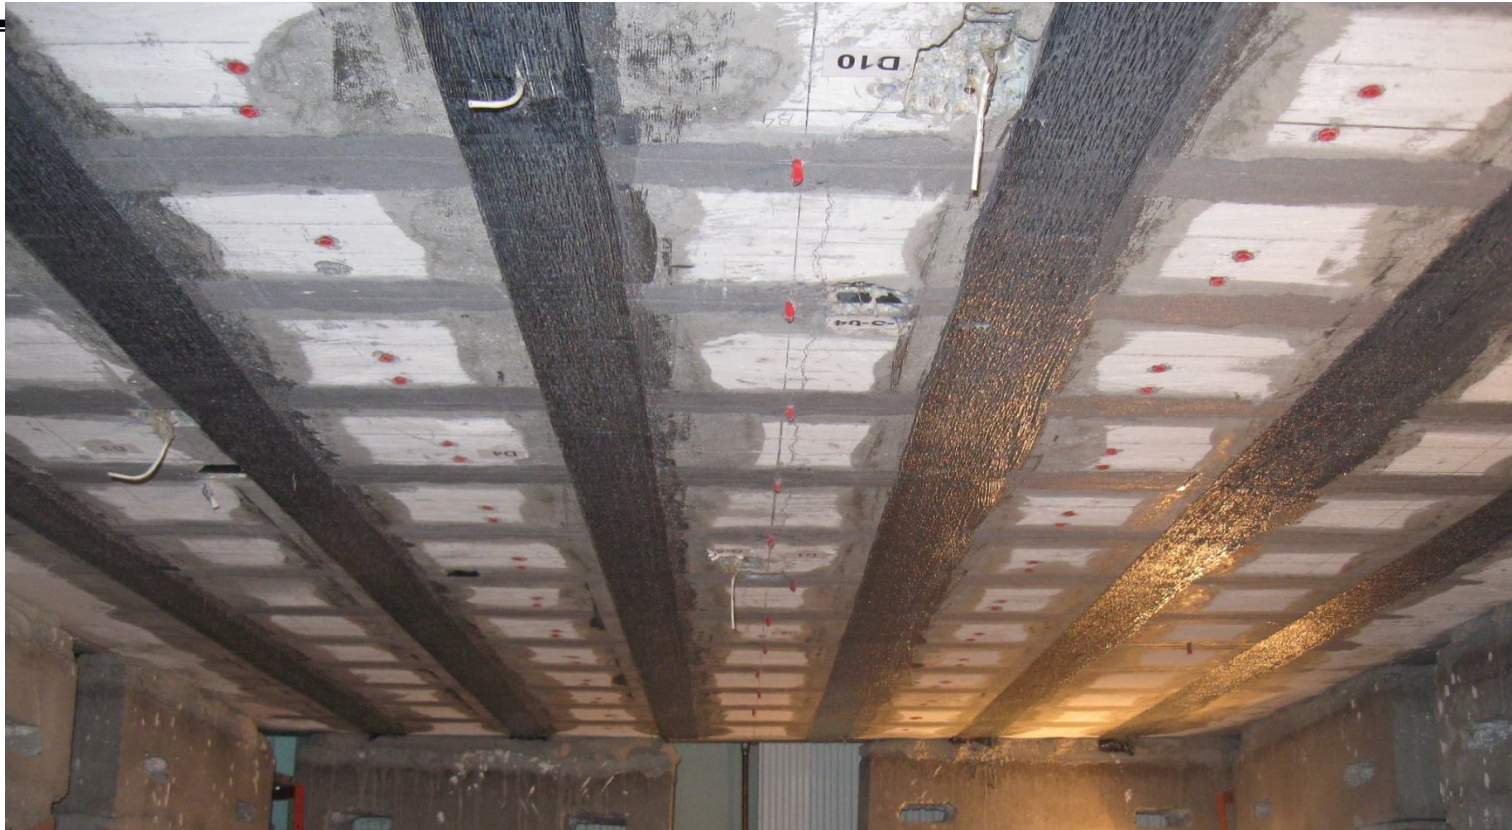
- 14 NSMR-FRP parallel to the short edge (1.2x10...2000 mm)
- 6 EB-FRP parallel to the long edge (0.12x100...3700 mm)

- tests completed so far - full slab prior to retrofitting (RCS-FS-UU-01) and after retrofitting (RCS-FS-DS-01)
- RCS-FS-UU-01
 - max load level: 113 kN (past this value, the strain in numerous reinforcement bars has reached yielding point and the vertical mid-span displacement has past the maximum allowable deflection ($L/250=2400/250=9.60$ mm)).
 - max strain in reinforcement was 7.52‰
 - max vertical mid-span displacement: 10.28 mm
 - four cracks appeared on the direction of the yield lines. The cracks originated at the corners of the load patch, being inclined at angles of 37°, 45°, 52°, and 55°.

- RCS-FS-DS-01
 - max load level: 180 kN (corresponding to a vertical mid-span deflection of 50 mm)
 - rupture in EB-FRP sheets and the NSMR-FRPs that were intersected by the principal cracks
 - max vertical mid-span displacement: 110 mm
 - four cracks appeared on the direction of the yield lines. The cracks originated at the corners of the load patch, being inclined at angles of 37°, 45°, 52°, and 55°.
