Rehabilitation and Maintenance of Buildings

Valeriu STOIAN

Lecture : 19/06/2014 – 8.30-10.00/10.30-12.00

European Erasmus Mundus Master Course

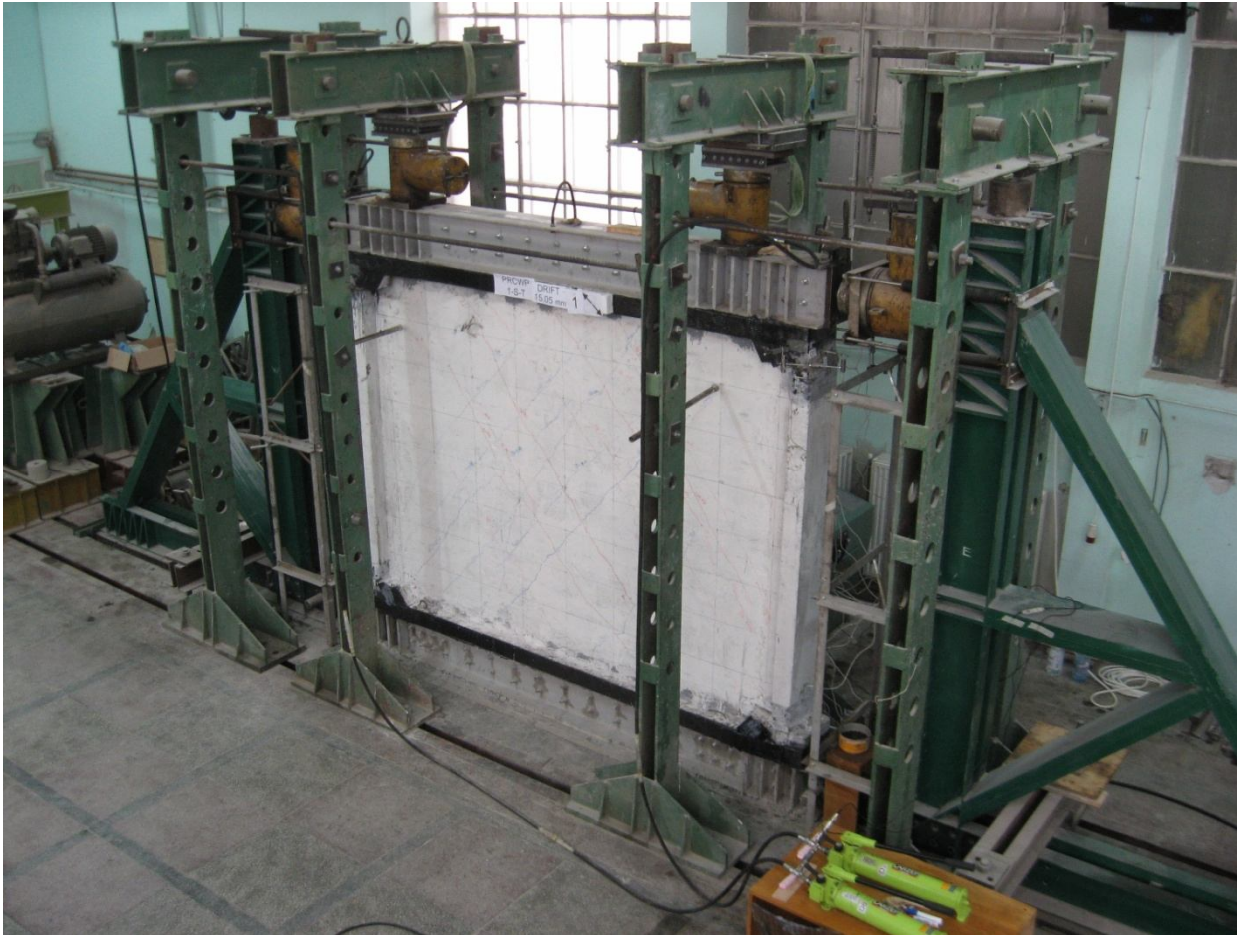
Loading degree:
 $4 = (2N+2V)$

Base and cap beams:
heavily reinforced steel
concrete composite

Base beam not fixed,
only supported

Specimen-to-base beam
anchorage: lap-welding
of 4 re-bars (ratio 0.17%)

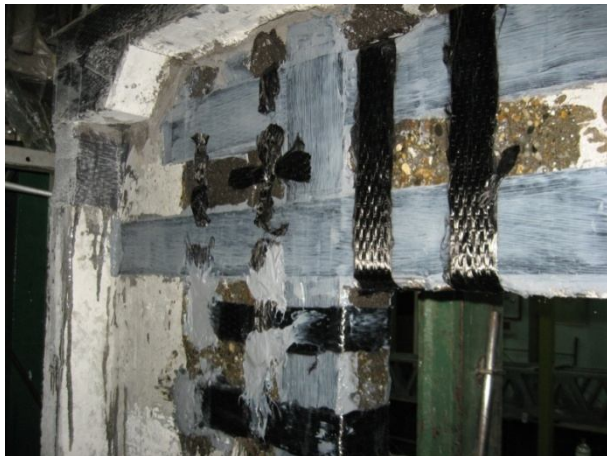
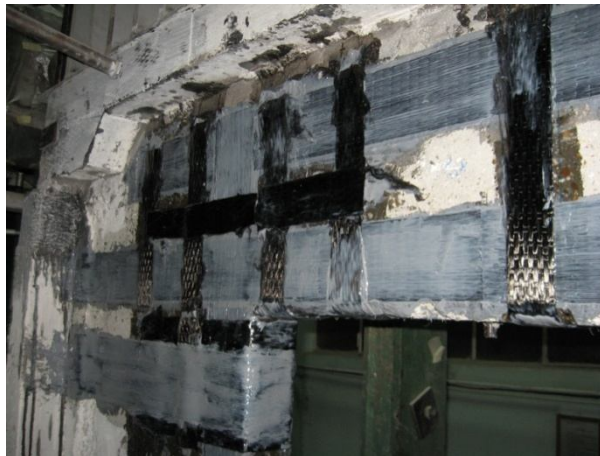
Shear strips

**Confinement
strips**

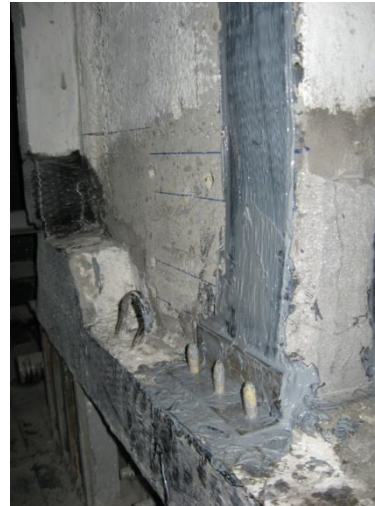
Base anchorage

Solution 1
**Bolted steel
angles**

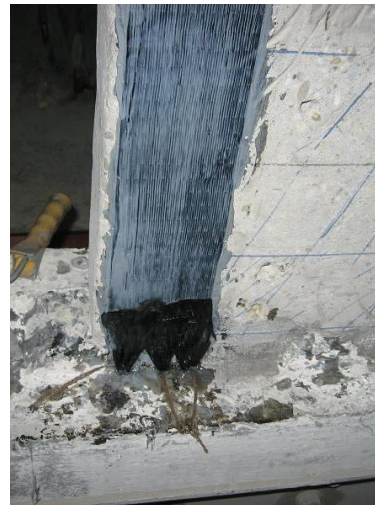
Solution 2
CFRP tows

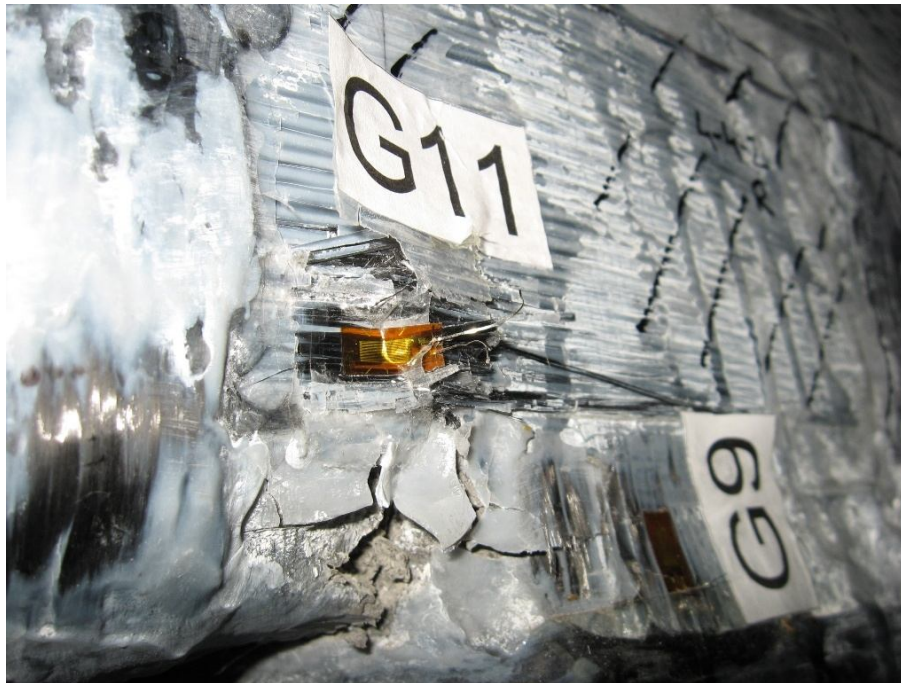
CFRP-strips subjected to alternating tension-compression reversals parallel to fiber direction are likely to fail prematurely.

Further subject-oriented investigations are necessary on this issue.

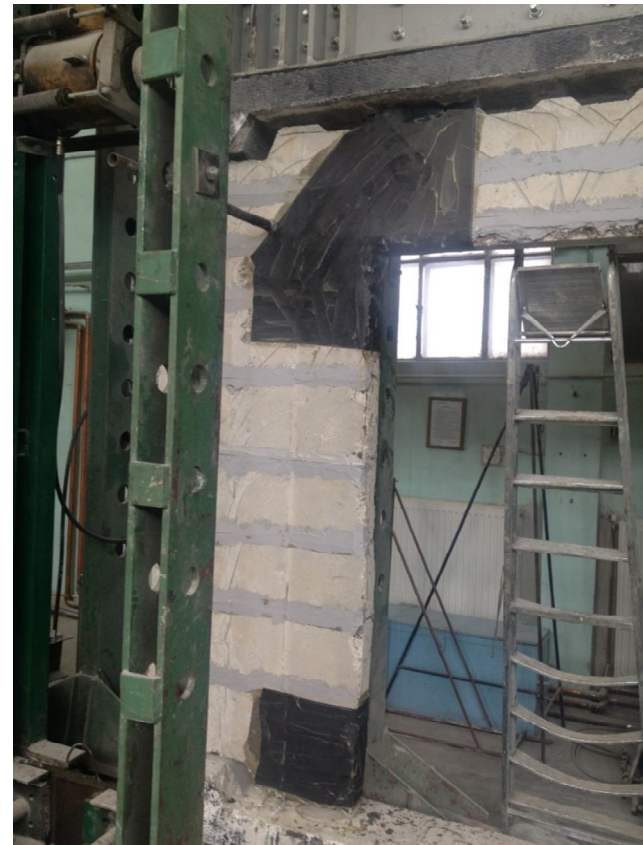
Force displacement diagram comparison

- In terms of maximum load supported by the element the PRCWP (11-L1-T) recorded 793.5 kN , while PRCWP (11-L1-T/R) 1007.5 kN.
- Drift level corresponding to the maximum load was 12.59 mm for the unstrengthened wall while for the post-damage strengthened one 8.02 mm.
- The PRCWP (11-L1-T/R) could not be taken to failure due to the available capacity of the testing facility, but analyzing the data one can remark that at a displacement level of 8.02 mm we have an increase in load bearing capacity of 60%.
- The strengthening system using TRM with CF grid proved to be the most expensive in the current experimental program (276.42 EUR/ m²), but we have to take into consideration the fact that the crack injection was not performed in the other cases and also the idea of strengthening versus retrofitting involving the carbon fiber grid wraps raised the total price.

Prior to damage strengthened wall with large door cut-out using mixed NSM-EBR technique results

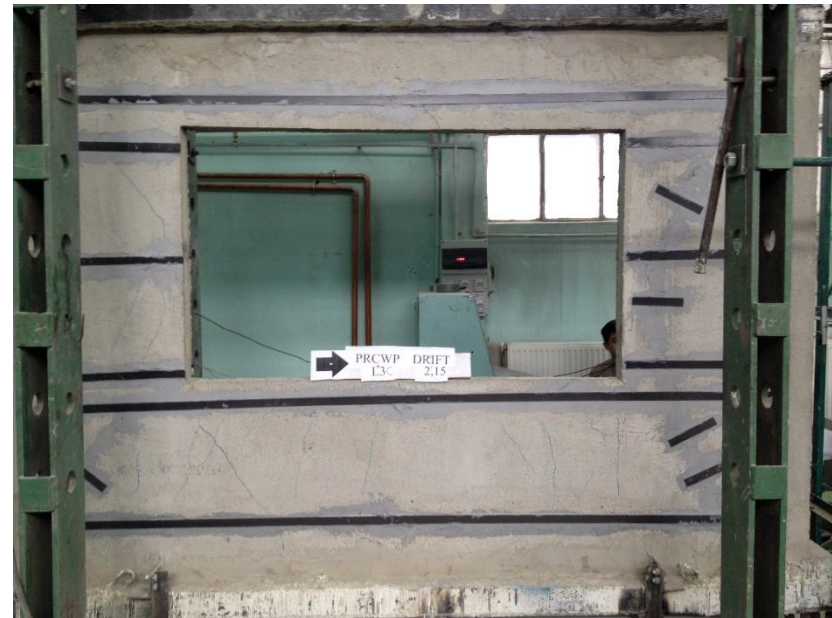
Force displacement diagram comparison

- The objective was to obtain similar bearing capacity as a PRCWP with an initial large door opening
- From the results it can be clearly seen that the retrofitting strategy was a success
- The bearing capacity was increased with 17 % from 246.5 kN to 288 kN
- The drift was 8.4 % smaller on the retrofitted specimen

Post-damage strengthened wall using EBR strips
