# Design for Fire and Robustness

# Structures after fire and Historical structures in fire

František Wald

Czech Technical University in Prague

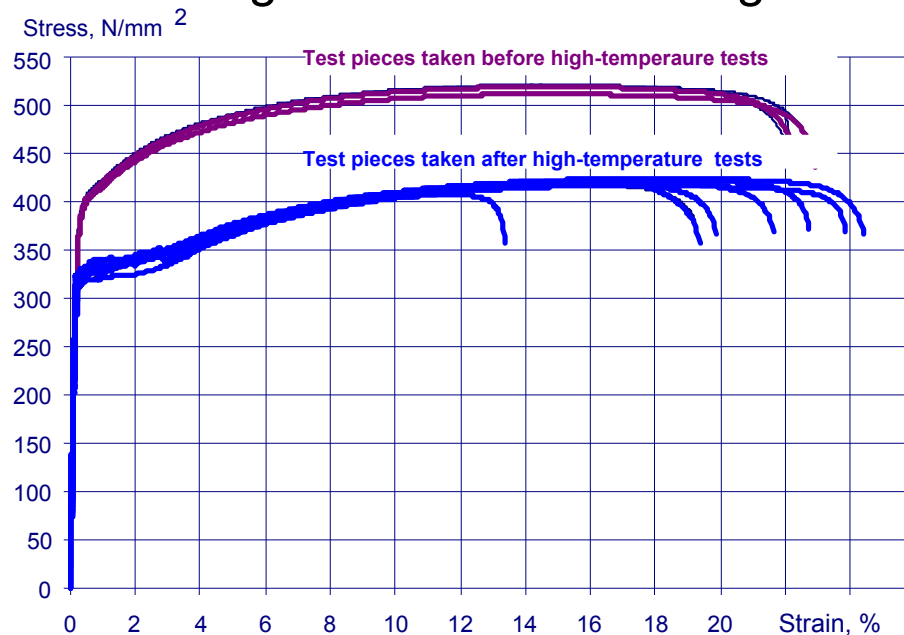
## Steel coupon test

### Steel degradation after heating to 950°C

see Outinen and Mäkeläinen, 2004

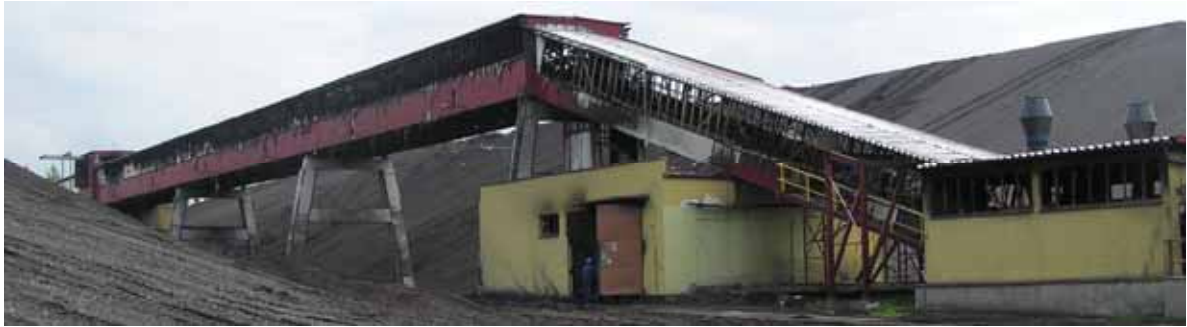
## Steel coal feeding bridge

- Fire - September 2005, Opatovice power station, Czech Republic
- Coal belt transport infrastructure completely burned
- Bearing structure noticeably damaged

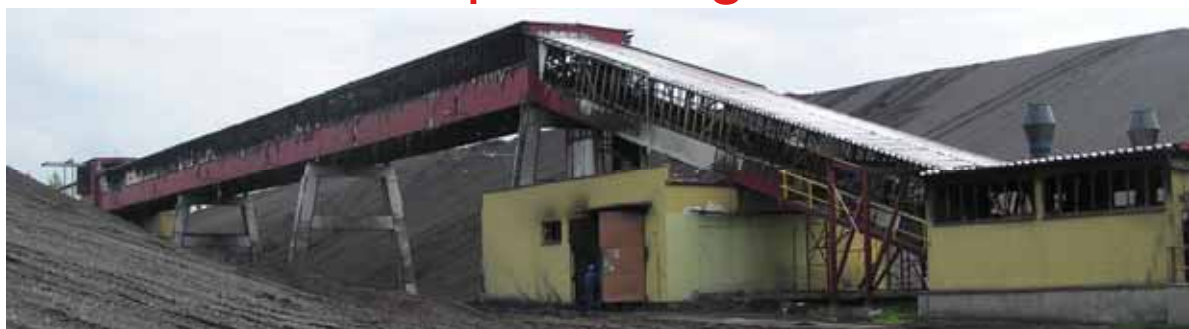
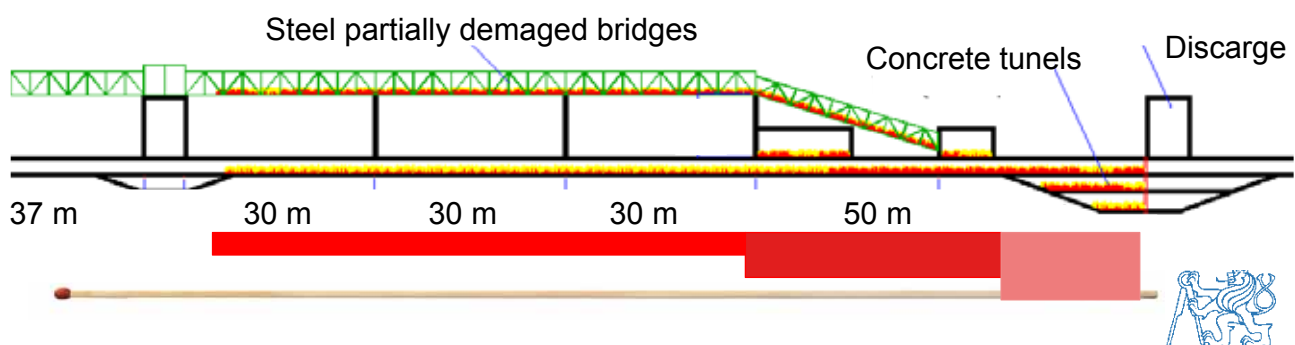
**120 m**  
of the steel transport bridges attack

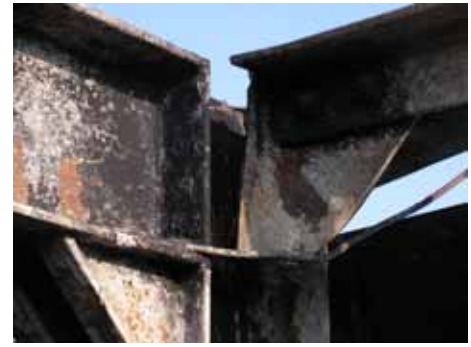
## Observations

- Geodetic measurements of major positions of the structure, joints of the trusses and the rail of the conveyor
- Geometric measurements of straightness of compressed elements
- Mechanical property by 54 coupon tests - reduction 10 %
- Microstructure of steel – changes acceptable

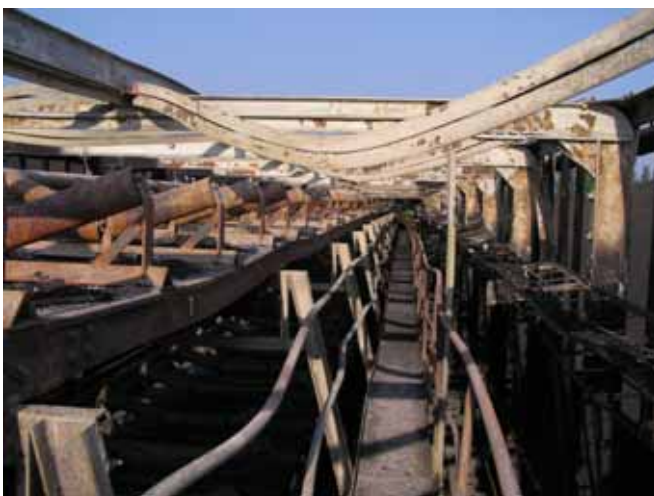
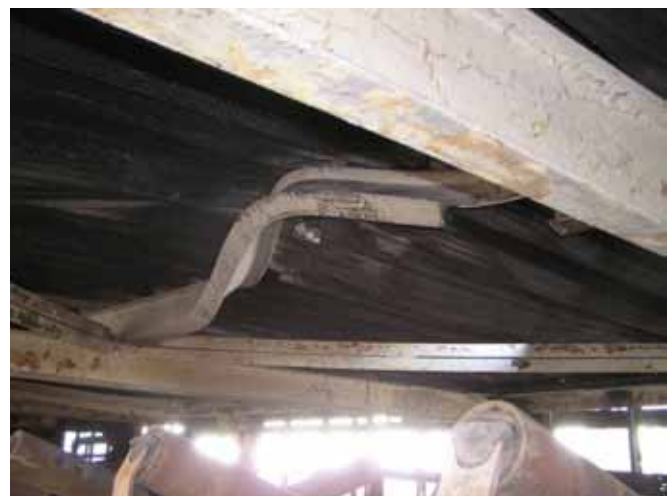
## Deformed upper stiffening truss

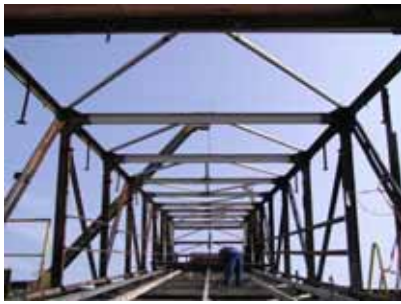
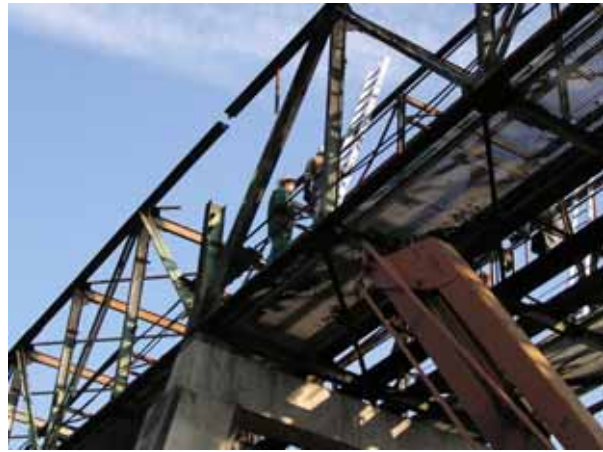
# Reconstruction

Replacing of the end frame

- Elements with excessive deformations were replaced
  - Maximum allowed out of straightness 10 mm
- Operational test after reconstruction

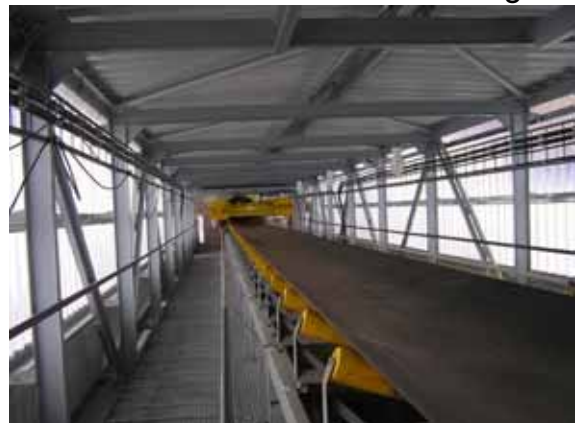
- Horizontal bridges
  - Upper truss stiffeners
  - Upper crossbeams
  - Upper parts of the props of the end stiffeners
- Inclined bridge
  - Also lower cross beams
  - Also lower stiffening trusses

View into the reconstructed bridge

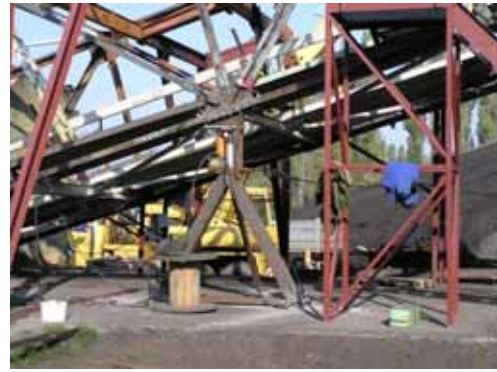
# Straightening of riveted connections

Straightening of frame geometry

- Not visibly deformed
  - After detailed calculation
    - Assumed 15 % reduction of resistance
    - Unsatisfactory connection
- strengthened by welding**

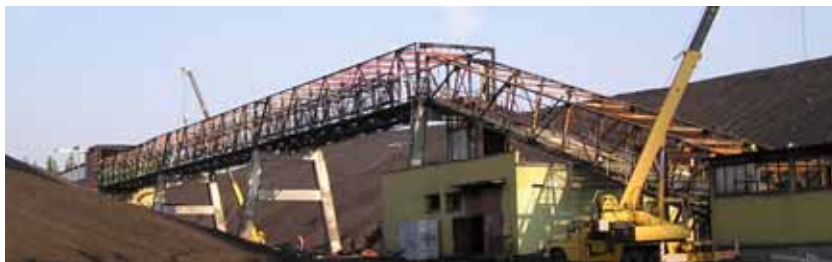
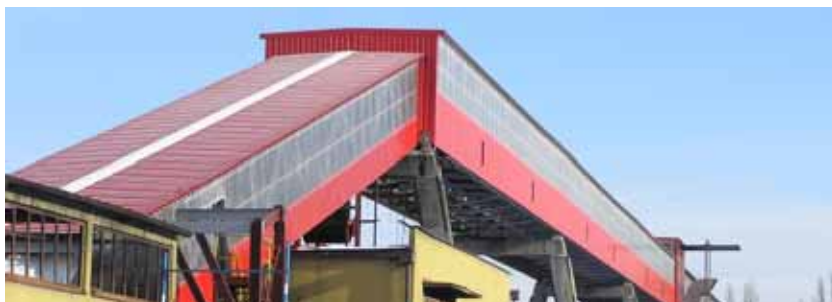
## Bridge after reconstruction

Uncovered bridge

Reconstruction in three weeks

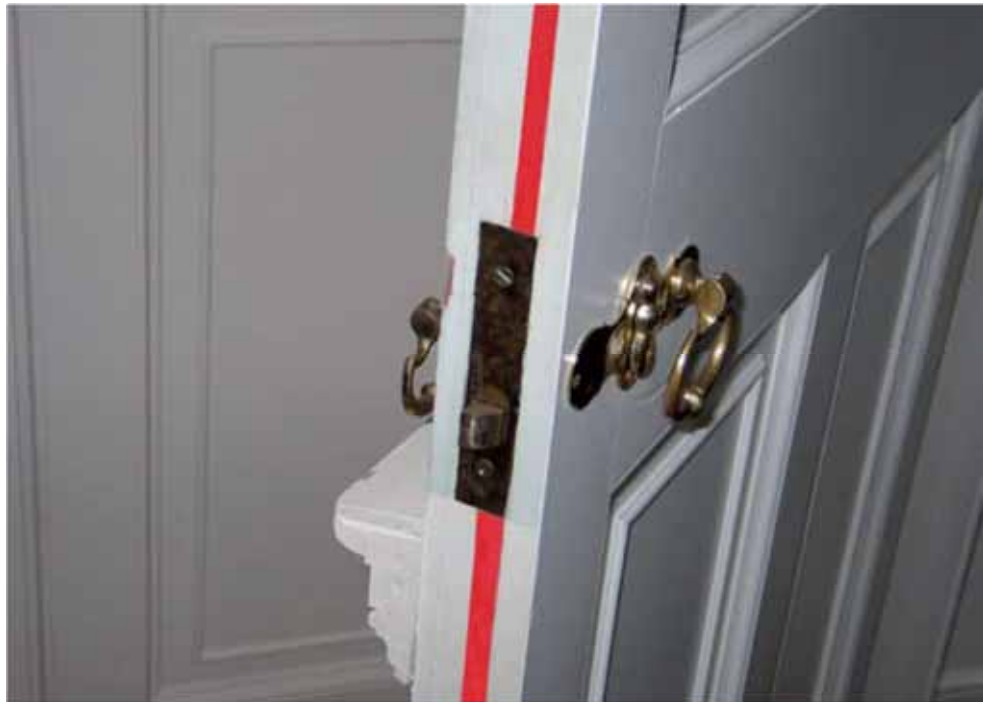
## Inserted intumescent door sealing strip

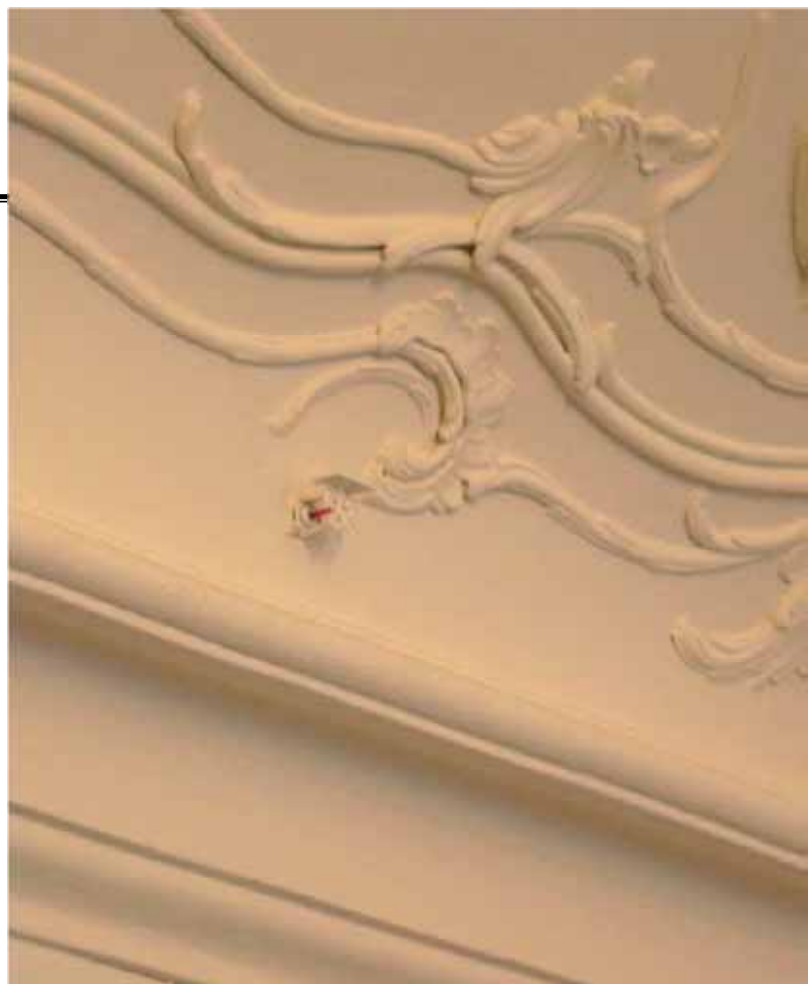
## Sprinkler

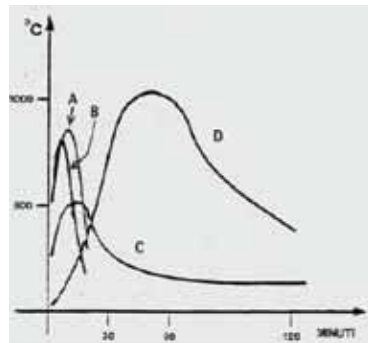
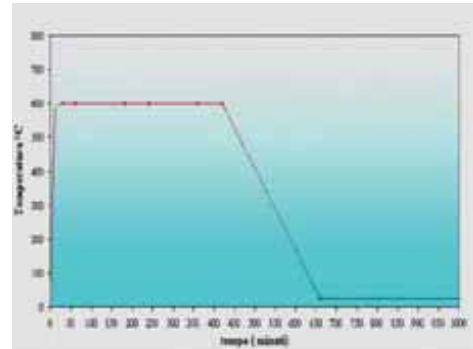
- Fire simulation by prof. Enzo Cartapati

Temperature of fire

Temperature of structure

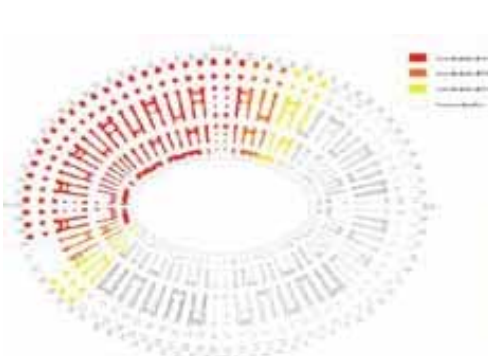
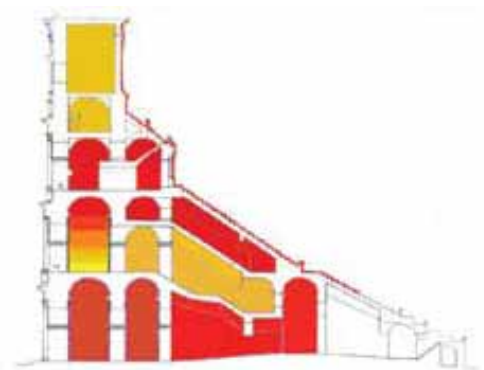
- Fire simulation by prof. Enzo Cartapati

Transfer of heat

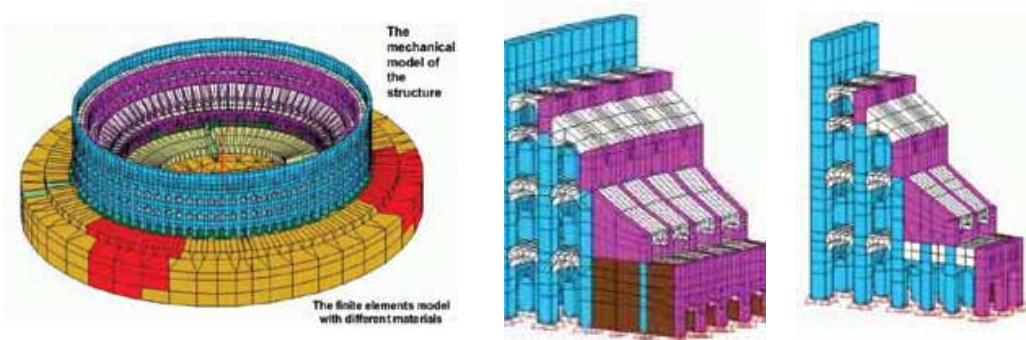
- Fire simulation by prof. Enzo Cartapati

Mechanical model
