APPLICATION OF THE CONDOR STATISTICAL MODEL IN THE CASE OF THE CLOCOȚIȘ ARCHED DAM FROM GORJ COUNTY

Albert Titus CONSTANTIN¹ Marie-Alice GHÎTESCU¹ Cristina ALEXANDRU¹

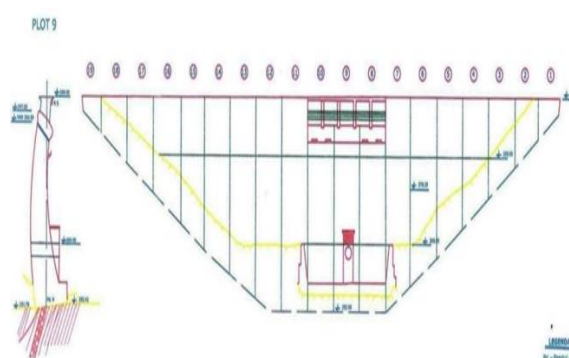
Figure 3. MCD displacement in main dam cross section

To follow the dam deformations in horizontally plan, a direct pendulum was installed on plot 9. The measurements are made both manually and automatic (WATMAN project).

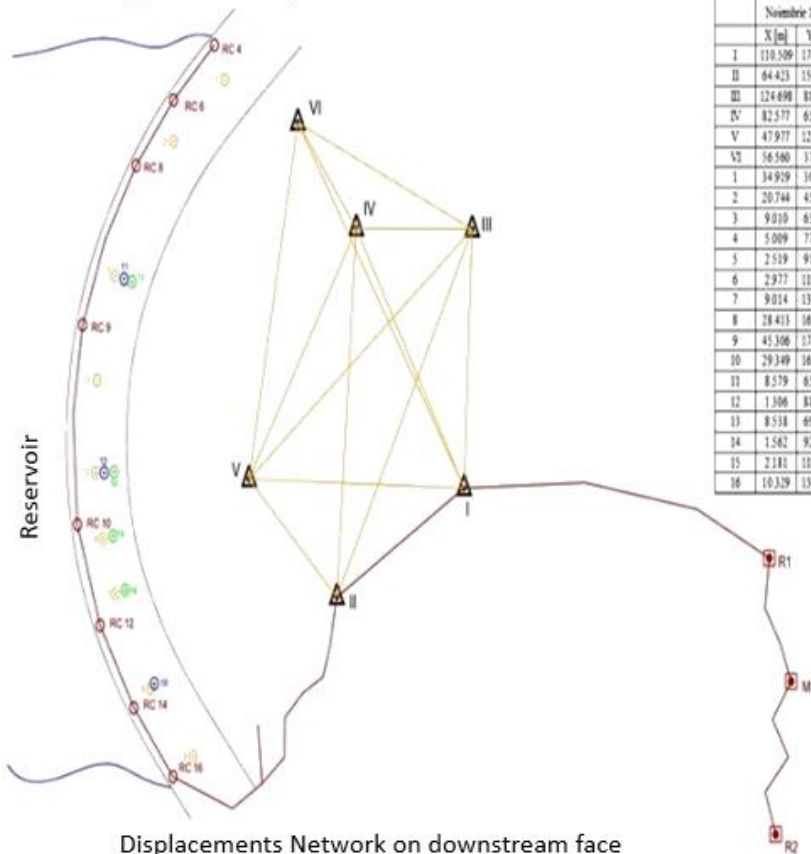
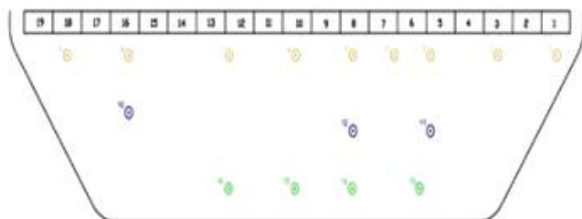
Figure 6. Level draft plan view and displacements network on downstream face

- Next are positioned six pillars of micro triangulation PI, PII, PIII, PIV, PV, PVI and are observed the 16 landmarks on the downstream face.
 - Observing the micro triangulation points is made on the Wild type level gauging stations.
