# HIGH HEAD HYDROPOWER STATION TECHNICAL REHABILITATION AND REFURBISHMENT

**Abstract.** The specific subject of the presented paper is to describe the technical and constructive rehabilitation and refurbishment of the Grebla HydroPower Station (HPS) and its annex elements. The Grebla HPS operates the discharge captured from Văliug Dam reservoir, as employed in the complex scheme of Upper Bârzava River Hydropower Arrangement, upstream of Reșița Town, south-west of Romania. The headrace gallery is loaded mainly by a bottom catchment at the base of the Gozna Dam, but also by adding the already turbinated discharge from Breazova HPS tailrace. The main headrace canal has a length of 14.2 km, accomplished mostly by excavation and lined by stone masonry with mortar. Still, about one third of the headrace length is represented by tunnels dug into the rock, some being concreted, others built in brick, and others being in natural state. In addition to these, there are also eight masonry aqueducts, with a total length of 65 m. The main canal ends at the Ranchina surging tank from where the three rivet metal penstock pipes (of 900mm in diameter) are loaded.

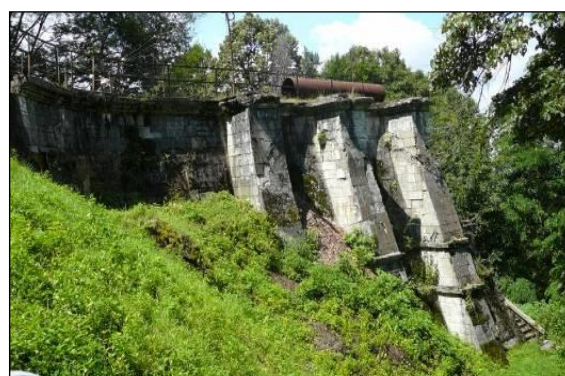
Figure 6. View of the Ranchina surge tank

This Ranchina loading tank functions also as a sedimentation basin, which from the three penstock ND900 metal pipes that supply the power station turbines start. The three forced pipes are connected with a collector from which the water is distributed to the two turbines installed in the power station.

- the washing gate is going to be replaced with a new (galvanized) one;
- two new automatic cleaning machines, equipped with hydraulically operated arms, for cleaning the grate will be installed for the grate on the access to the penstock pipes (the cleaning machine will be automatically operated from the power station control room);
- the installing area will be adapted to the needs of fitting new grates, also tailored to the requirements of the automatic cleaning machine;
- two new machines for cleaning the grate will be installed, as equipped with hydraulically operated arms.
