Transactions on HYDROTECHNICS

Volume 61(75), Issue 2, 2016

Monitoring the Văliug dam behaviour during exploitation by using topographical observations

Eleş Gabriel* Popescu Daniela* Pişleaga Mihaela*

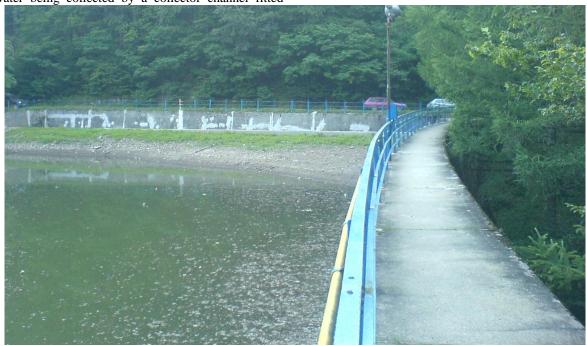
Figure 1. The left bank of Văliug Dam with the spillway, view from the left crest of the dam

The surface spillway (Figure 1) is made in free overflow manner with practical profile having a length of 37.0m, built on the left bank of the dam, the water being collected by a collector channel fitted

The collector (Figure 1) channel has a funnel shape in horizontal plane, with the width decreasing untill 4 m. and the longitudinal slopes varying between 2.5 and 9 %. The section height at the enterance of the collector channel is 503.10 mdM.

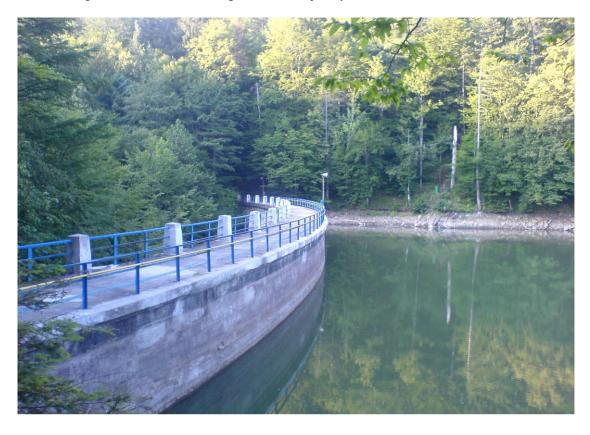
Figure 2. The right bank of Văliug Dam, view from the right crest of the dam

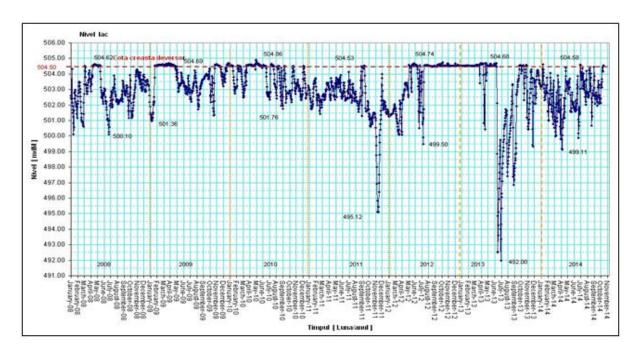
Figure 3.The daily variation of temperature from 01 January 2008 to 01 November 2014

For better surveillance on construction behaviour the topographical measurements and observations must be correlated with other observations such as water level in the basin (Figure 3), air and water temperature (Figure 4),

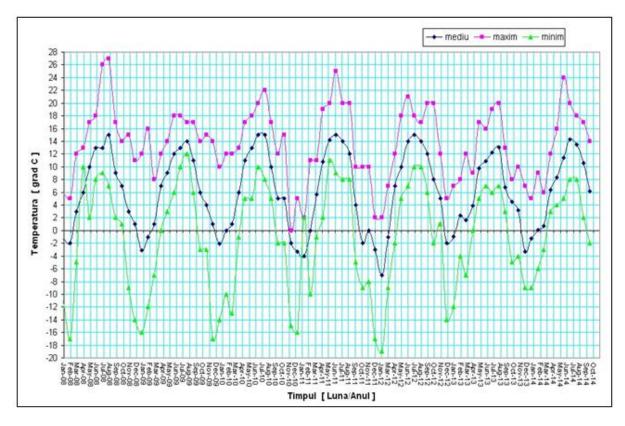
Figure 4.The air temperature variation. Average monthly values, maximal and minimal
