Modernizing Greoni –Ticvani land reclamation system

Abstract: In this paper are presented regularization works of Lisava, Oravița, Răchitova, Răchitova 1, Fragilor și Potoc Valley, reprofiling of drainage canals, completing the crossing of Greoni Ticvani land reclamation system. The draining surfaces Caras River floodplain is also are presented in the paper. The area under study is 1200 ha and includes drainage works and corresponding hydrotechnical constructions. Works that were performed had a positive effect on the environment, removing excess moisture from the soil and excess moisture from precipitations directing to drainage channels to natural emissaries

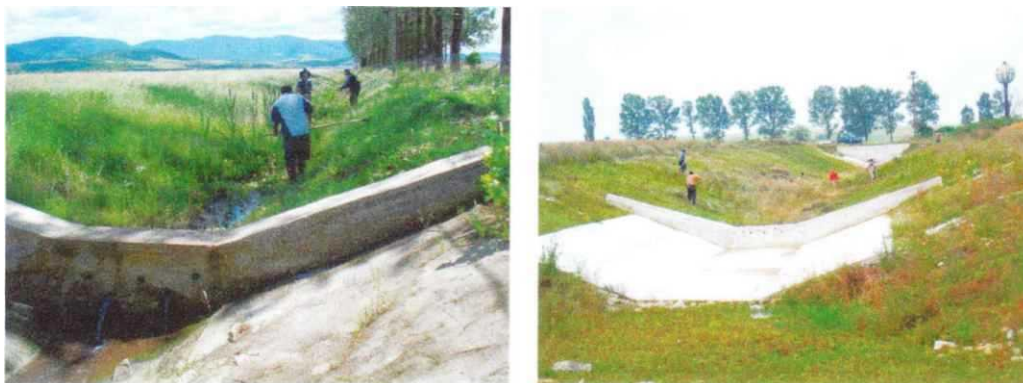
Figure1. Clean vegetation on the channels

- destruction of aquatic and woody vegetation from the channels, handmade and mechanic works with brushcutter and Stihl chainsaws, from ANIF, in an area of 1660 ha (Fig.1);

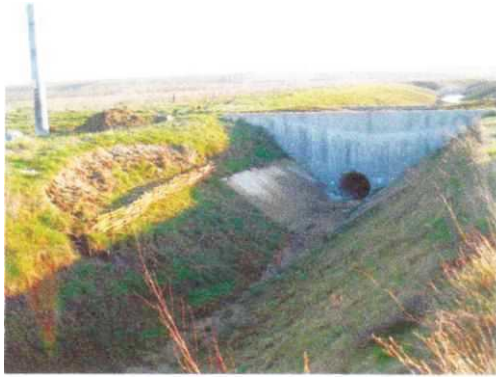
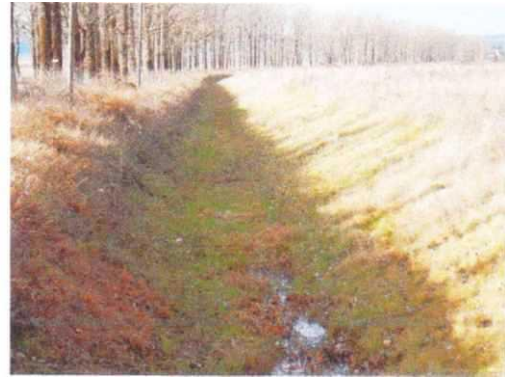
Figure2 Consolidation in embankments with wattle fences

- Strengthening the channels eroded slopes by perennial grasses, - works that was made manual by leveling, raking and seeding the slope of the channel and strengthen embankments with wattle fences in an area of 23 ha (Fig.2);

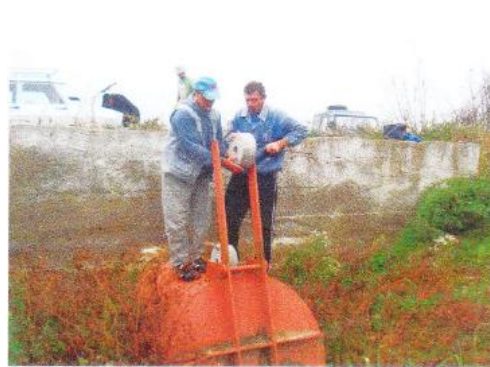
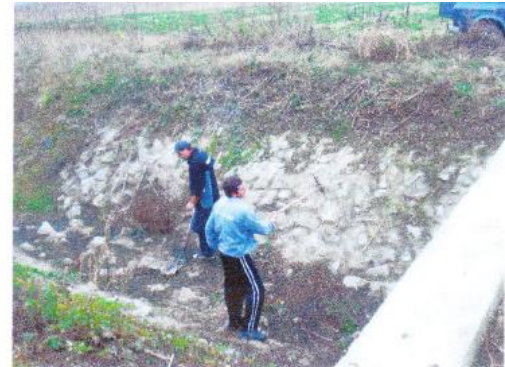
Figure3. Maintenance works on the counterweights metal clip and maintenance on bridges

- Maintenance of channels and hydraulic structures (bridges, falls, dams undercrossings with metal clip etc.) to ensure drainage section – works made manually, consisting of mud and silt cleaning the tubes and tubular culverts from the undercrossings pier, cleaning channels on small portions, damaged or clogged by heavy rains or other hazardous weather, realizing a volume of 1350 cubic meters (Fig.3);

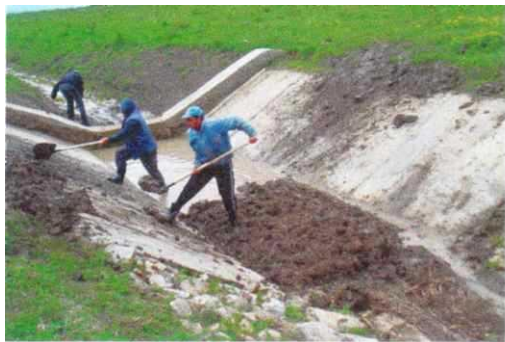
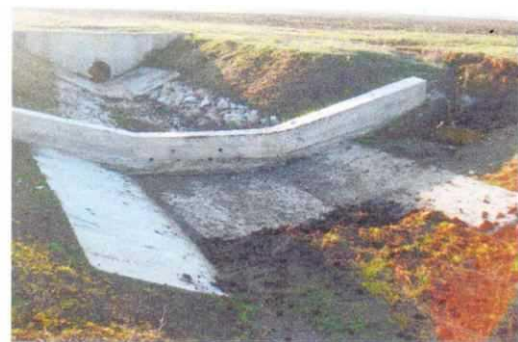
Figure 4. Maintenance thresholds and culverts

- Clogging the canals and valleys settled for mud deposits, made with draglines, excavators, bulldozers in 38.500 volume mc;
 - Repairs to the hydraulic constructions (culverts-6 PCs., falls to 5 PCs, under crossing pier, with metallic clip-2 PCs., Rapids-3 PCs.) (Fig. 4);
