Issues Regarding the Hydromorphological Pressures and their Impact on Water Quality from Surface Water Accumulation in Timiș and Bega River Basin

Abstract: Banat River Area is located in the southwestern part of Romania, covering a territory that stretches from south of the Mureș River to the confluence of Cerna River with the Danube an area of 18 393,15 km², which represents 7,7% of Romania's territory. The Banat Hydrographical Space Area is composed of six hydrographic basins and from the river basins tributaries of the the left side of the Danube River between Cerna River and Nera River. This paper analyzes the aspects of the hydro morphological pressures for Bega and Timiș River which have characteristics specific to the southwest part of the country, still they also stand out as systems with specific characteristics for each river basin and the human influence has a definite role for the water drainage in this area, some hydro technical arrangements have a history of more than 250 years in this part of Romania. The barrier lake with a surface greater than 0.5 km² are in number of 9 in the Banat Hydrographical Space and as a hydro morphological pressure they cause mainly flow

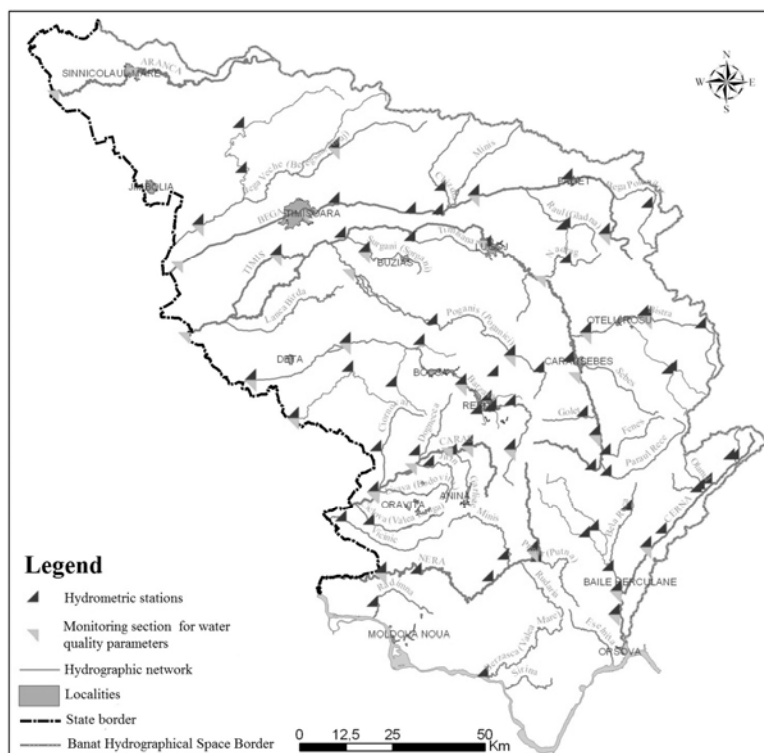
Figure 1. The monitoring network for surface waters

During 2013 [1], water quality in the Hydrographical Space Banat was tracked through 36 monitoring sections with a frequency of monthly monitoring of physical - chemical parameters and indicators 4 times a year for the biological and bacteriological parameters. Also, there were a total of 10 lakes surveyed, namely: Surduc in Bega River Basin; Trei Ape, Poiana Mărului, Gozna and Secu in Timis River Basin; Buhui and Dognecea Mică in Caraș River Basin; Taria in Nera River Basin; Valea lui Iovan and Herculane in Cerna River Basin. From these, the barrier lake Buhui, Dognecea Mică and Taria have a surface of less than 0.5 km² (Figure No. 1).

The samplings were made from sections established for each lake, in dam area, in the middle inlet lake (lake tail) and major branch. Samplings were performed, depending on the location of the section, on multiple vertical. Generally, the frequency of sampling is four times a year for all indicators, except sections capture from reservoirs aimed water supply to the population, when the frequency can be greater (4-12 times per year). Samples were analyzed for physico - chemical, biological and microbiological point of view.
